# Environmental Management and Monitoring Plan (EMMP)

*Overall - HDB Central Development*

**Housing and Development Board (HDB)**

2630017-002-Rev0

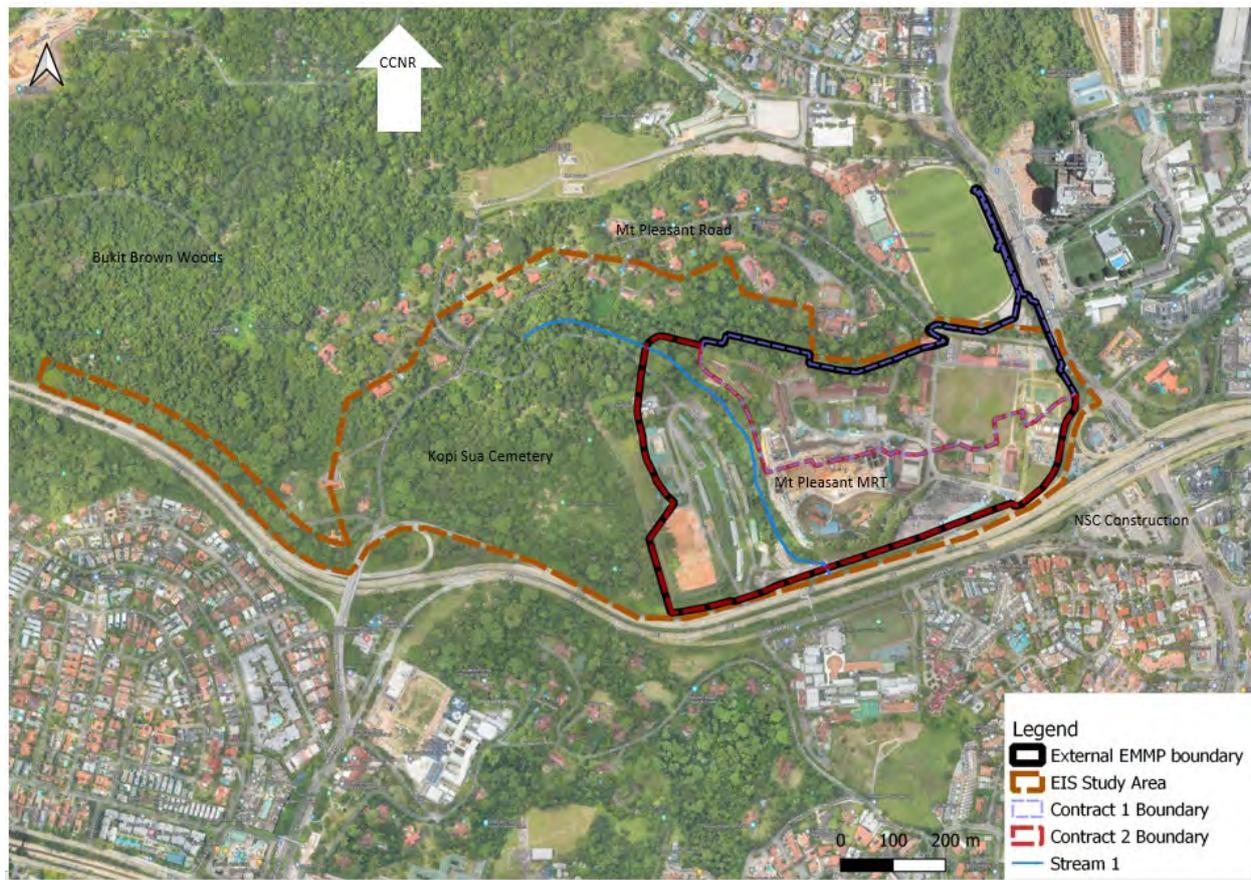
Figure 1: Map showing the EIS Study Area, the Overall EMMP and Contract 1 and 2 boundaries

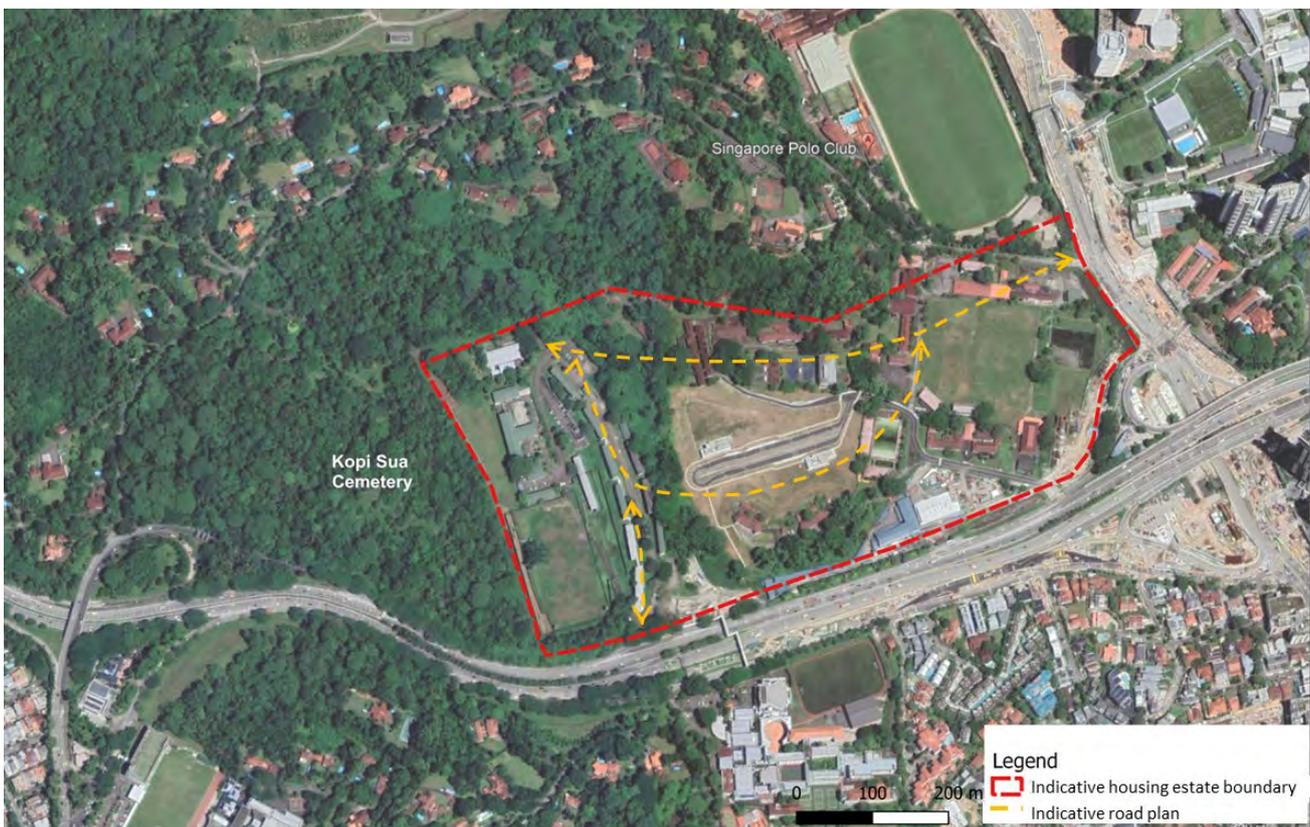
**Figure 2: Site's Conceptual Development Plan**

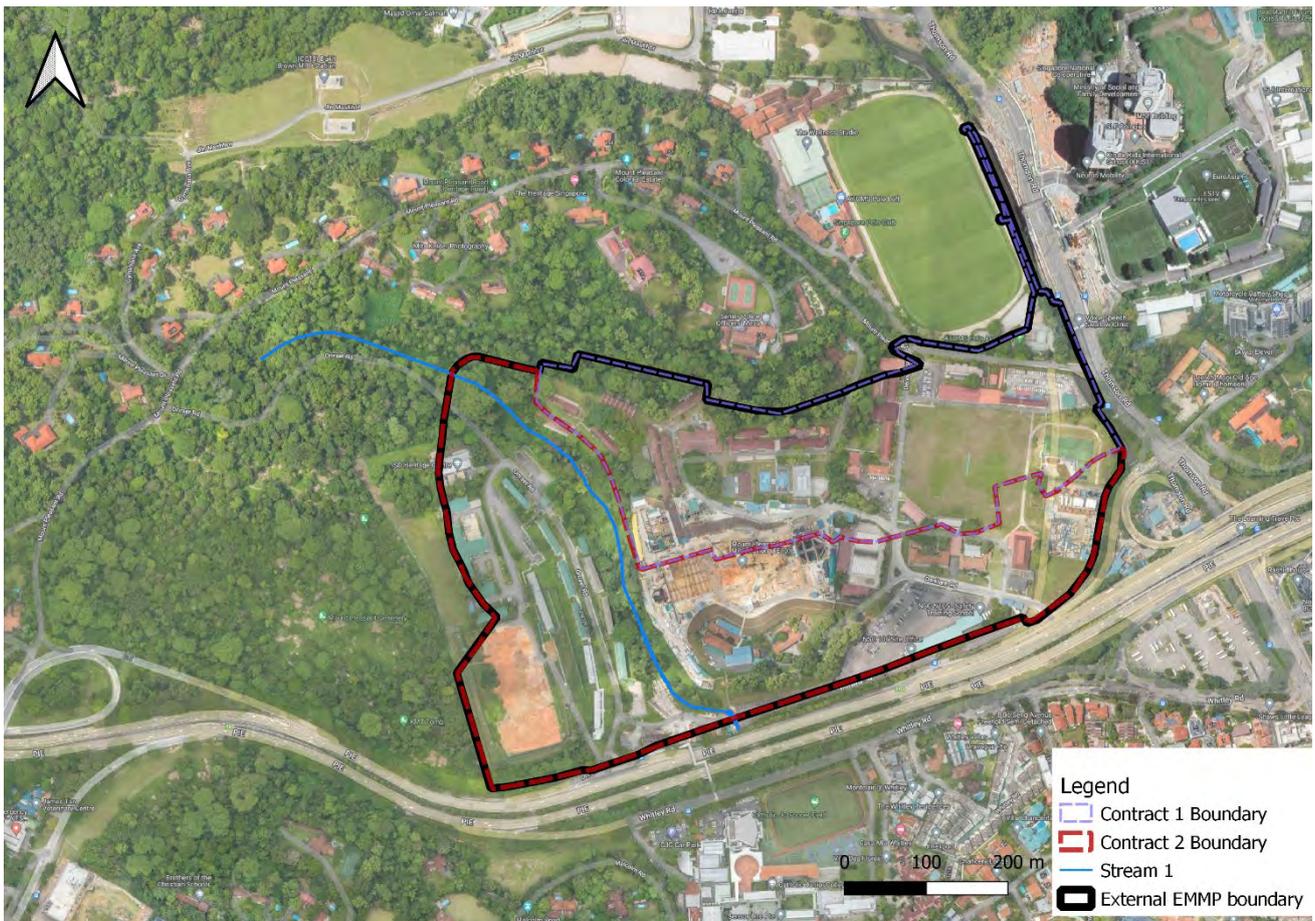
**Figure 3: Stream 1 within the Overall EMMP boundary**

The Contractor is required to submit an Erosion and Sediment Control Plan (ESCP) and, the ECM should be planned in relation to the phased handover of the Site. Stream 1, a habitat identified of high importance within the Site, runs along the western part of the Overall EMMP boundary (Figure 3). A buffer of 12 to 30 m from the stream and Contract 1 boundary is included to ensure the upstream (approximately 30%), which is outside the EMMP boundary, will be preserved fully. The 70% of the stream within the Overall EMMP boundary will be diverted as part of Contract 2.

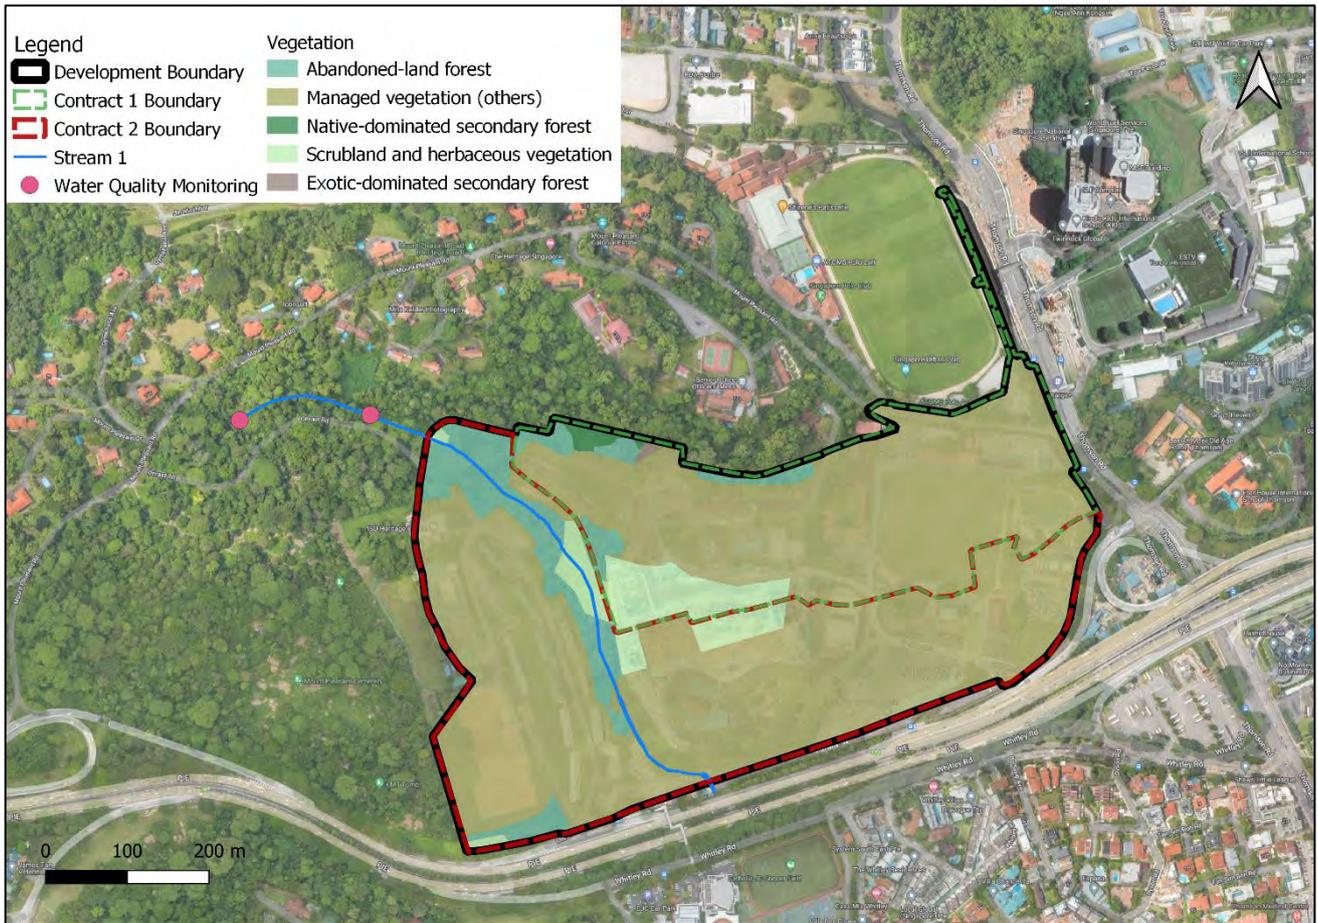
**Figure 10: Locations of water quality samples**

Monitoring of water quality was carried out in two locations upstream of Stream 1 by means of in-situ water quality parameters including temperature, pH, conductivity and dissolved oxygen (DO). Water samples were collected and sent for analysis of the NEA Trade Effluent Discharge parameters for uncontrolled watercourse.

The results of water samples at both locations were found to be within NEA allowable limits for uncontrolled watercourse and were found to be suitable for aquatic life.

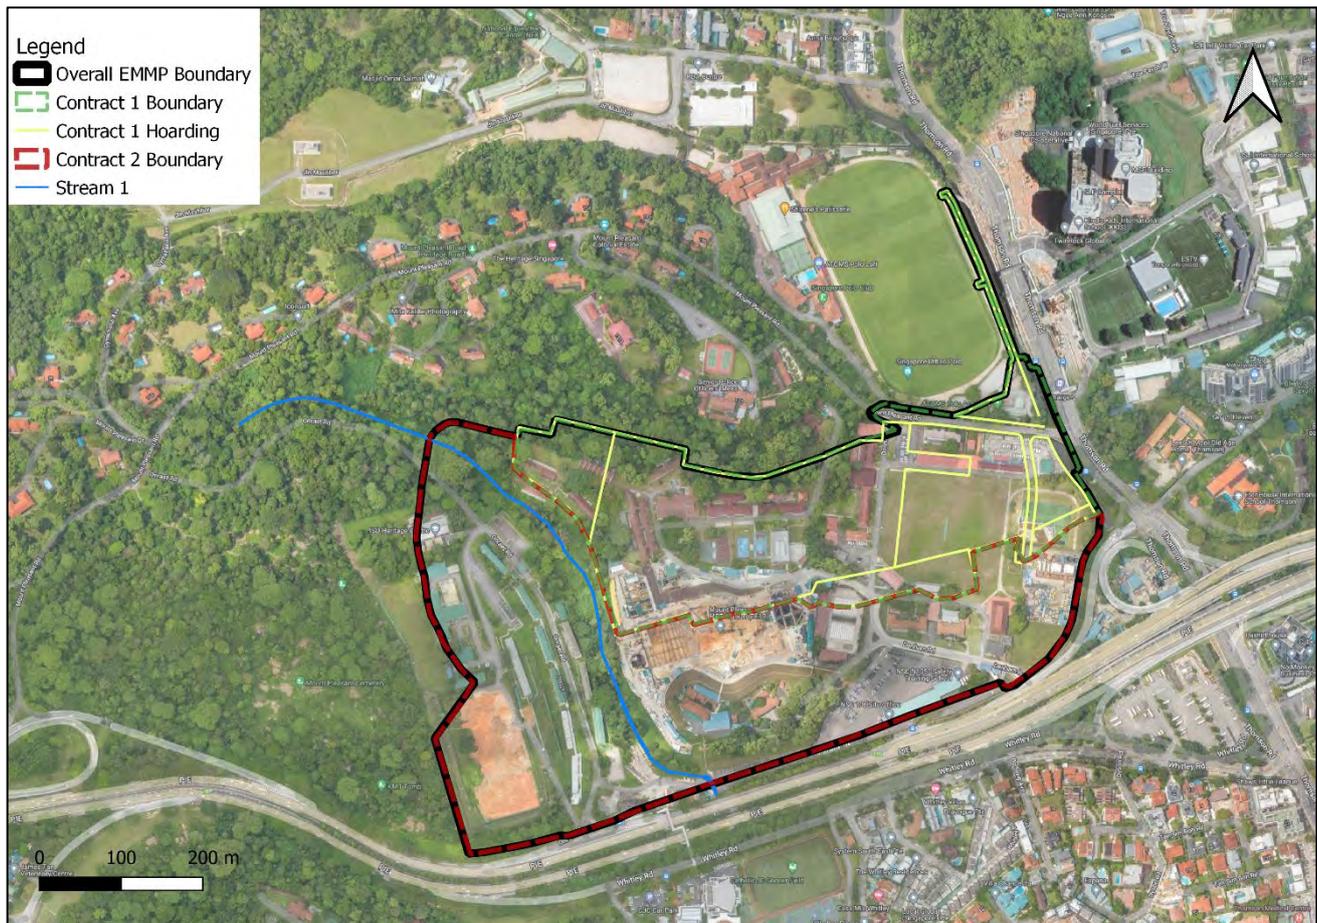
**Figure 12: Hoarding plan for Contract 1**

Based on the recommendations in the gazetted EIS (2021), HDB plans to conserve the upstream 30% of Stream 1. A 30-m buffer is to be maintained on either side of the stream to preserve forest habitat for the aquatic fauna in Stream 1. The lower part of Stream 1 within the Overall EMMP boundary will eventually be diverted as part of Contract 2. While the stream is not yet diverted, the hoarding of Contract 1 will be erected 12 to 30m away from Stream 1 (Figure 12).

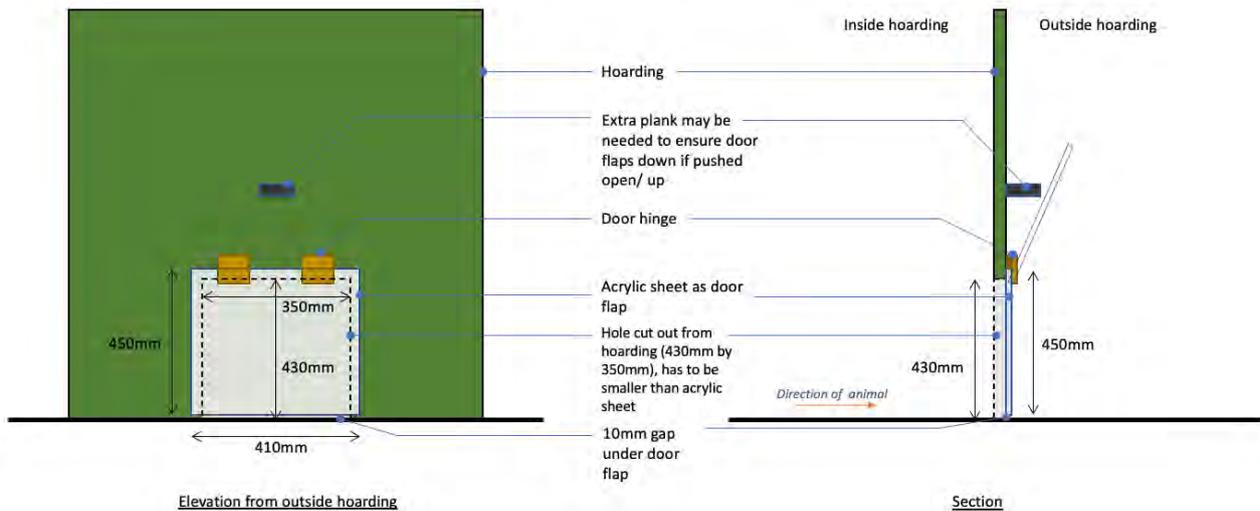
**Figure 13: Diagram of wildlife exit point**

After installation of the hoarding, internal barriers, and wildlife exit points, the Ecologist will inspect the integrity of the structures to ensure it meets the specifications listed above.

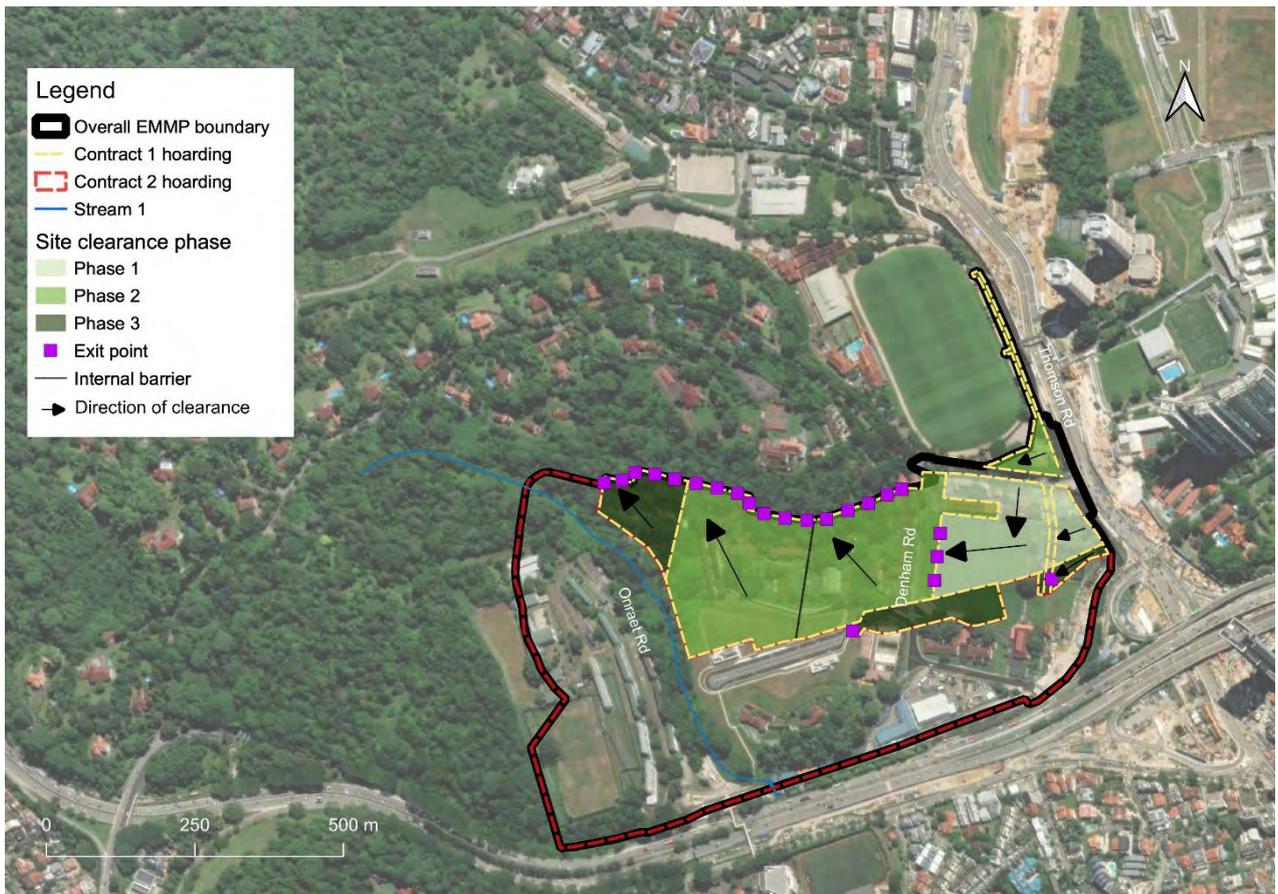
Figure 14: Direction of Site clearance – Contract 1

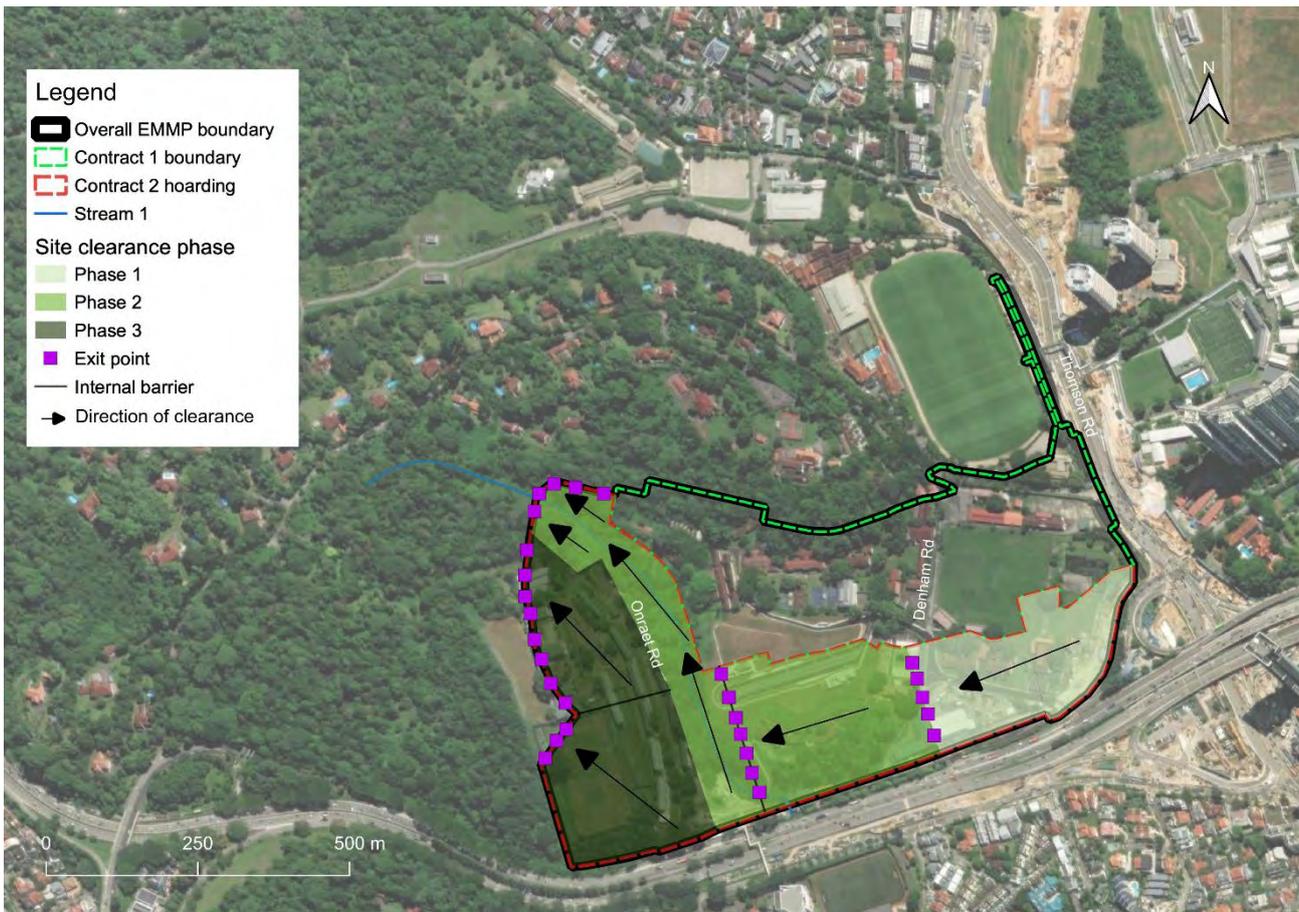
**Figure 15: Indicative direction of Site clearance – Contract 2**

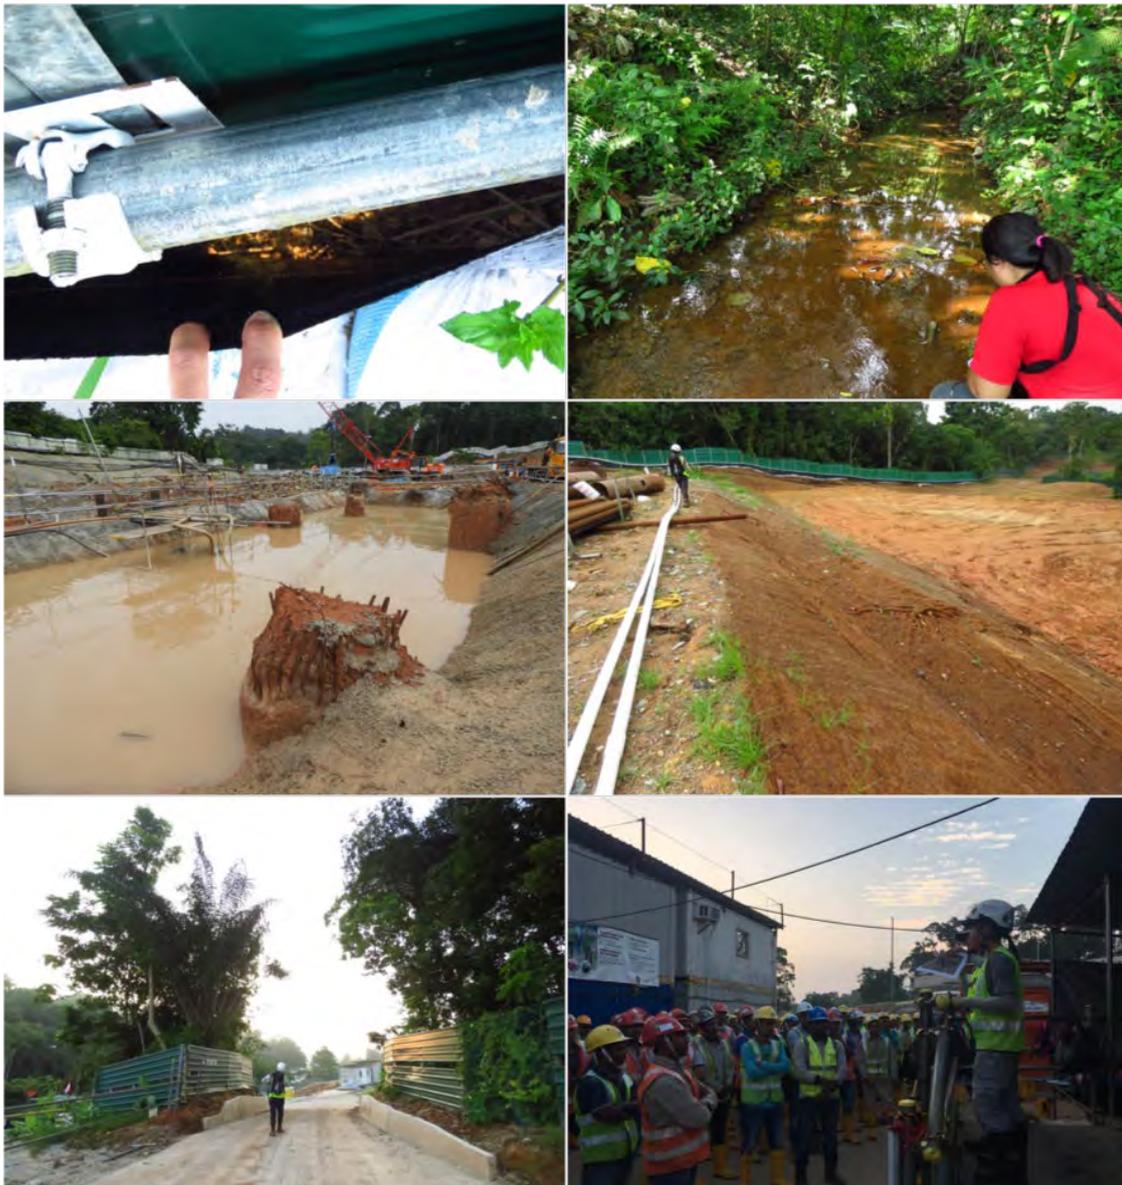
**Figure 18: Fauna inspections every two weeks to ensure the integrity of hoarding, and that no fauna entrapments exist on site (e.g., ECM sedimentation ponds, erosion control blankets, tree protection zones, and biodiversity awareness training for site personnel)**

Fauna inspections will be conducted by the Ecologist within the Contract boundary every two weeks. The following will be noted during the inspections:

- Presence of trapped/injured/dead fauna.
- Potential fauna entrapments (e.g., ECBs, TPZs, pits, drains, ponds, trenches, tanks).
- Gaps in hoarding that may allow entry of ground-dwelling fauna.
- Improperly disposed/stored food and food packaging.
- Unauthorised discharge or siltation into the upstream portion to be conserved (i.e., outside of the overall EMMP boundary)

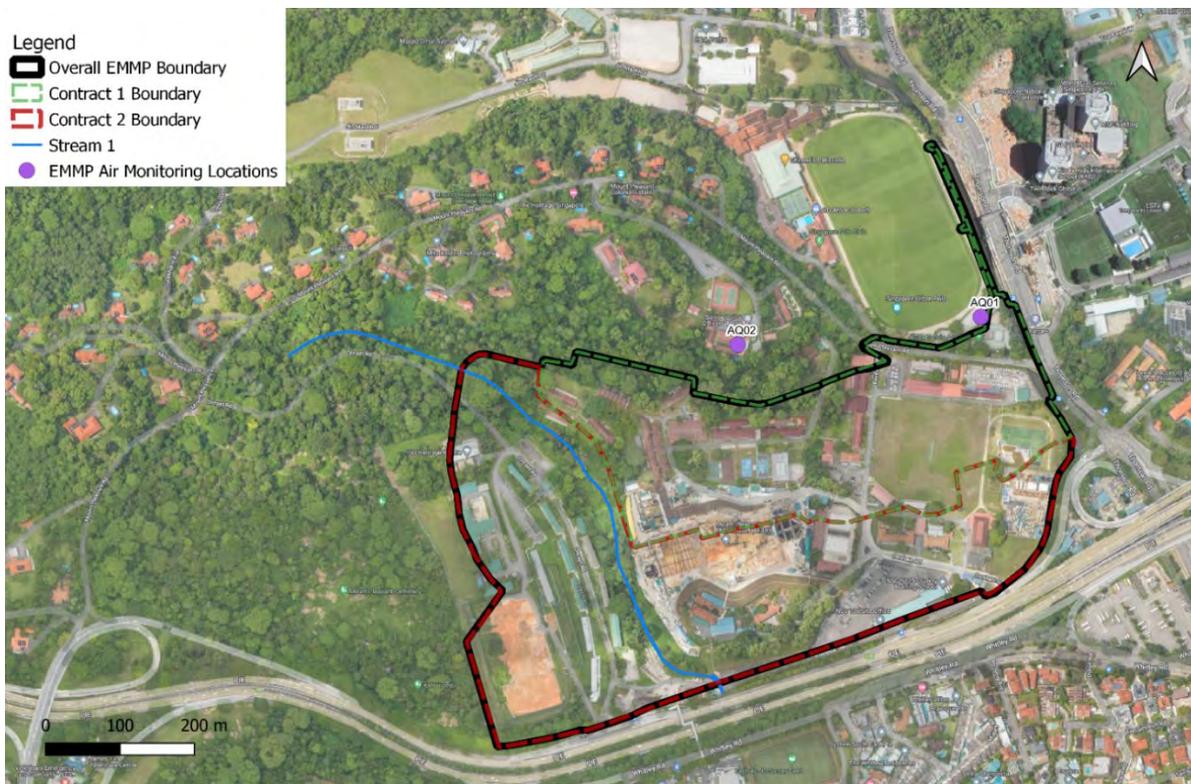
**Figure 20: Proposed EMMP for Air Monitoring Locations**

Location	Parameters	Frequency and Duration
<ul style="list-style-type: none"> <li>■ AQ01 - Singapore Polo Club</li> <li>■ AQ02 - 157C Mount Pleasant Road</li> </ul>	PM <sub>10</sub> and PM <sub>2.5</sub>	<ul style="list-style-type: none"> <li>■ Particulate monitoring prior to construction to establish the pre-construction levels.</li> <li>■ Continuous particulate monitoring during the earthworks and infrastructure phase.</li> </ul>

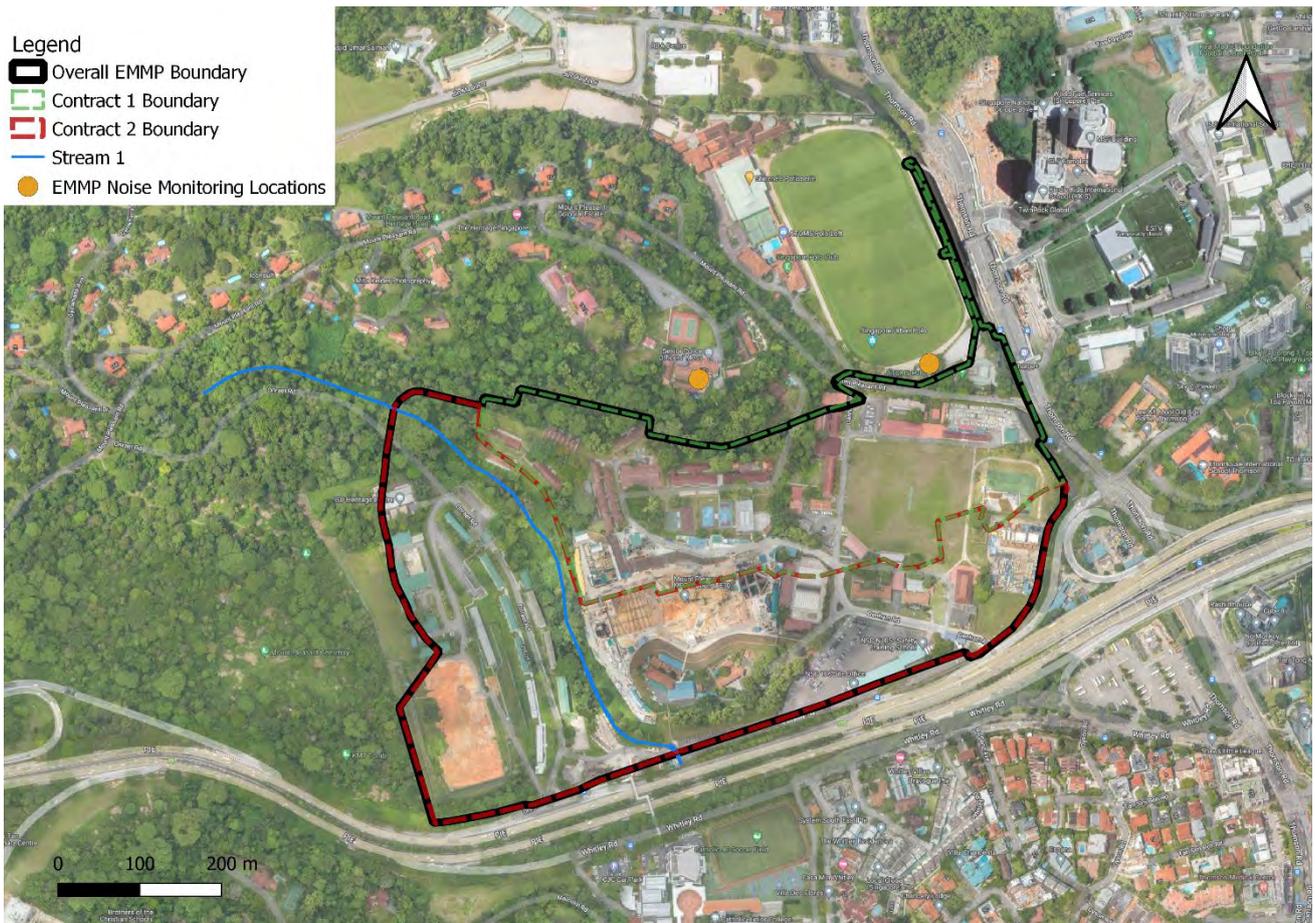
**Figure 21: Proposed EMMP Noise Monitoring Locations**

Location	Parameters	Frequency and Duration
Monitoring at the following locations: <ul style="list-style-type: none"> <li>■ NQ01 - Singapore Polo Club</li> <li>■ NQ02 - 153 Mount Pleasant Road</li> </ul>	$L_{Aeq}$ (12 hour), $L_{Aeq}$ (1 hour), and $L_{Aeq}$ (5 min)	<ul style="list-style-type: none"> <li>■ 7-day pre-construction baseline</li> <li>■ Continuous noise monitoring for the entire duration of the earthworks and infrastructure phase.</li> <li>■ In the event of a valid complaint, once a month in the area where the complaint is for as long as the particular complaint related construction activity continues.</li> </ul>

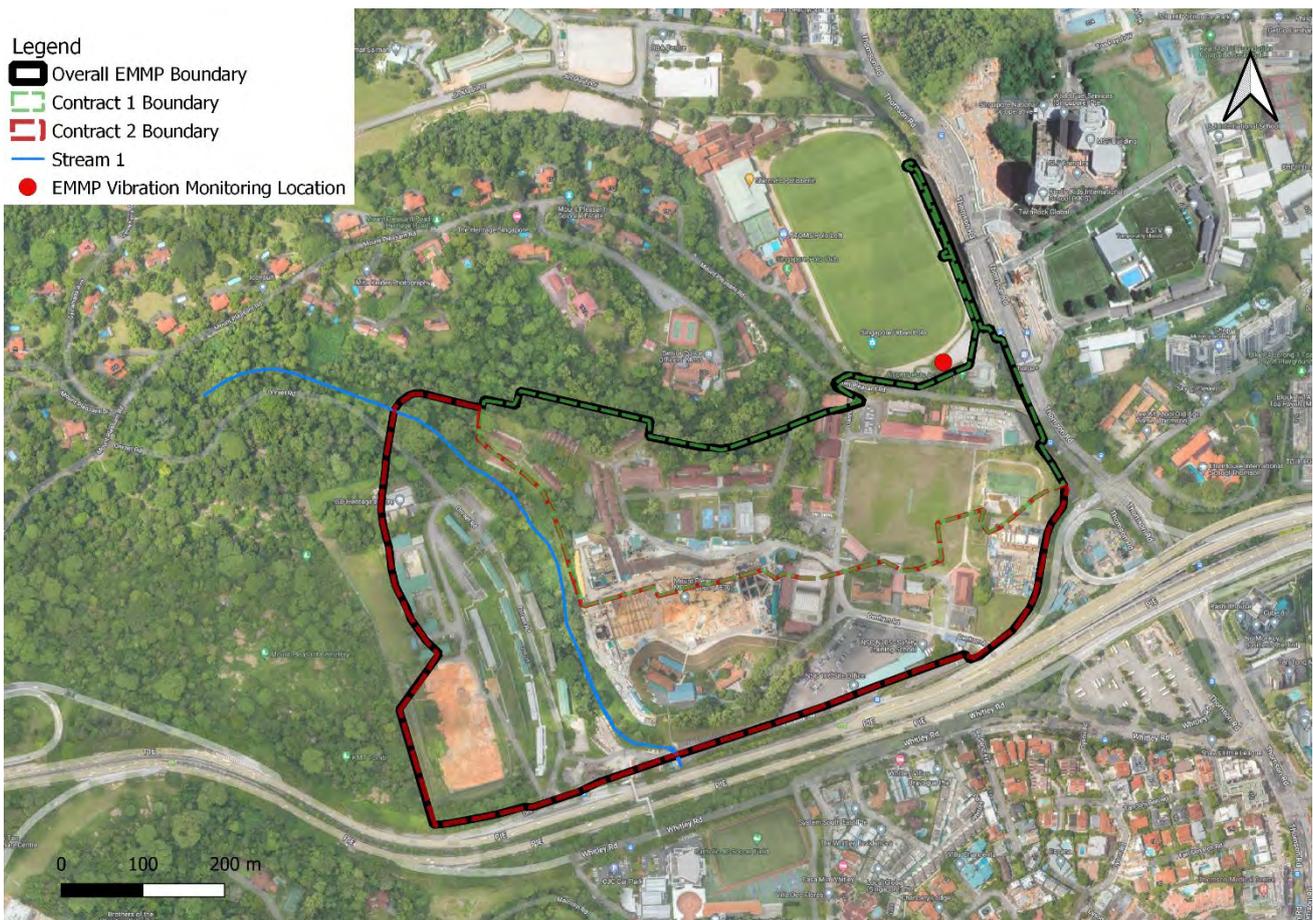
**Figure 22: Proposed EMMP Vibration Monitoring Location**

Continuous monitoring is recommended at the Singapore Polo Club vicinity (Figure 22) to determine any trigger levels during the construction works. This location is assessed as representative of general vibration impact to nearby receptors.

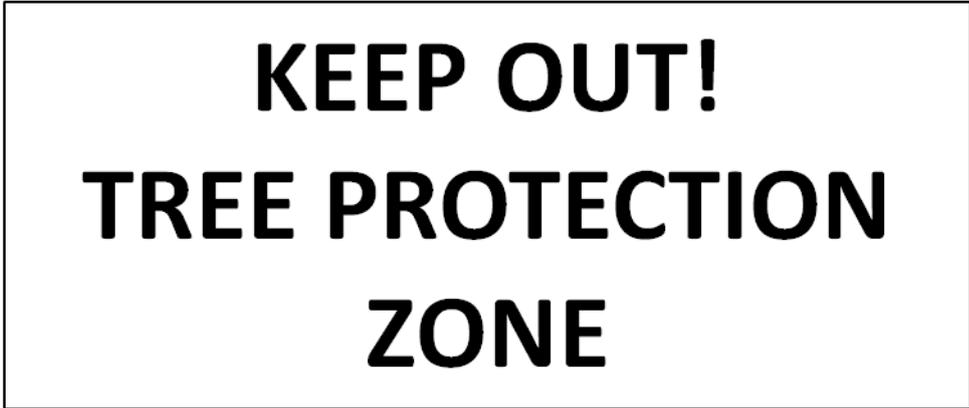
A readily-visible and waterproof sign shall be installed on all sides of the fencing around each individual protected tree. The size of each sign must be a minimum of 300mm wide and must contain the wording below:

**KEEP OUT!**  
**TREE PROTECTION**  
**ZONE**

Entry prohibited. This fence shall remain in place throughout the entire construction period.

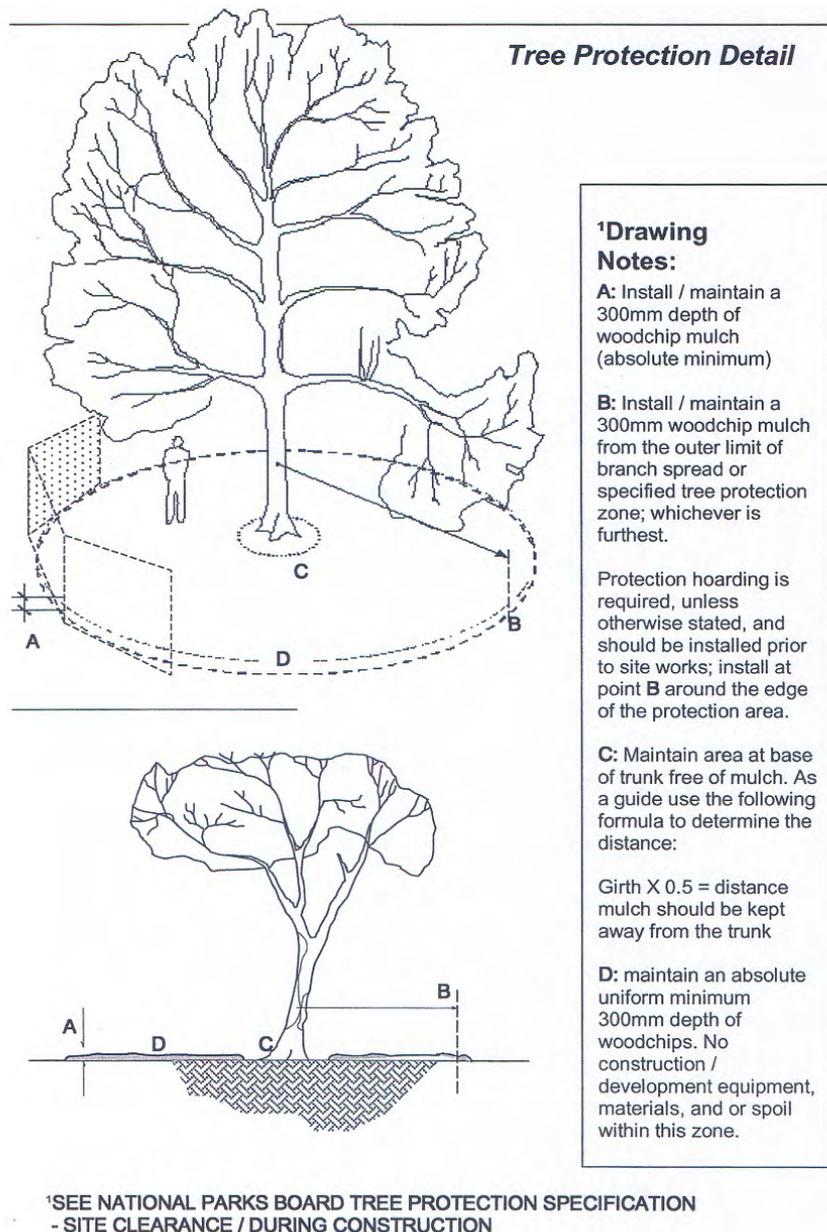
A diagrammatic representation of a proper Tree protection zone is presented below.

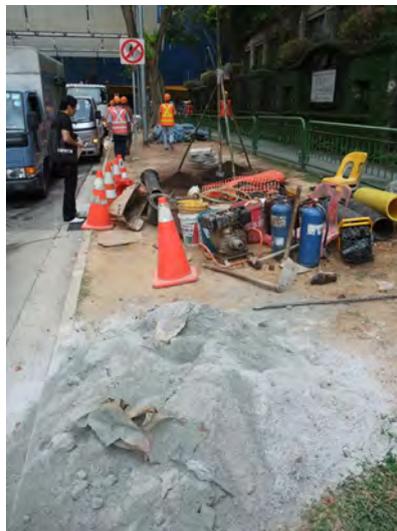
**Figure 1: Construction material and heavy machinery are prohibited within the TPZ**

- No ground disturbance, grading, trenching or other construction activities shall occur within the TPZ except as specified and/or approved by the attending arborist or authority.
- No construction material, debris, machinery (e.g. generators) or other construction waste shall be stored within the TPZ. Weight and presence of these materials increases soil compaction and reduces the area exposed for water infiltration and gaseous exchange.

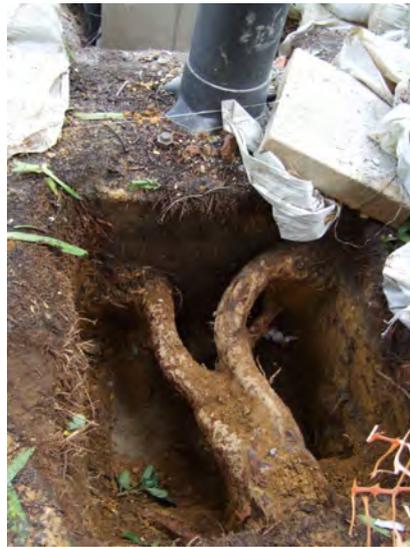
**Figure 2: Trial trench by skilled workers using hand tools exposing root architecture**

- Excavation works within the TPZ are strictly prohibited. Unless otherwise specified by the attending arborist, all work done within the TPZ shall be completed with manual trenching with hand tools or other hand held power tools that will not cause any root/tree damage.

If roots need to be cut, it shall be done using proper equipment (e.g. pruning saw, chain saw) under the supervision of the attending arborist.

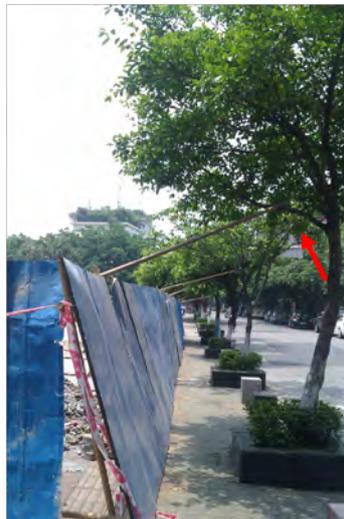
**Figure 3: Using tree as anchor may damage its bark.**

- Nailing, tying or pasting of materials on trees is prohibited. The tree shall not be used as an anchor for supporting structures during the construction.

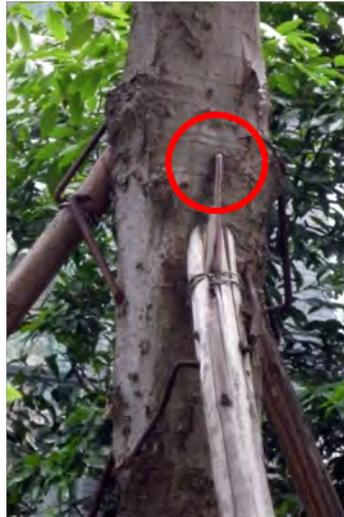
**Figure 4: No nails shall be driven into the tree as it promotes infiltration of pests/diseases**

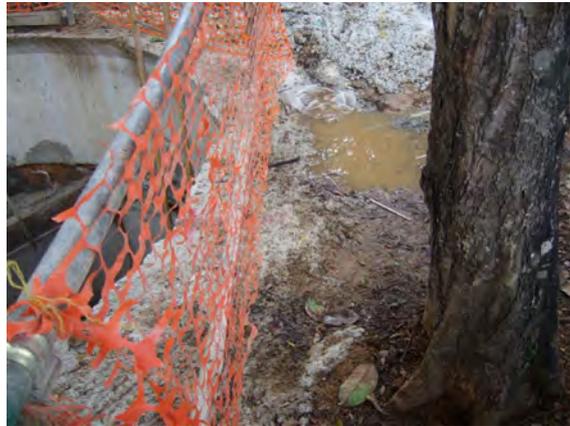
**Figure 5: Construction cement deposited at tree base.**

- Phytotoxic materials such as fuels, oils, cement, chemicals, and paint shall be kept away and stored/mixed at least 2.5m from the tree protection zone. Such chemicals can significantly change the cation exchange capacity and pH of the soil, rendering nutrient uptake inefficient and creating an environment too toxic for the roots to grow.

Construction sludge especially from piling works should not be deposited within the TPZ. Such sludge is usually high in clay content and when layered over and within the TPZ could significantly alter the water infiltration and gaseous exchange rates of the root absorption area of the tree.

Canvass sheets/Eco-mat must be laid on the existing soil near the tree in view of soil protection during the demolition, drilling or other construction activities pertaining to concrete structures.

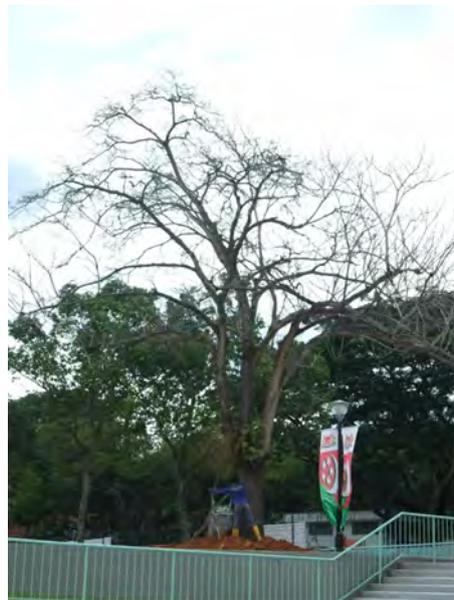
**Figure 6: Tree showing signs of decline overtime.**

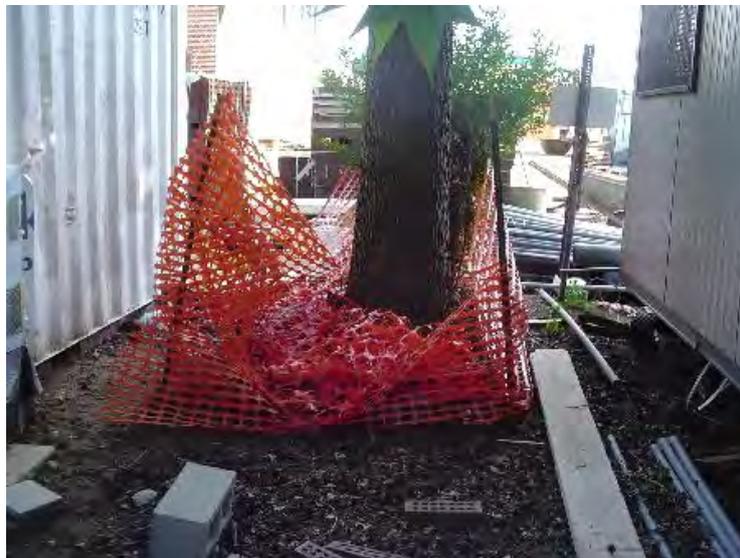
**Figure 7: Inappropriate installation/maintenance of TPZ during construction.**

**No removal of the TPZ will be permitted under any circumstances.**

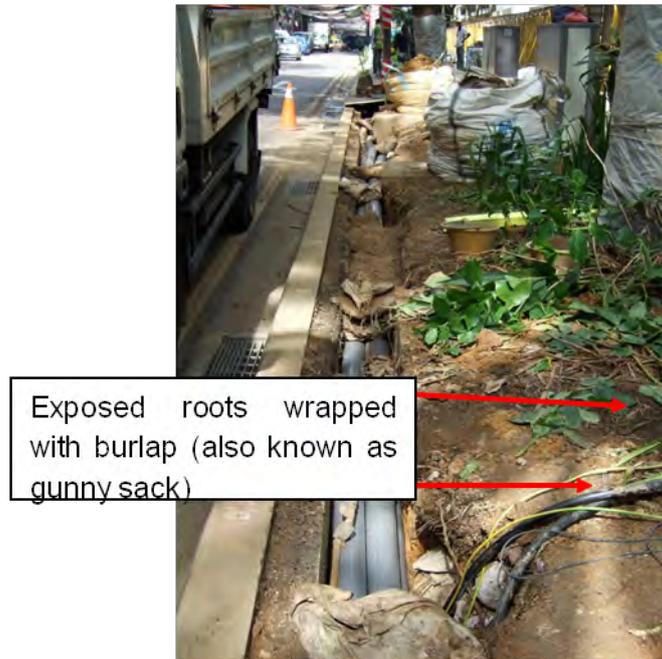
No roots greater than 0.2m in diameter shall be cut without approval of the attending Arborist. Tunneling under roots is the approved alternative. Prior to excavation for foundation/footing/walls, or grading or trenching within the TPZ, roots shall be severed cleanly outside the TPZ to the depth of the planned excavation. When roots must be cut, they shall be cut cleanly with a sharp saw to sound wood and flush with the trench site.

**Figure 9: Tunneling under roots.**

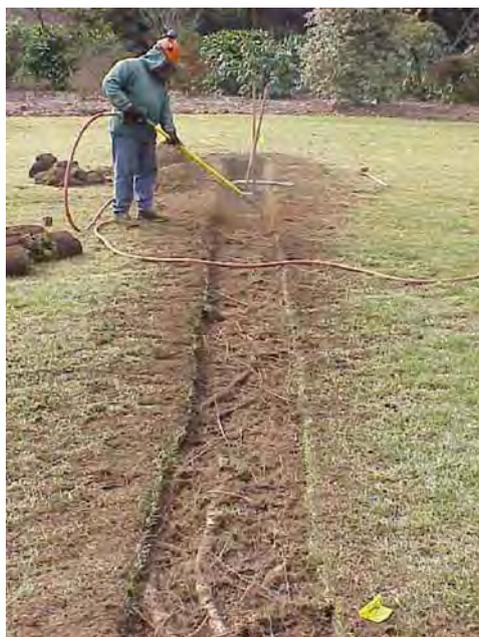
Any approved excavation, demolition, or extraction of material shall be performed with equipment that is placed outside the TPZ. Hand digging, hydraulic, or pneumatic excavation (e.g. air spading) are permitted methods for excavation within the TPZ.

**Figure 10: Root exploratory works using an air spade. Air spading avoids damage of structural and even feeder roots of the tree.**

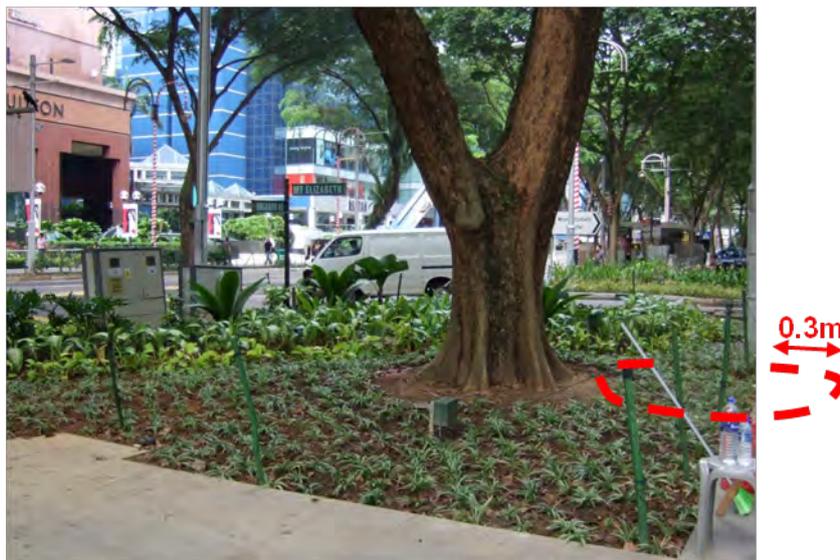
Figure 10: New plantings at a minimum distance of 300mm (all round) from root collar

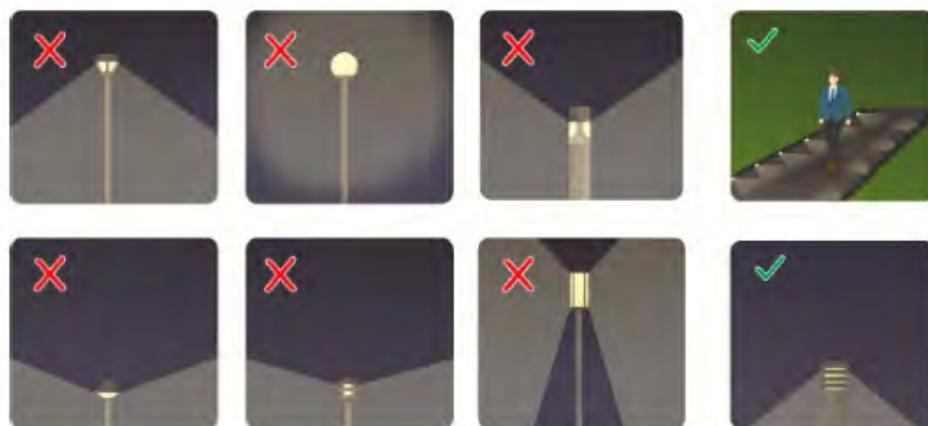
Figure 2 Lighting should be directed to ensure only the intended area is lit (figures adapted from Witherington & Martin 2003).
