PROPOSED DEVELOPMENT AT HDB EASTERN

ENVIRONMENTAL MANAGEMENT AND MONITORING PLAN (EMMP) FOR HDB DEVELOPMENT (EASTERN)

Job No: SO00797-1 Rev 7

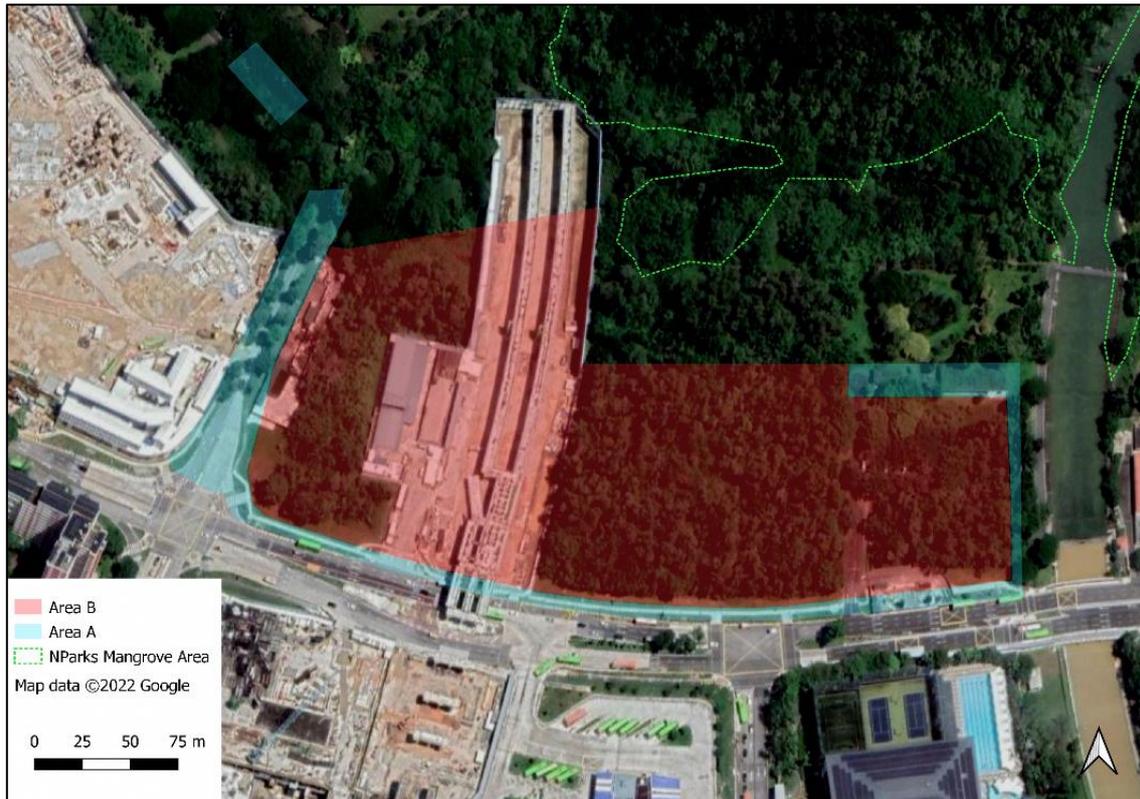
Figure 1-4. Demarcation of Area A and Area B

The Project development area is divided into Area A and Area B. Due to differing existing conditions of the site: Area A and B, the development is separated into two distinct phases: Phase 1 and Phase 2.

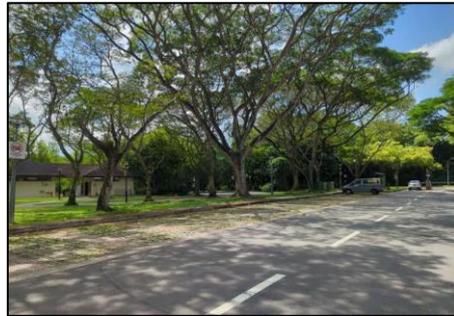
Figure 1-5. Construction of drop-off porch, part of Phase 1A (photo taken on 05/02/23)

This satellite work area is not connected to the larger Area A development. The work focuses on converting existing carpark lots of Pasir Ris Carpark C into a sheltered drop-off point, which may require removal of several trees. The construction of a new drop-off porch also serves as a replacement to the existing drop-off porch near Pasir Ris Carpark B which will be affected by the development works. The site is illustrated below, Figure 1-5.

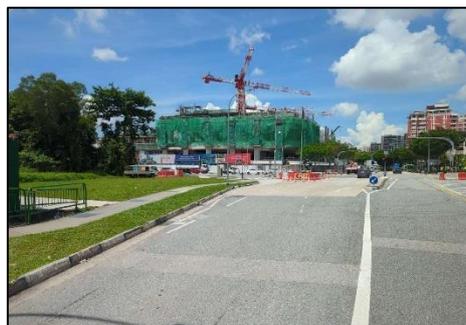
Figure 1-6. Road widening of Pasir Ris Green, part of Phase 1A (photo taken on 05/02/23)

Pasir Ris Green is an existing 2-lane road within Area A. The development work involves the widening of Pasir Ris Green by 1 additional vehicular lane to create a left-turning storage lane from Pasir Ris Green to Pasir Ris Dr 3 near the existing traffic junction. In tandem with the road widening works, a 2m wide cycling path and a 1.8m widened footpath will be constructed along Pasir Ris Green. To serve the new housing developments, a new pedestrian crossing with covered linkway will be constructed at Pasir Ris Green. The site current conditions are illustrated below, Figure 1-6.

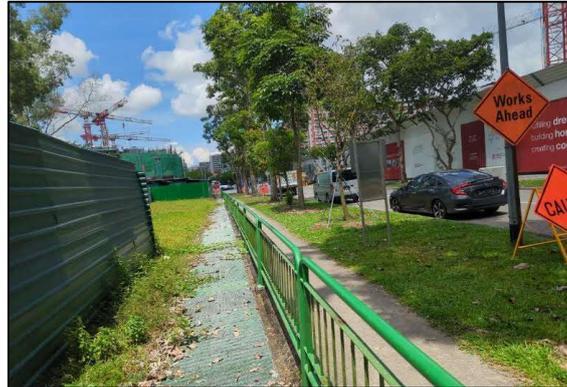
Figure 1-7. Construction of covered drains, part of Phase 1A (photo taken on 05/02/23)

This work consists of construction of covered drains along one side of Pasir Ris Green. Along Pasir Ris Green, the works include removal of the existing open drains along Pasir Ris Green and footpath, and construction of a covered drain and new footpath. The site current conditions are illustrated below, Figure 1-7.

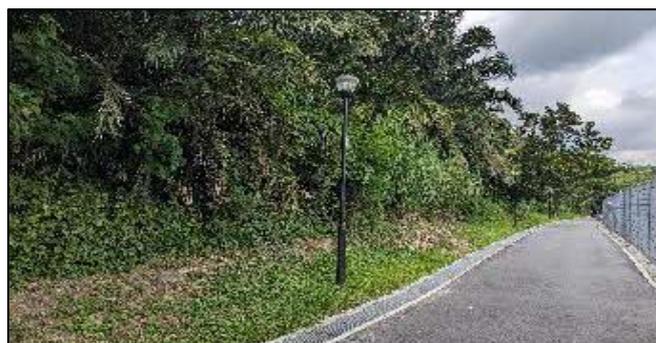
Figure 1-8. Laying of services and construction of service road, part of Phase 1A (photo taken on 05/02/23)

The work includes diversion of general services (i.e., water pipe, sanitary line, power cables) that currently serve the existing park facilities near Pasir Ris Carpark B. As the expected works within Area B would impact these services, the services would be diverted and laid around the perimeter of Area B, allowing for the park facilities to continue operations during all phase of the construction. Similarly, an existing NParks service road used for parks maintenance would also be diverted to take access off the park connector located on the eastern side of the park. The site current conditions are illustrated below, Figure 1-8.

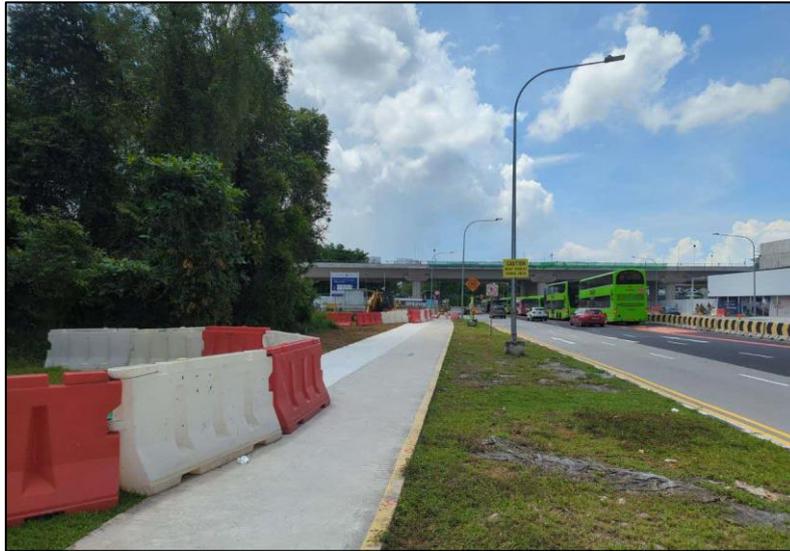
Figure 1-9. Construction of sewer and drains, part of Phase 1A (photo taken on 05/02/23)

This work consists of construction of sewer lines along Pasir Ris Drive 3. The development lies within the road reserve of Pasir Ris Drive 3. Although no tree felling is expected, some streetscape flora may be impacted by the works. Eight (8) temporary construction shafts are proposed along the permanent sewer manhole located along Pasir Ris Drive 3. The installation of sewer pipes would be carried out via pipe-jacking method between temporary construction shafts, thereby reducing the affected ground area. Permanent sewer manholes are constructed within the temporary shafts with manhole access openings installed above ground level after the completion of pipe-jacking works, The site current conditions are illustrated below, Figure 1-9.

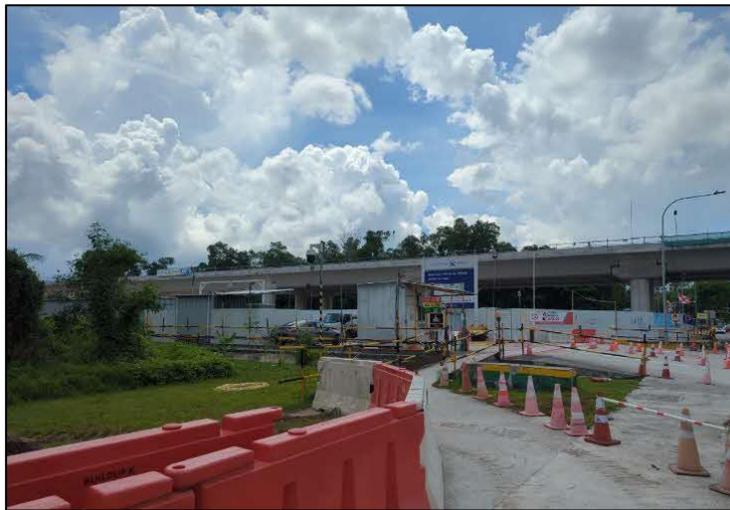
Figure 1-11. Current site condition, Area B (photo taken on 05/02/23)

These works are within Area B and would commence in Phase 2, which is expected after the end of Phase 1B and the Pasir Ris Rail Turnback Project. The works include the construction of multi-storey residential housing blocks, carparks, commercial facilities, and supporting infrastructures. Agencies are exploring the provision of a proposed footpath along the Pasir Ris Rail Turnback to replace an existing footpath which provides direct connectivity for pedestrians from Pasir Ris Drive 3 into Pasir Ris Park. Night works are expected in Phase 2. The details of the housing development construction works are still being developed and a Light Management Plan will also be provided before Phase 2 works commence. The site current conditions are illustrated below, Figure 1-11 and Figure 1-12.

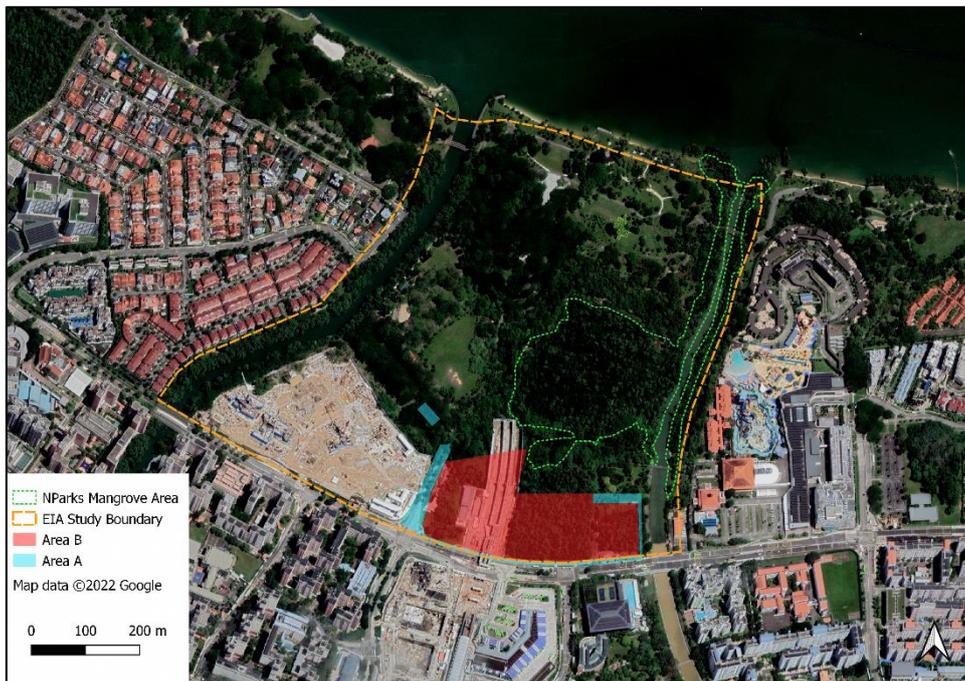
Figure 4-1. EIS Study Area conducted in 2019.

This EMMP document was prepared based on the Environmental Impact Study (EIS) by Ramboll Environ Singapore Pte Ltd in 2019. The EIS highlights development works for the area, which includes both residential and transportation development. The study area relative to the Project area is reflected in Figure 4-1.

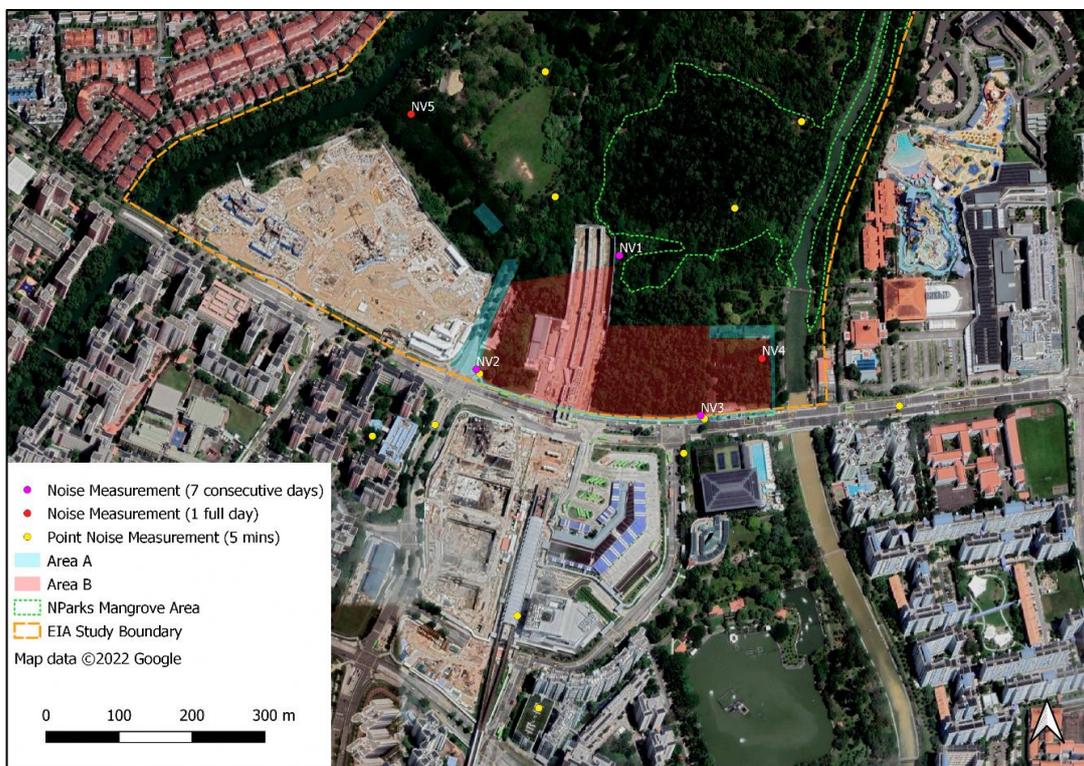
Figure 4-4. EIS Noise Meter Locations, extracted from recent EIS dated 11/04/2019

Long-term noise measurement (7 consecutive days) was conducted between 14th November to 5th December 2016, while short-term noise measurement (1 full day) was conducted on 24th and 26th November 2016. Point measurements for one weekday and one weekend over a 5-minute period was also measured. The locations of the Noise Measurement Meters are located in Figure 4-4 and Table 4-6.

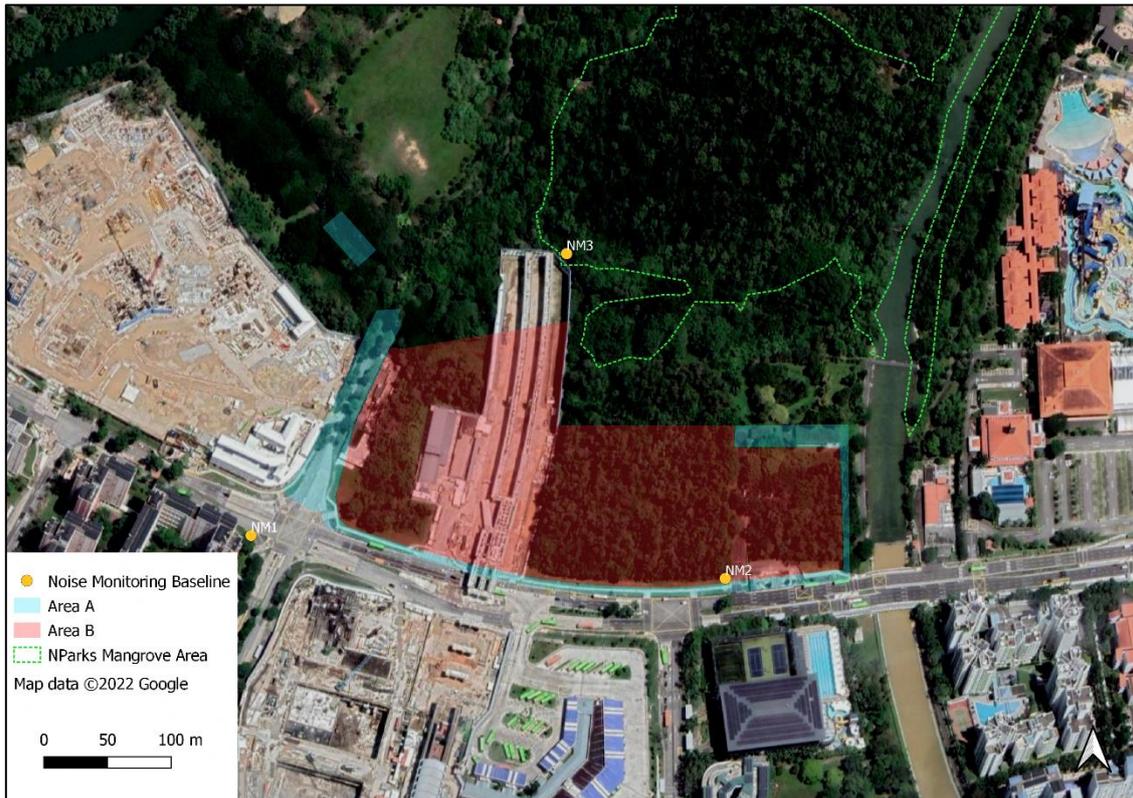
Figure 4-5. Pre-Construction Baseline Noise Meter Locations

Long-term noise measurement (7 consecutive days) was conducted between 1st April to 7th April 2023. This was sampled using three noise level monitoring devices. The locations of the Noise Measurement Meters are located in Figure 4-5. The breakdown (Table 4-9) represents the typical baseline noise level in the surrounding area.

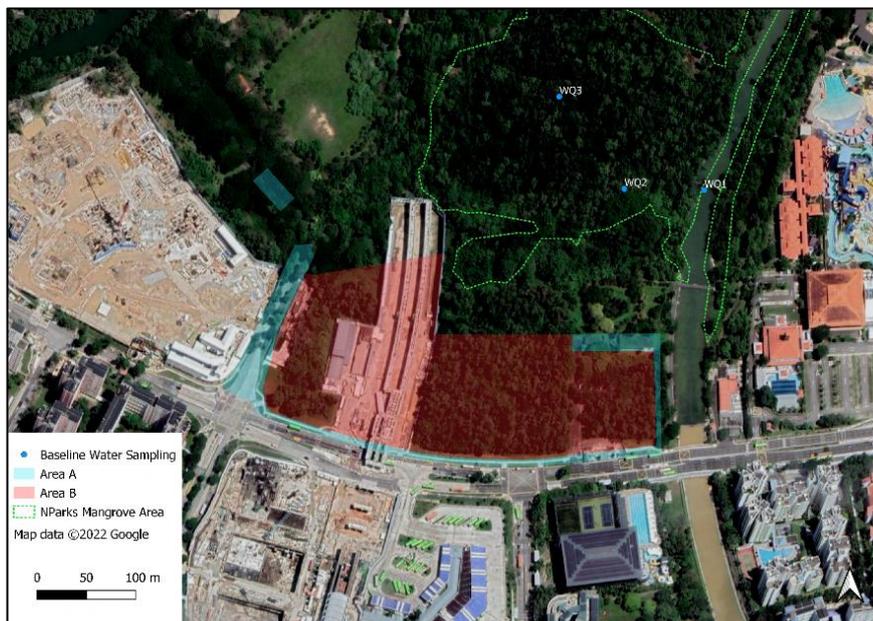
Figure 4-7. Pre-Construction Baseline Water Sampling Locations

One (1) rounds of surface water sampling were carried out on 17th April 2023, when the tide was ~2.2 m to 2.5 m and observed to be flowing towards Sungei Tampines. The sampling was executed during mid to high tide for the samples within the mangrove forest. Refer to Figure 4-7 for baseline water sampling locations.

Table 4-13 shows the water quality results of different sampling points. TSS was found to generally be high, especially at W2 and W3. The exceedance was expected and likely to be naturally occurring as sediments and organic matter may have been disturbed during sample collection at W3.

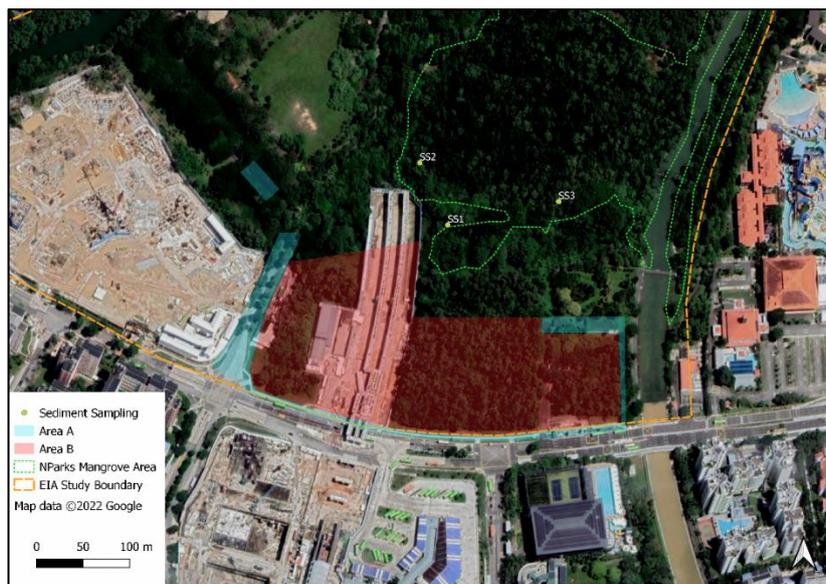
Figure 4-8. EIS Sediment Sampling Locations, extracted from recent EIS dated 11/04/2019

Location	Description	Rationale
SS1	Mangrove area at the north of the Project site	Baseline pre-development sediment quality of the mangrove downstream of the Project site
SS2	Southwest corner of mangrove at the north of the Project site	Baseline pre-development sediment quality of the mangrove downstream of the Project site
SS3	Southeast corner of mangrove at the northeast of the Project site	Baseline pre-development sediment quality of the mangrove downstream of the Project site

The sediment analysis results (Table 4-15) were compared to the Australian and New Zealand Environment Conservation Council (ANZECC) recommended Sediment Quality Guidelines (SQGs) and the Dutch Standards (2000 edition) for assessing land contamination and remediation, as there is no sediment quality regulatory standard available in Singapore. Based on the observation when collecting the sediment samples, the surficial sediment in the mangrove area generally comprised sandy and lighter-coloured sediments, and slowly became clayey and darker-coloured below the surface layer after taken the samples.

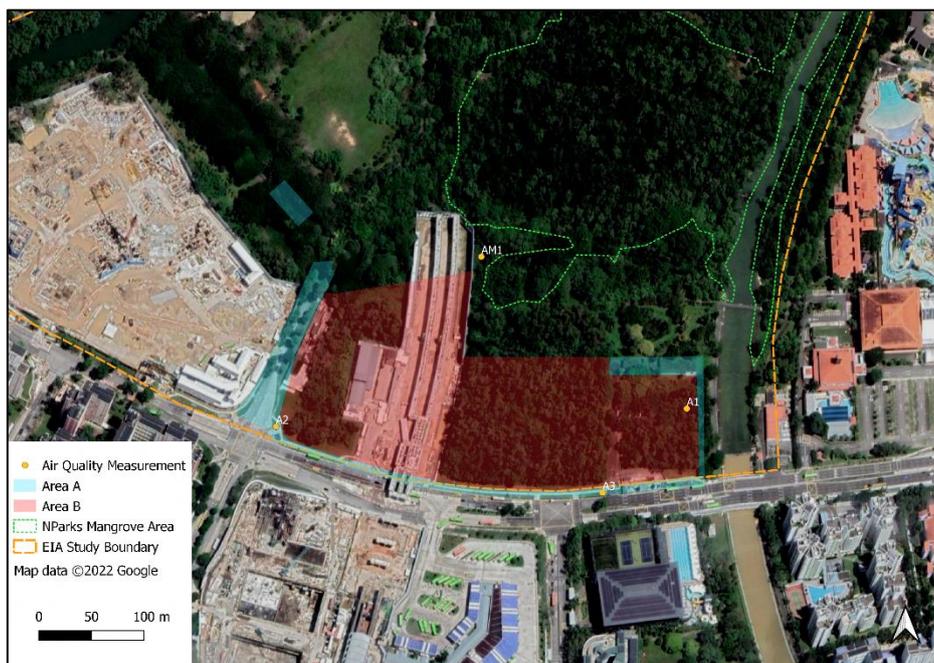
Figure 4-9. EIS Air Quality Monitoring Locations, extracted from recent EIS dated 11/04/2019

Location	Description	Rationale
AM1	Approximately 15 m off to the right of the paved footpath, near to the edge of mangrove area	<ul style="list-style-type: none"> Baseline pre-development ambient air quality at the Project site and at the edge of mangrove forest Meteorological conditions in the vicinity of the Project site
A1	Near Piai Plaza at Pasir Ris Park, east of the Project site	Baseline particulate matter levels at Pasir Ris Park directly adjacent to the Project site
A2	Vegetated area within the site boundary, facing Pasir Ris Sports Centre	Baseline particulate matter levels at the edge of Project site, facing sensitive receiver (Pasir Ris Sports Centre)
A3	Vegetated area at the diagonally across HDB cluster Blk 570 to 580	Baseline particulate matter levels at the edge of Project site, facing sensitive receiver (HDB cluster Blk 570 to 580)

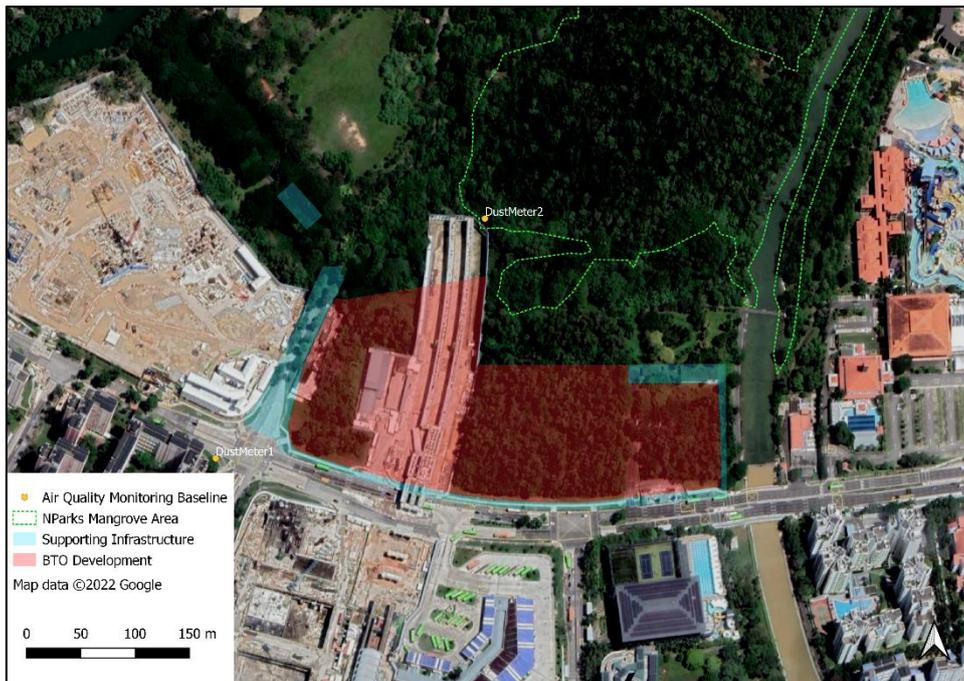
Figure 4-10. Pre-Construction Baseline Air Quality Monitoring Locations

Ambient air quality monitoring was conducted between 10th May 2023 and 29th May 2023. Air quality parameters such as particulate matter (PM_{2.5} & PM₁₀) was monitored during the period of time. Continuous monitoring (24-hr) for the duration of one week was carried out at all selected air quality monitoring stations, Figure 4-10 and Table 4-18.

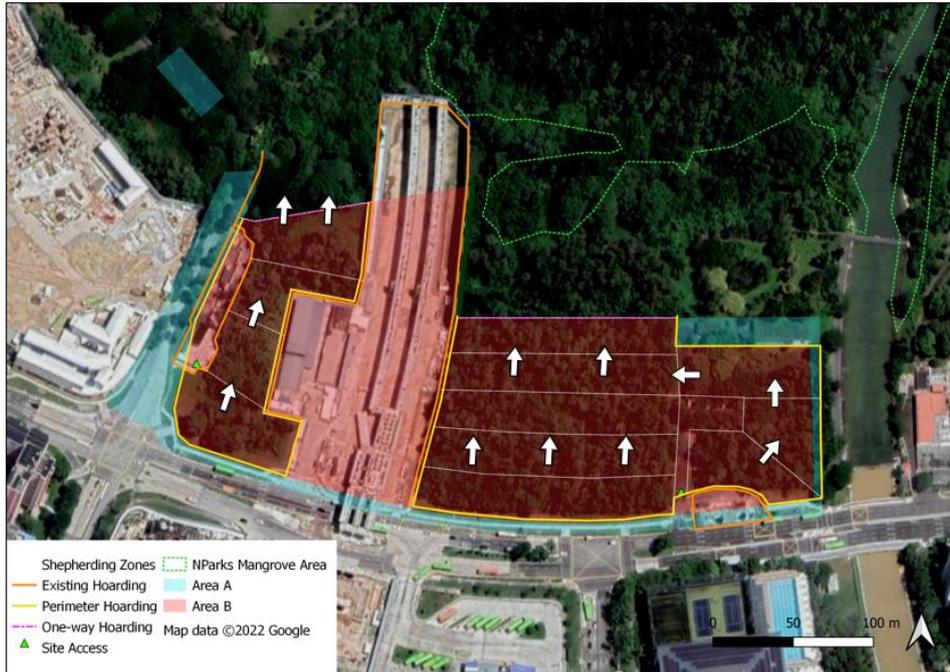
Figure 5-1. General Shepherding Direction

From the recent EIS prepared; the general shepherding direction would be towards the northern mangrove area. The recommended shepherding direction proposed in the recent EIS is reflected in Figure 5-1. The current proposed shepherding direction agrees with the EIS.

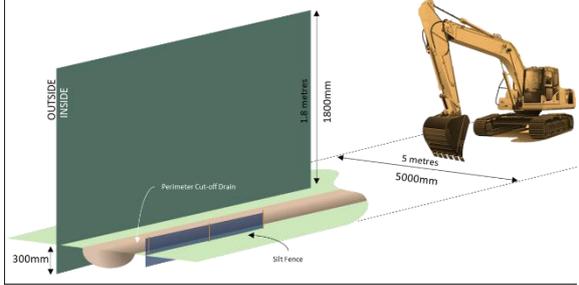
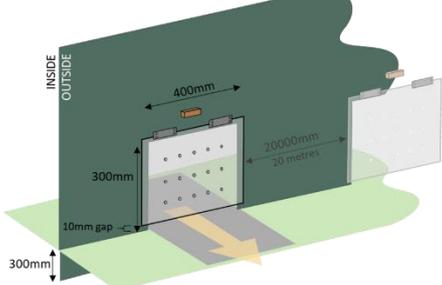
Perimeter Hoarding	One-way Hoarding

Due to the potential presence of wild boars within the Project area, One-way Hoardings would be set up along the northern boundary of the Project. The One-way Hoarding serves as wildlife exits. This ensures all wildlife, except for wild boars, can leave the site during shepherding. In addition, the One-way Hoardings are designed to ensure single directional movement of wildlife (out of the site), while also preventing wildlife beyond a pre-determined size from exiting the site. Refer to the Wildlife Shepherding Plan (Appendix I) for more details.

Perimeter Hoarding would first be implemented around the Project site to prevent unnecessary vegetation damage outside the Project area. Installation of the Perimeter Drain and appropriate placement of Silt Fences would occur after putting up the Perimeter Hoarding. This would minimise the impact to the necessary work area. The expected working space to set up the Perimeter Hoarding and Drains is 5m width along the boundary of the Project, or where hoardings are required. The ECMs should also be fully set up and operational, with Holding Ponds and Treatment Tanks prior to Phased Clearing. As vegetative clearance for the setting up of these preliminary mitigation measures are necessary, Pre-Felling Check for nest and entrapped fauna should be conducted before any clearance. Clearance should also be limited to the necessary work area for the implementation of these mitigation measures.

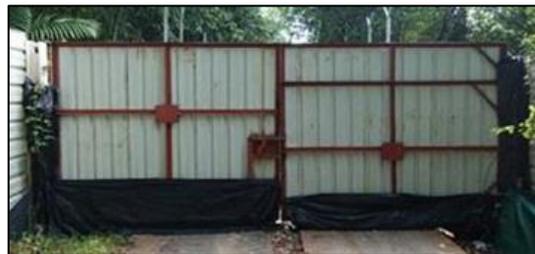
Figure 5-2. Example of access gate with silt fence

Should access gates be installed, silt fence should be attached to the bottom of the gates. The gate should also remain closed during shepherding, and whenever it is not in use. No opening greater than 50mm, where possible, to ensure wildlife do not leave through these openings.

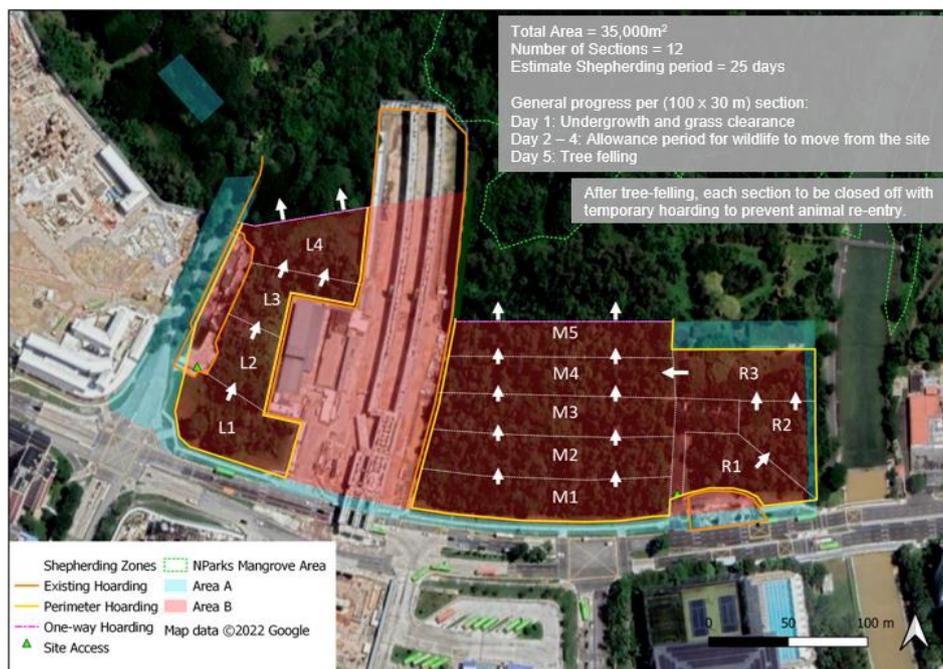
Figure 5-6. Wildlife Shepherding Phased Clearing

- **Step 1:** The areas to be cleared are divided into sections, each section is typically 100 x 30m.

- Only after tree felling completed within the previous Section, Step 2 (undergrowth clearing) for subsequent section may commence.
- After the vegetation have been cleared (both undergrowth and trees), the One-way Hoarding along the northern boundary should be replaced with permanent hoardings to prevent wildlife from re-entering. The planned 12m Noise Barrier (Refer to Section 5.3.3) along the northern boundary can be utilised as a permanent hoarding. Similar specifications for the perimeter hoarding apply to the permanent hoardings used. This will allow the contractor to begin earthworks within the completely cleared site. Temporary hoardings may be used during the period permanent hoardings are set up. The site should eventually be hoarded up entirely, as based on the project boundary.

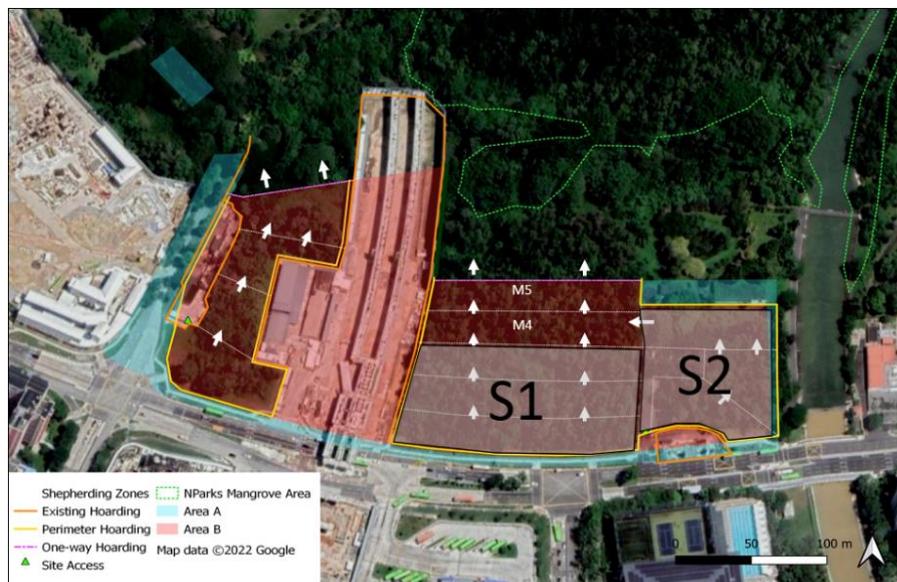
Figure 5-8. Sequence of Clearing for M4

Both S1 and S2 can be cleared simultaneously. However, shepherding of Section M4 may only proceed after the entirety of S1 (Section M1, M2, M3) and S2 (Section R1, R2, R3) have completed tree felling. This is best illustrated below. This ensures the wildlife from S2 are shepherded out and would not be trapped as the shepherding phase progresses.

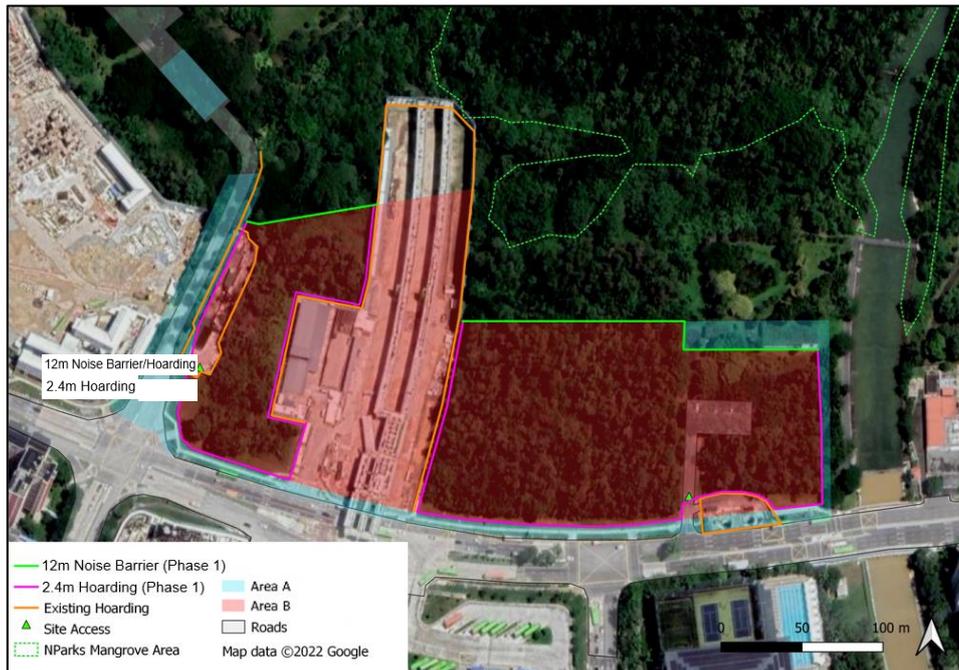
Figure 5-9. 12m Noise Barrier and Hoarding

The proposed layout for the 12m noise barrier is as illustrated in Figure 5-9.

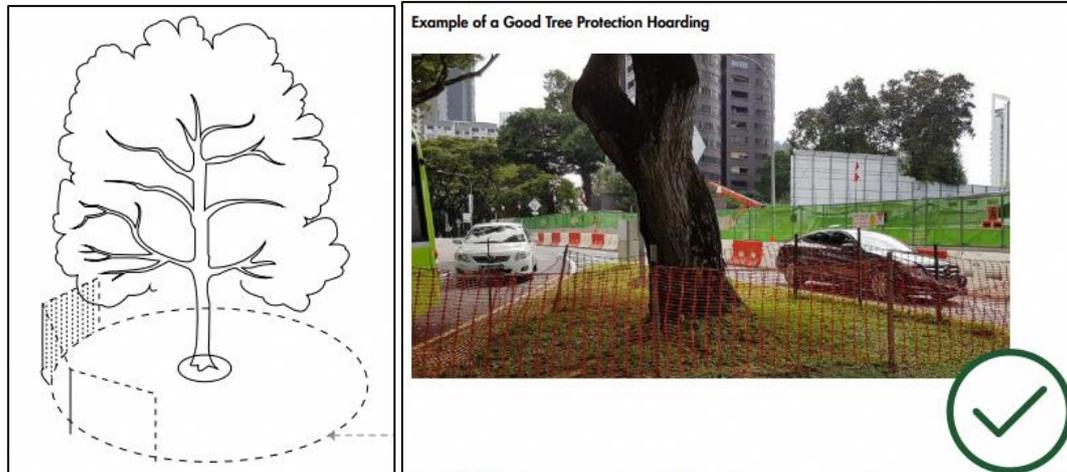
Figure 5-11. Tree Protection Zone (NParks, 2018)

In order to successfully prevent tree damage, construction activities have to be diverted away from the trees. A good practice to prevent tree damage and ensure tree survival is to place a fence around the TPZ. Bright orange polyethylene fencing or other effective tree protection fencing should be provided along the limits of the protection zone around the tree identified to be retained. This is to demark the TPZ within which activities are restricted before construction begins and kept intact until completion. There must be no excavation, raising or lowering of soil level, compaction or any form of construction activities including temporary works within the hoarded area. Dumping of debris, excavated materials and/or storage of construction materials and equipment is not allowed within the TPZ. Protection

hoarding is required, unless otherwise stated, and should be installed prior to site works. The extent of each individual TPZ is illustrated in Figure 5-11.

Girth	Recommended TPZ radius (Measured as distance from centre of a tree)
<0.5m	1 m
0.5m – 1m	2 m
1m – 1.5m	3 m
1.5m – 2m	4 m
>2m	5m

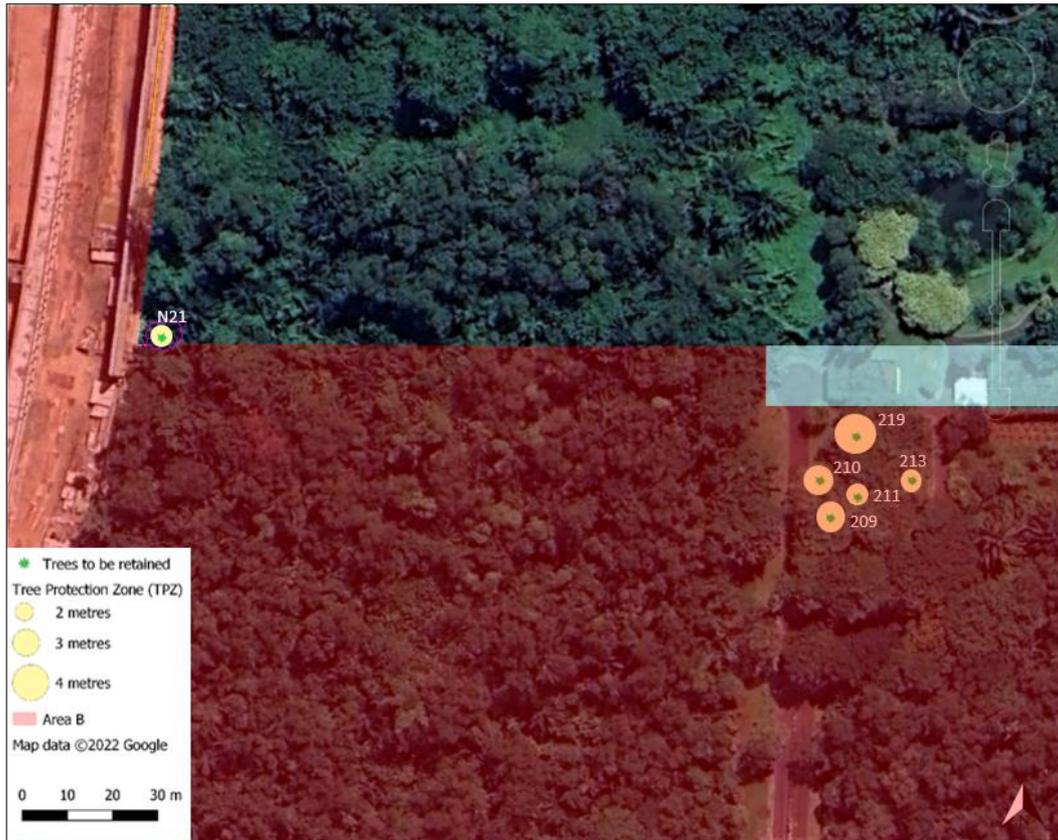
Figure 5-12. Tree Protection Zone of respective trees identified to be retained

No	Tree ID	Botanical Name	Latitude	Longitude	Buffer Size	Physiological Health	Tree Structure
1	209	<i>Terminalia mantaly</i>	1.375834	103.951739	3	Good	Good
2	210	<i>Terminalia mantaly</i>	1.375901	103.951729	3	Good	Good
3	211	<i>Terminalia mantaly</i>	1.375879	103.951790	2	Good	Good
4	213	<i>Terminalia mantaly</i>	1.375903	103.951897	2	Good	Good
5	219	<i>Terminalia mantaly</i>	1.376003	103.951814	4	Good	Good
6	N21	<i>Terminalia catappa</i>	1.376205	103.950444	2	Average	Fair

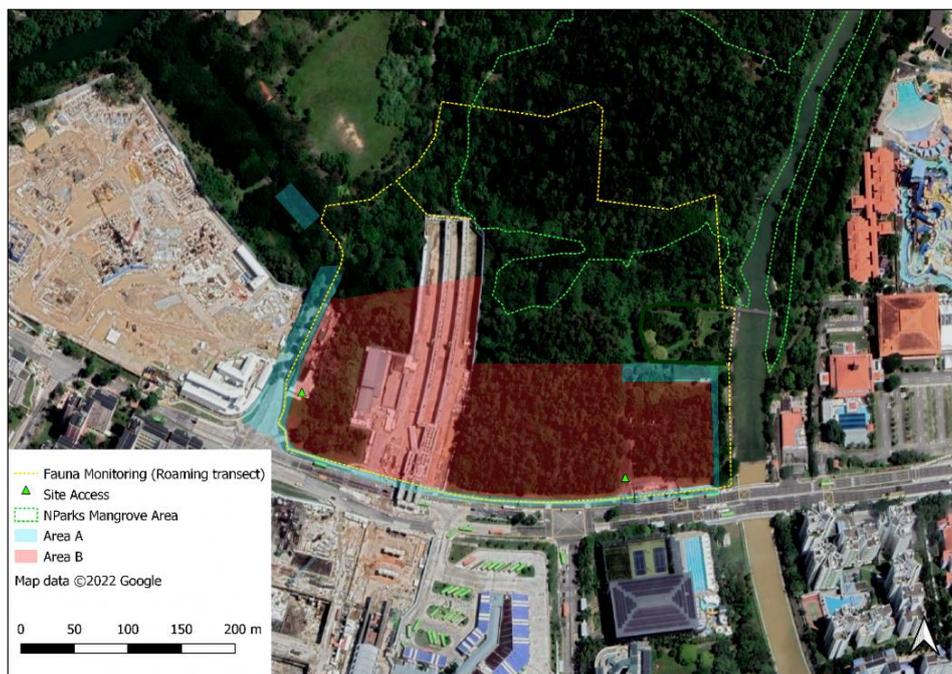
Figure 5-13. Monthly Fauna Monitoring Proposed Survey Transect

The Biodiversity Monitoring Survey would include a field survey of the surrounding vegetation. The field survey includes a roaming transect along accessible paths. The focus of the monthly surveys would be on the vegetation north of the Project site. The Project area, accessible roads, and proposed roaming transects are illustrated below:

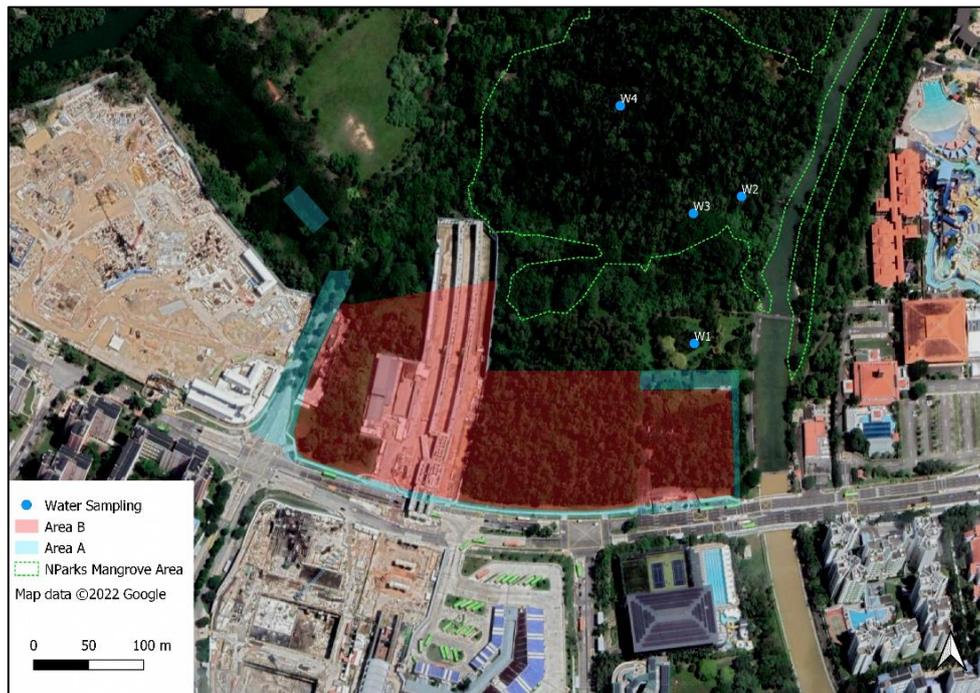
Figure 5-14. Monthly Water Quality Sampling Points

Water sampling shall be done monthly at four (4) sampling points at water bodies outside the Project, and two (2) sampling within the Project (at ECMs). The sampling location of the external water bodies are as seen in Figure 5-14 and Table 5-7. All sampling points are similar to the ones conducted during the EIS Water Sampling points. Furthermore, they do not differ much from the Pre-Construction Baseline Water Sampling points. Should any sampling points be not available during the construction and operation phase, a similar sampling location would be chosen, or a sampling point downstream from the same sampling point. Comparisons may be made with the baseline results and NEA and PUB trade effluent guidelines to monitor any major impacts from the construction on the existing water bodies. Sampling of water from the ECMs are to determine if the water is properly treated before discharge into the public drainage.

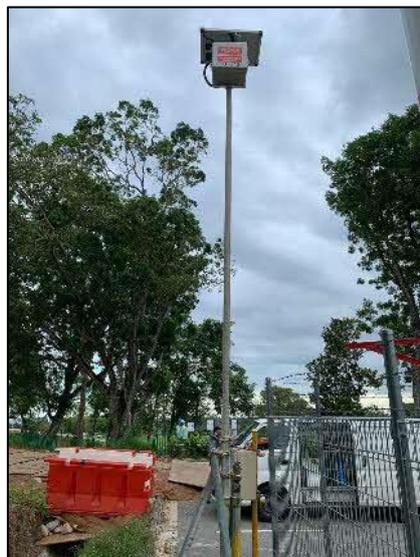
Figure 5-15. Example of Noise Monitoring Meter

The Noise Monitoring Meter will be temporary stationed at the selected locations as indicated in Figure 5-16 and Table 5-9. But this may also shift due to the site conditions, and construction work phasing. The location will be constantly updated within the Monthly Monitoring Report.

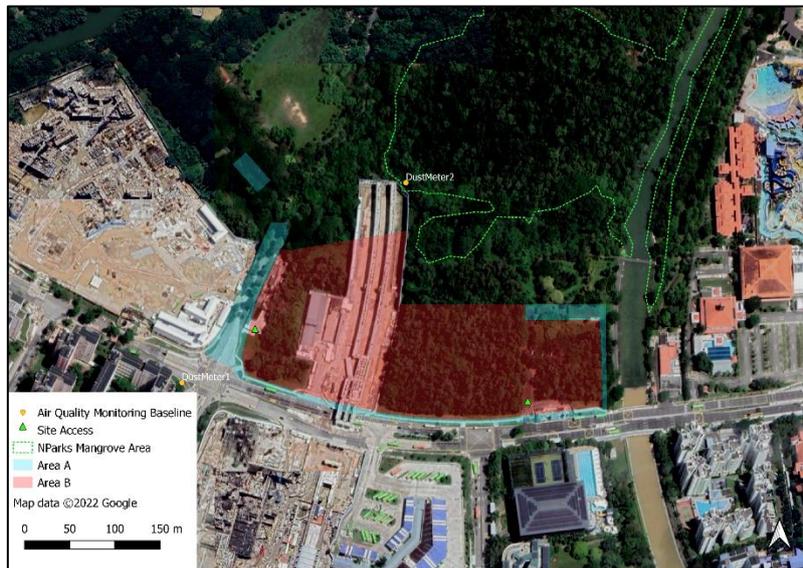
Figure 5-17. Dust Meter Location

Two (2) continuous dust monitoring location were selected. PM_{2.5} and PM₁₀ would be monitored during this period. All monitoring points are similar to the ones conducted during the baseline assessment. Comparisons may be made with baseline results and the Singapore Ambient Air Quality Targets to monitor any major impacts from the construction activities. For any exceedance, the contractor shall investigate the cause and take immediate steps to address the source of pollution.

The location of the Air Quality Monitoring Meter will be temporary stationed within Figure 5-17 and Table 5-13. But this may also shift due to the site conditions, and construction work phasing. The location will be constantly updated within the Monthly Monitoring Report. The aim of the Air Quality Probe would be to determine any excessive introduction of pollutants into the ambient environment.

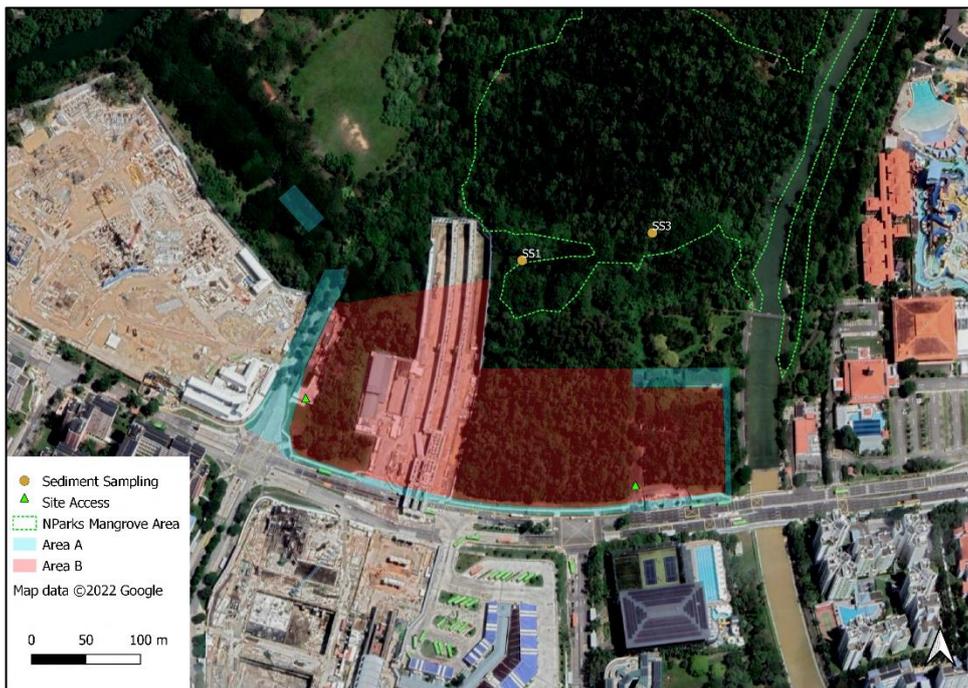
Figure 5-18. Sediment Sampling Location

Two (2) quarterly sediment sampling were selected. A sample of 500g per sampling point will be collected quarterly (every 3 months). The sediment samples will collect the top 10cm of mangrove sediment at each of the sampling location. This carried out through the use of dedicated sampling equipment (i.e., Van Veen Grab Sampler). The sample would be sent to an accredited Comparisons may be made with baseline results to monitor any major impacts from the construction activities. For any exceedance, the contractor shall investigate the cause and take immediate steps to address the source of pollution. All sediment samplings are similar to the ones conducted during the EIS.

The location of the Sediment Sampling points was temporary selected within Figure 5-18 and Table 5-15. But this may also shift due to the site conditions, construction work phasing, or natural changes (i.e., tide conditions). The location will be constantly updated within the Monthly Monitoring Report. The aim of the Sediment Sampling would be to determine any excessive introduction of pollutants into the ambient environment. The sediment samples would be collected from the boardwalk within Pasir Ris Mangrove.

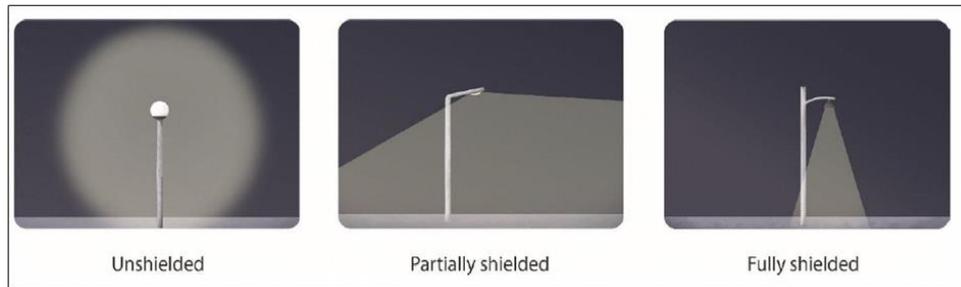
Figure 5-19. Lights should be shielded to avoid lighting anything but the target area or object. Figure adapted from (Witherington & Martin, 2003)

- All light fittings should be directed or shielded to avoid lighting anything but the target object or area (Figure 5-19) except lighting for safety and security purpose. Existing lights can be modified by installing a shield.

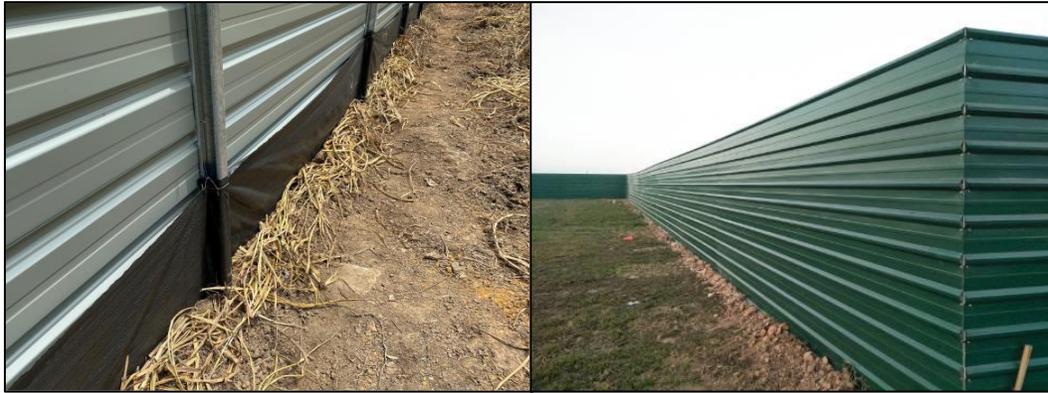
Fixed / Permanent hoarding

- Smooth top edge and silt fence weighted down with earth.
- Minimum height of 2.4 m, and opaque.
- The hoarding should also be embedded 300 mm into the ground.
- Perimeter hoarding prior to Phased Clearing should follow the above hoarding specifications.
- 12 m height of noise barriers facing the mangrove areas after Phased Clearing should also follow the above hoarding specifications.

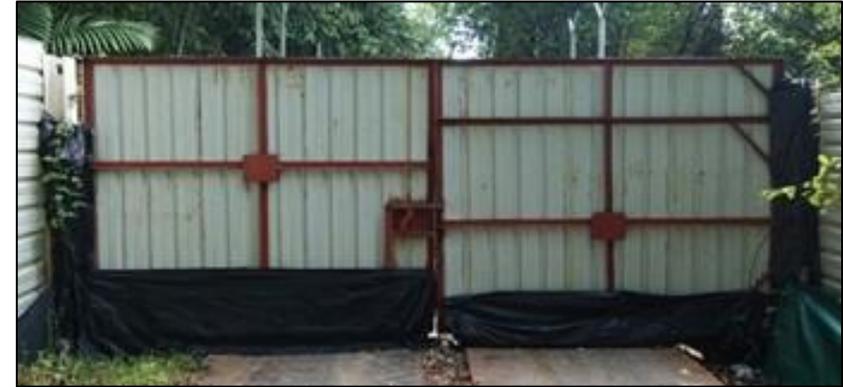
Gate with silt fence
(Openings should not be larger than 50mm)

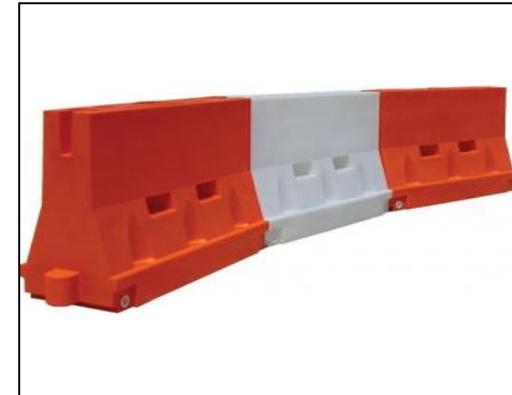
Interlocking Water barrier (without openings), as form of temporary barrier can be used in between zones

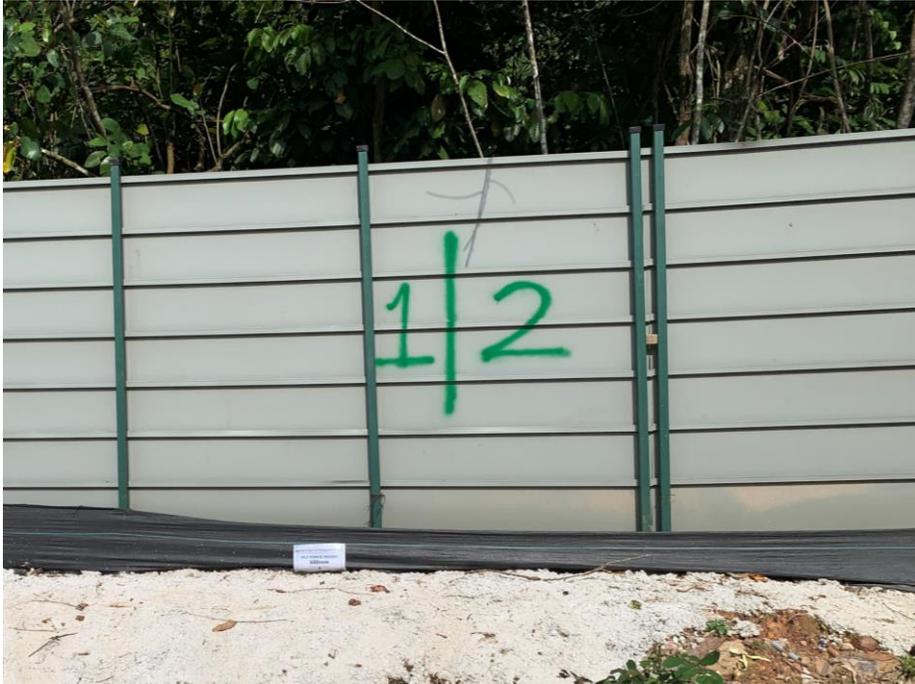
Spray paint is used on the initial hoarding to mark out wildlife shepherding sections. This ensures vegetation clearing is kept to the stipulated $\sim 3000 \text{ m}^2$ (or $100 \times 30 \text{ m}$) per day.

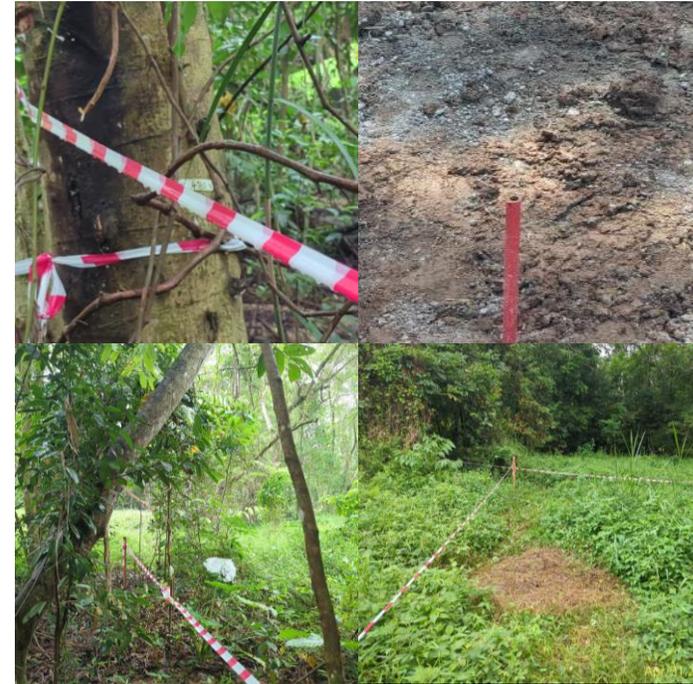
Clear demarking of boundary onsite prior to any clearing. This can be done using red/white tape, or pegs in the ground. This ensures no excessive clearing beyond the intended boundary is carried out.
