PROPOSED DEVELOPMENT AT HDB EASTERN

ENVIRONMENTAL MANAGEMENT AND MONITORING PLAN (EMMP) FOR HDB DEVELOPMENT (EASTERN)

Job No: SO00797-1 Rev 7

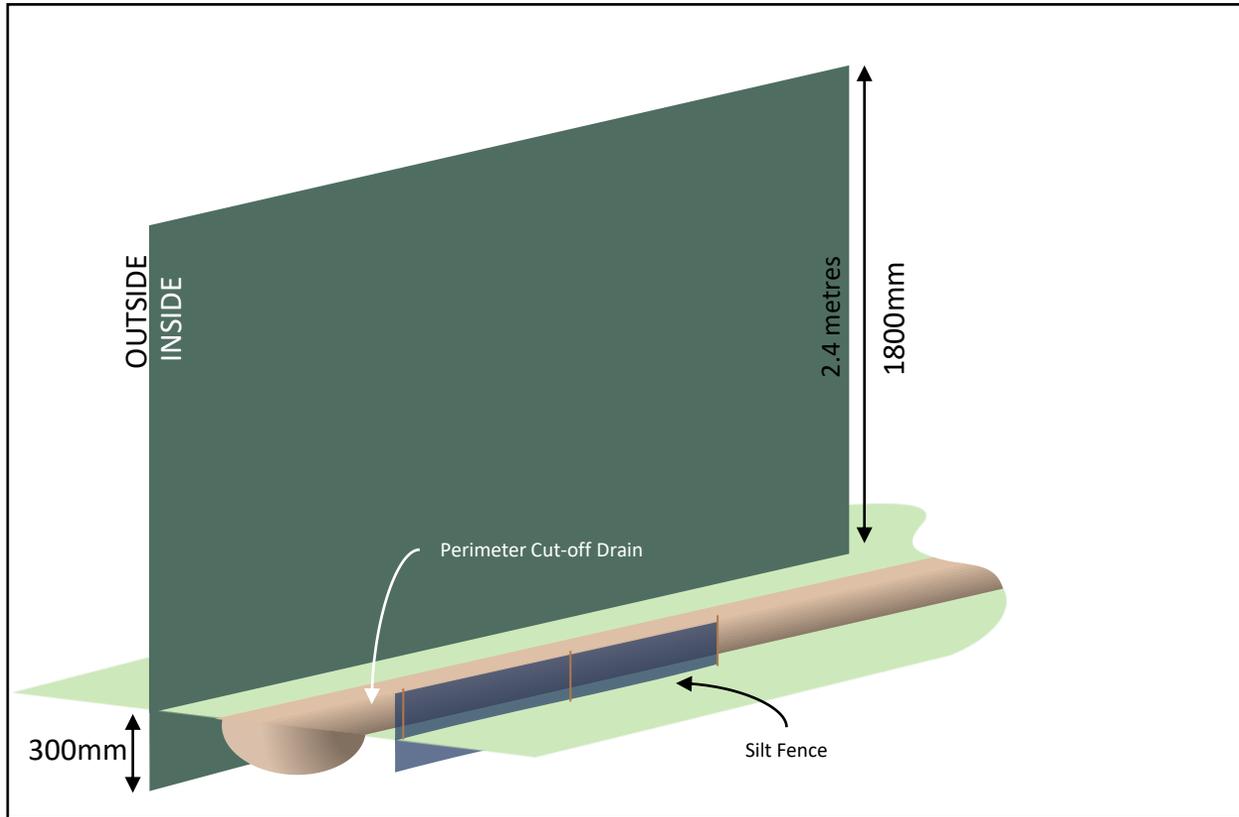
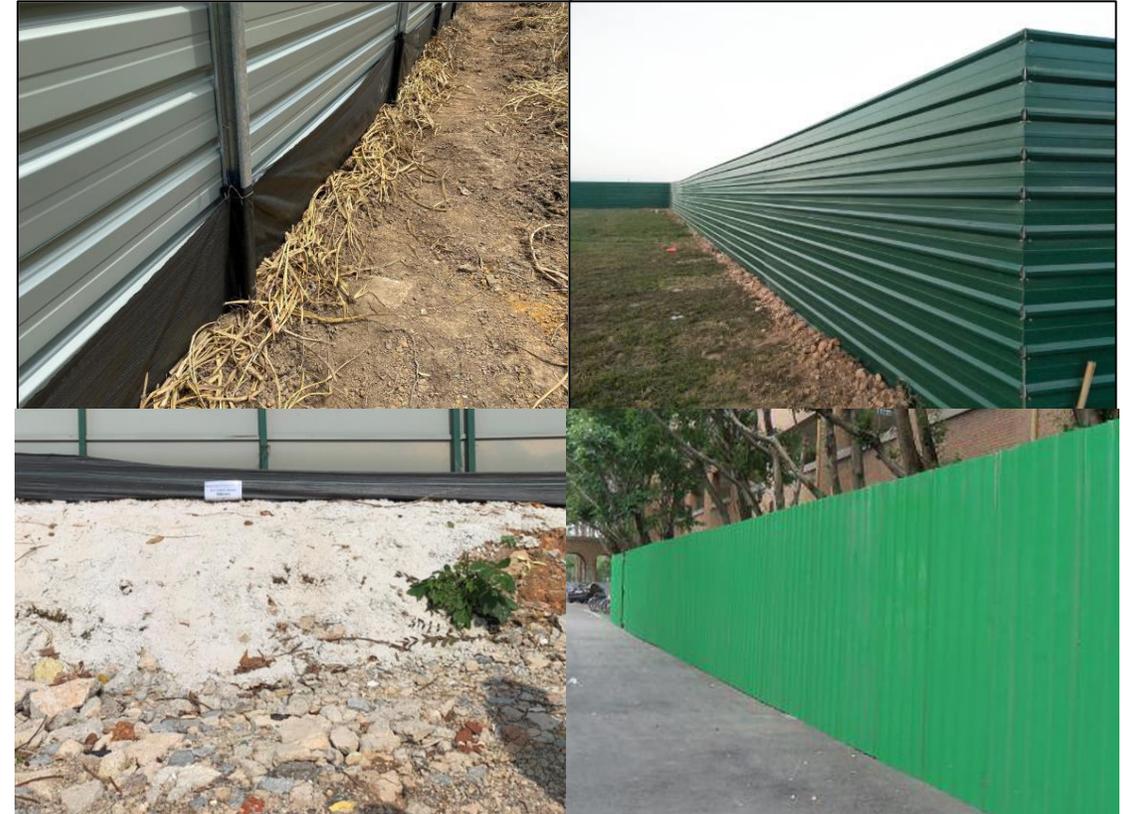
First 300mm embedded hoardings, followed by perimeter drains, silt fences, and ECMs are to be installed accordingly before Phased Clearing commences. This ensures silty water does not exit the site during shepherding phase.

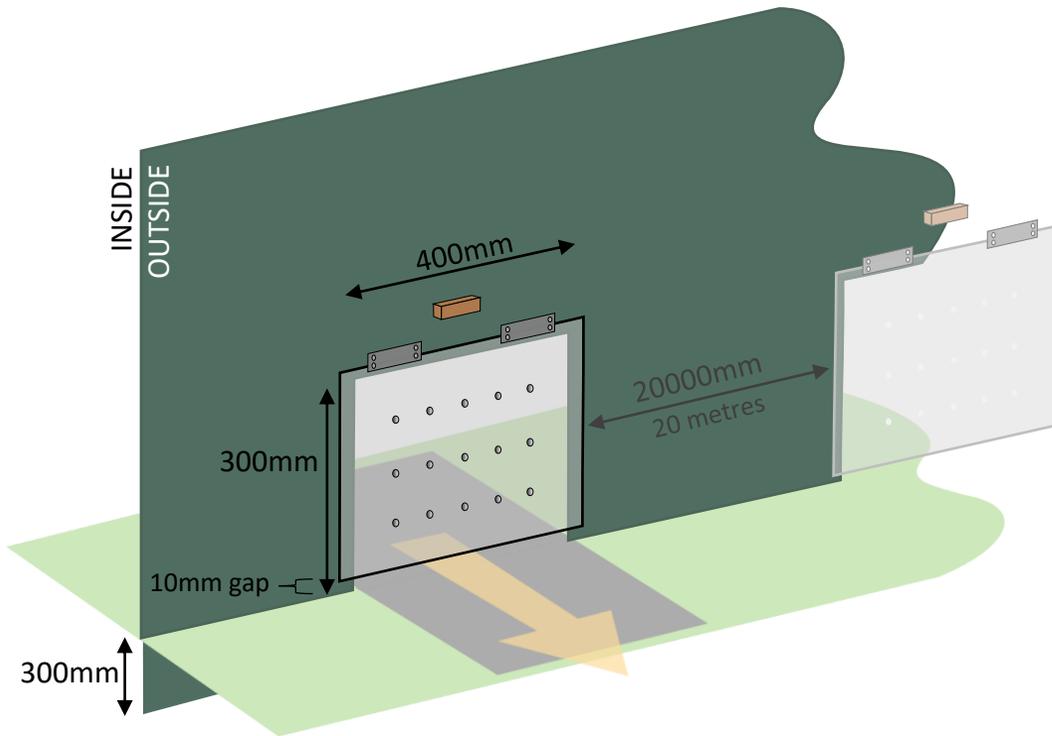
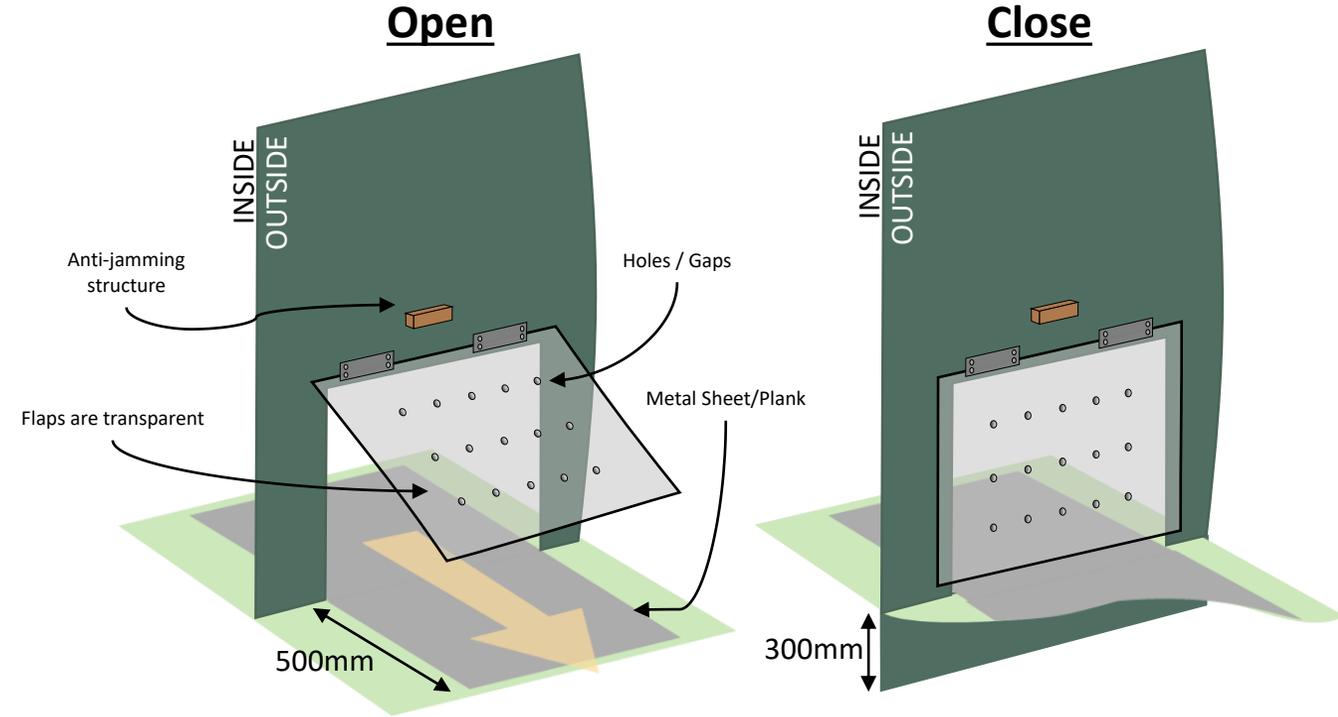
One-way hoardings are utilized when the objective is to prevent larger wildlife (i.e., wild boar) from leaving the site. Placed along the direction the wildlife is shepherd towards. Flaps are spaced 20m apart (along the One-way Hoarding). These hoardings are permanent hoardings with an added one-way transparent flap, with a 1 cm gap and holes.

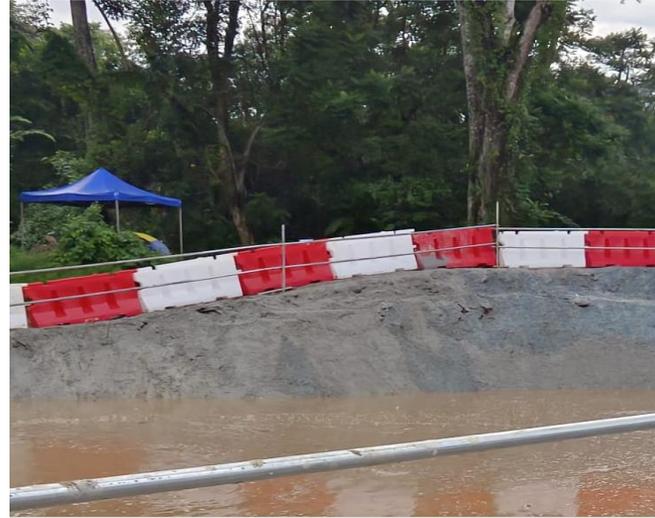
Water Barriers around Holding Pond

- Holding Pond / Detention Tank should have Water Barriers to prevent wildlife from entering

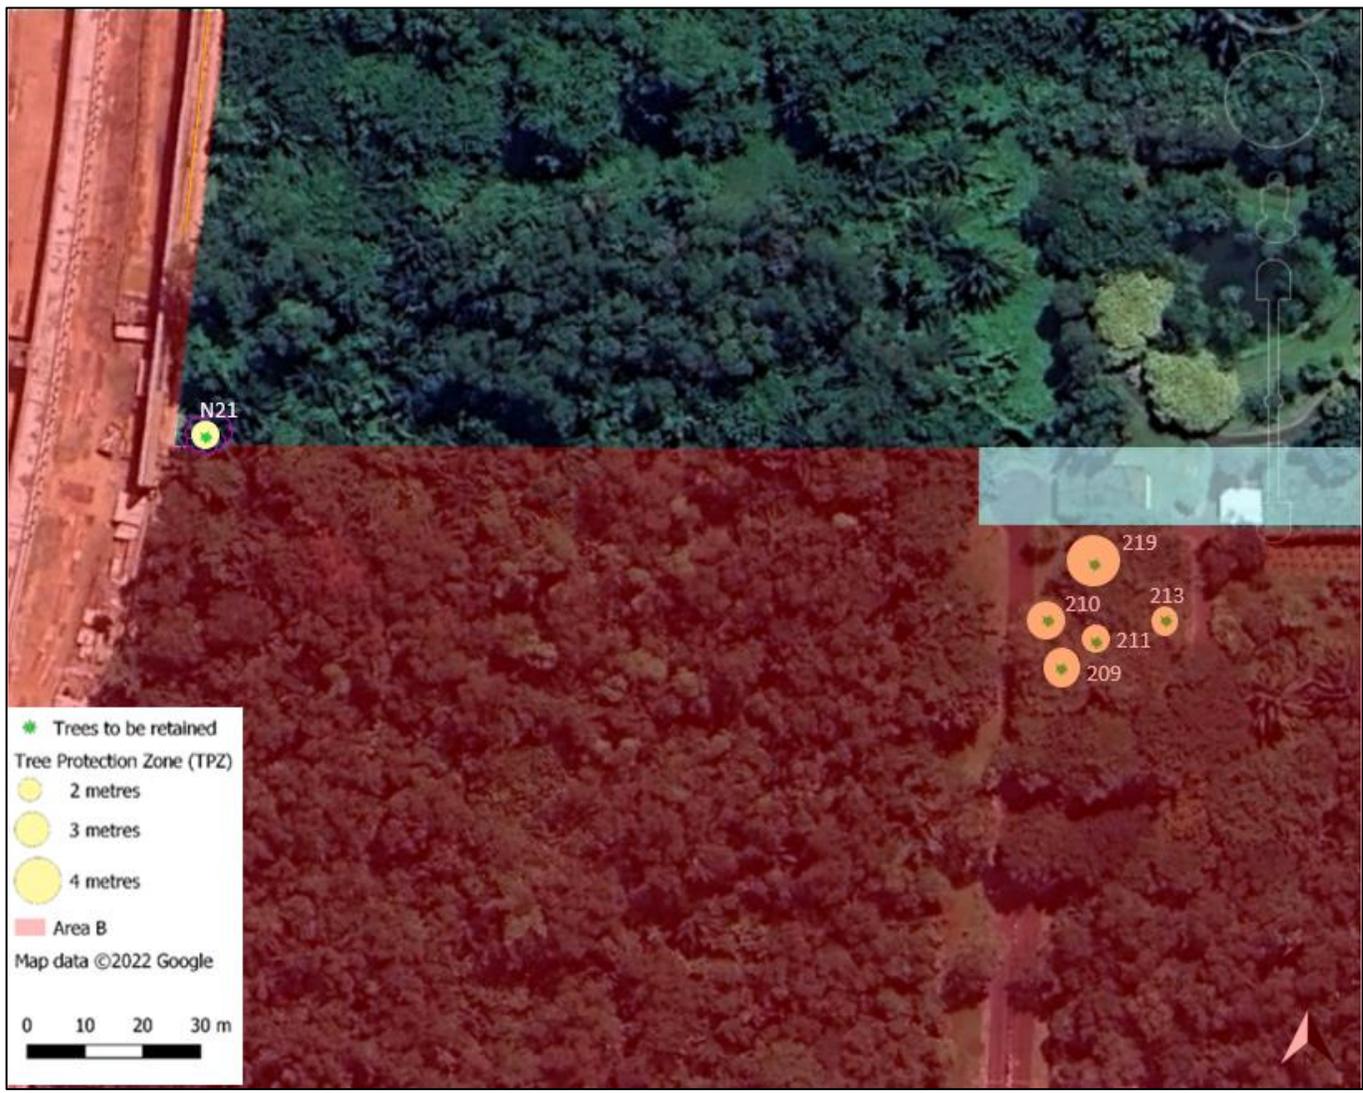
Tree Protection Zones (TPZ)

Several trees within the Project site have been identified for potential retention for landscaping.

No	Tree ID	Botanical Name	Latitude	Longitude	Buffer Size	Physiological Health	Tree Structure
1	209	Terminalia mantaly	1.375834	103.951739	3	Good	Good
2	210	Terminalia mantaly	1.375901	103.951729	3	Good	Good
3	211	Terminalia mantaly	1.375879	103.951790	2	Good	Good
4	213	Terminalia mantaly	1.375903	103.951897	2	Good	Good
5	219	Terminalia mantaly	1.376003	103.951814	4	Good	Good
6	N21	Terminalia catappa	1.376205	103.950444	2	Average	Fair

Before the commence of any clearance or shepherding, the trees within the Project site highlighted to be retained would be visibly marked out, as illustrated in Figure 5-10. The Tree Protection Zone (TPZ) would then be established to ensure the retained trees are provided with sufficient space such that the tree crown and roots are not affected by construction activities (i.e., soil compaction, mechanical damage, setting up of hoarding). The objective of the TPZ is to minimise the impact of construction activities on trees, including but not limited to mechanical injury to roots, trunks and branches due to contact with equipment, materials, debris or other activities. It also aims to minimise compaction of soil, which results in poor functioning of roots, and changes in soil levels that can cut off or suffocate roots. The TPZ size varies depending on the tree size. In general, all development works should consider the space of the TPZ into the planning of the Project as no permanent or temporary use of the space (i.e., for storage, scaffolding) within the TPZ should occur so as to ensure the trees within the TPZ remain healthy. The TPZ recommended measures are highlighted in the recommended TPZ size is listed below:

In order to successfully prevent tree damage, construction activities have to be diverted away from the trees. A good practice to prevent tree damage and ensure tree survival is to place a fence around the TPZ. Bright orange polyethylene fencing or other effective tree protection fencing should be provided along the limits of the protection zone around the tree identified to be retained. This is to demark the TPZ within which activities are restricted before construction begins and kept intact until completion. There must be no excavation, raising or lowering of soil level, compaction or any form of construction activities including temporary works within the hoarded area. Dumping of debris, excavated materials and/or storage of construction materials and equipment is not allowed within the TPZ. Protection

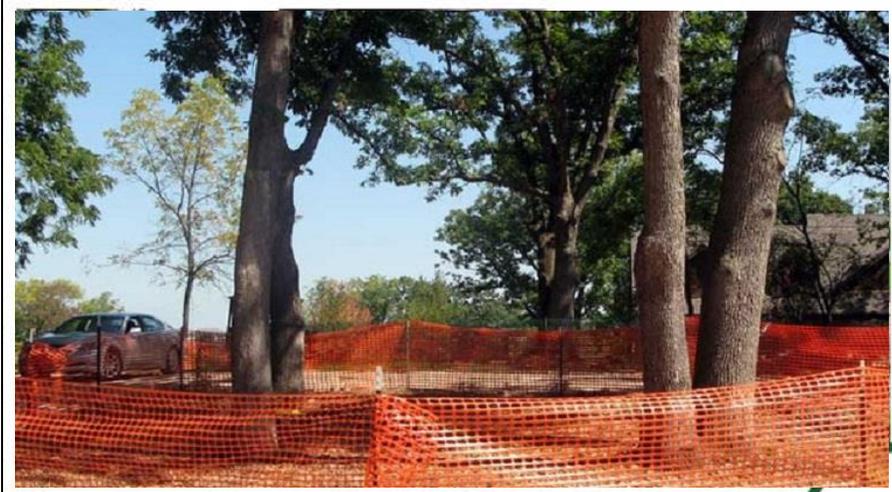
Example of a Good Tree Protection Hoarding

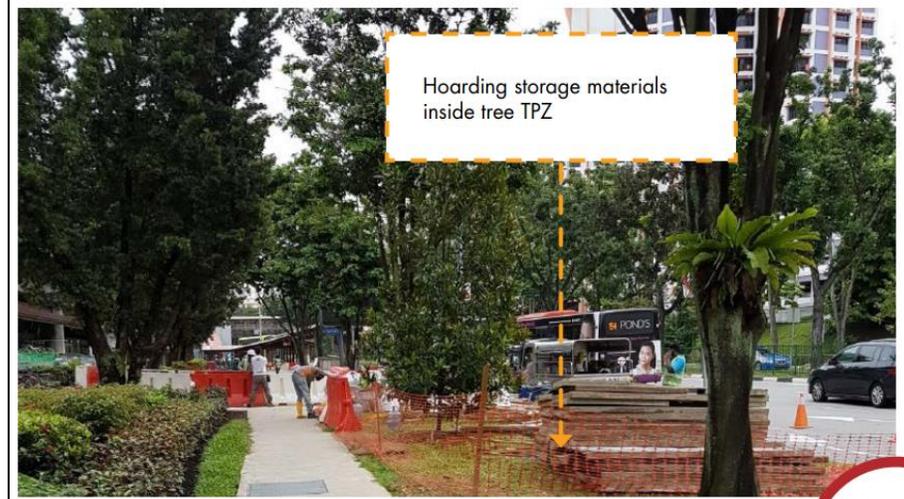
Example of a Poor Tree Protection Hoarding

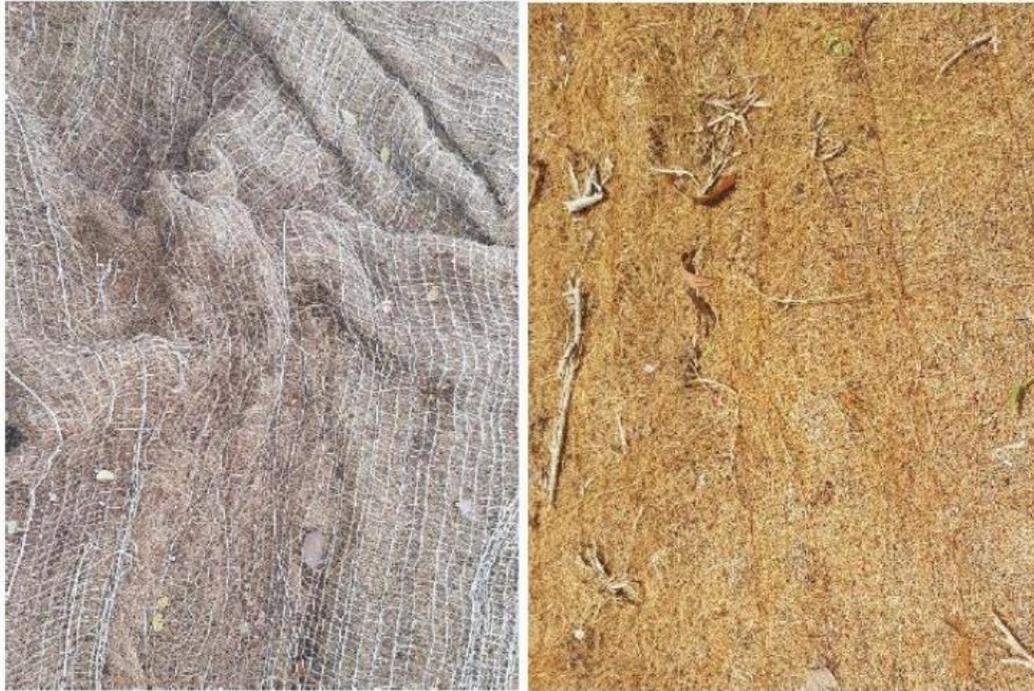
Only 100% biodegradable erosion control blankets (ECBs) allows to be used to prevent injury to wild animals.

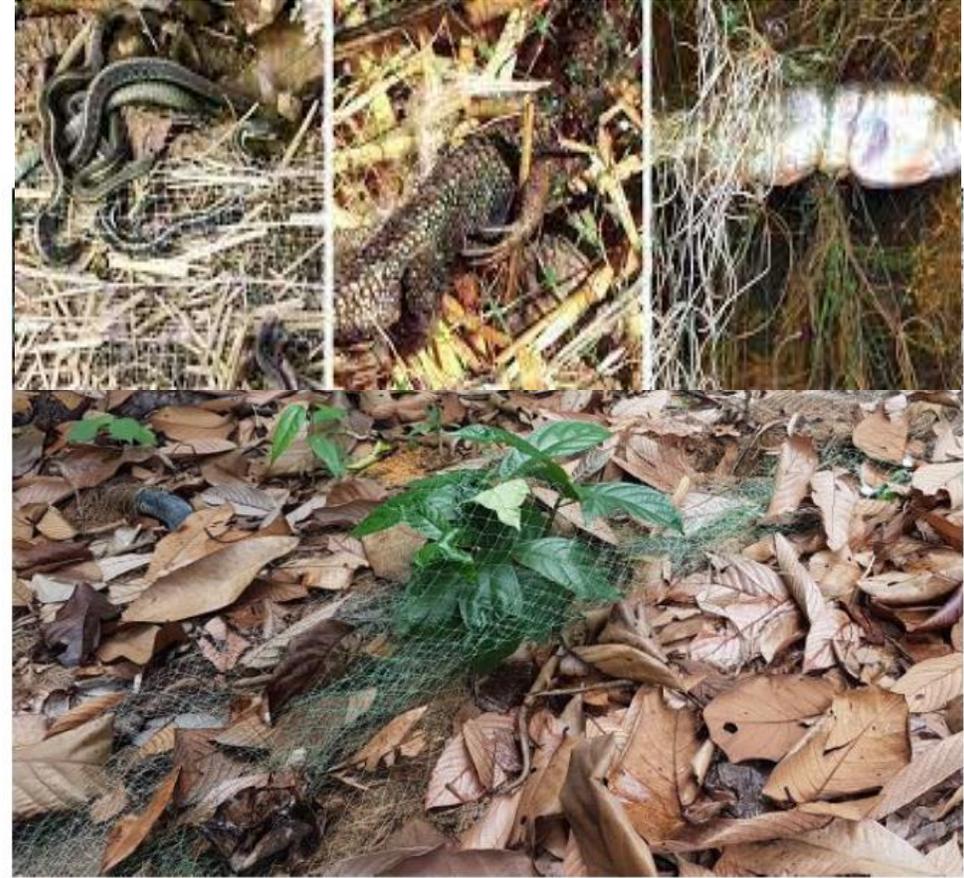
Non-biodegradable ECBs such as with nylon nets could trap or cause injury to small wild animals such snakes, pangolins, porcupines, and frogs

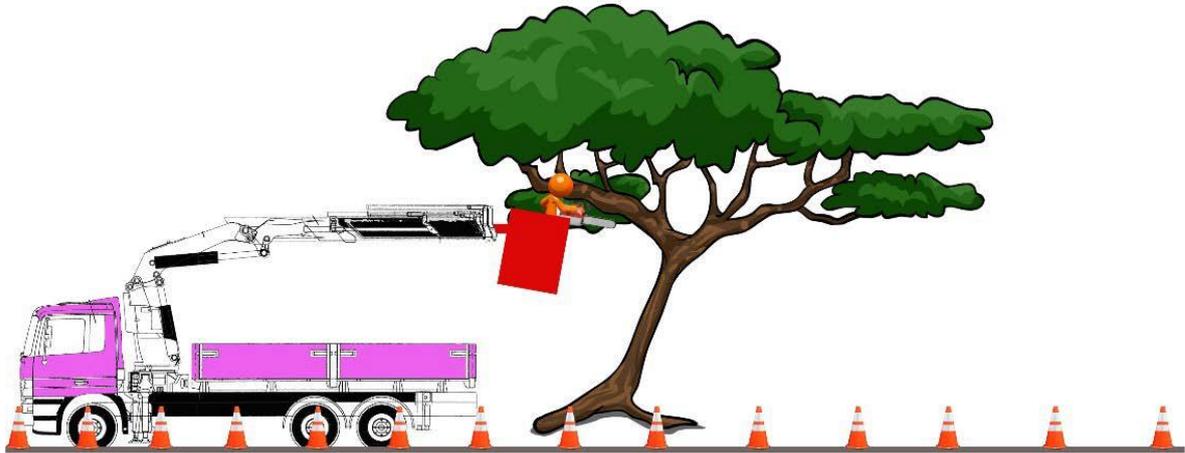
3.1: Method of Tree-Felling (Single Lorry Operation)

- When the lorry is in position, the lorry will unload the man-lift cage and workers to attach the man-lift cage on to the boom arm of the lorry crane.

- Once the man-lift cage is attached, worker in the man-lift cage is to put on full body safety harness and anchor the 2 lanyards to the man-lift cage and boom arm before cage is lifted.

- The process is repeated till all trees in the work area are felled. Workers to clear and tidy up work area before moving to the next work zone.

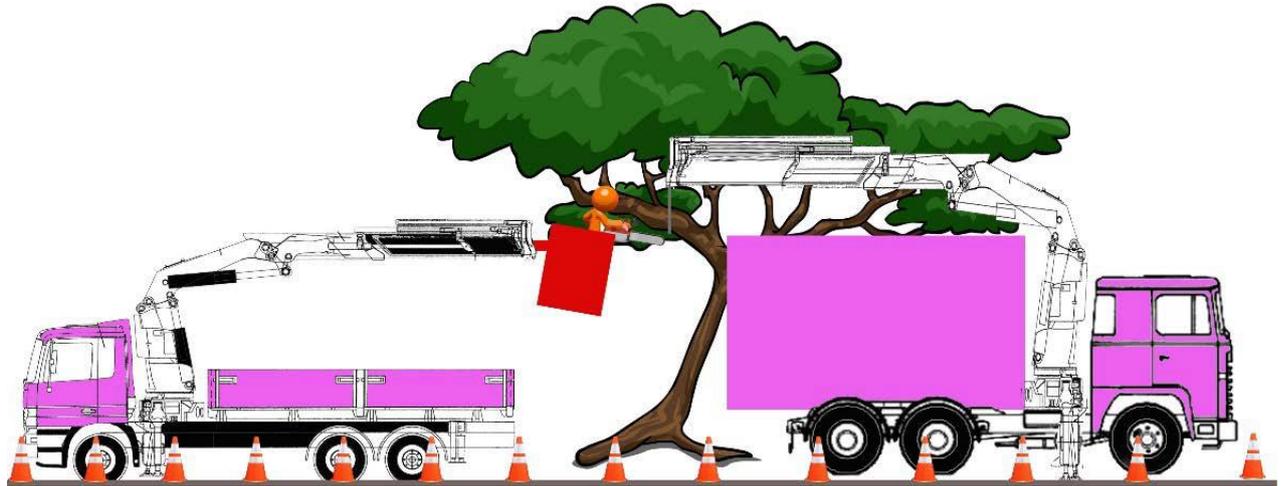
3.2: Method of Tree-Felling (Double Lorry Operation)

- For Double Lorry Operation, one vehicle will be responsible for the tree cutting while the other vehicle will be responsible for supporting larger branches when cutting.

- Man-lift cage to be attached to the lorry responsible for tree cutting. If the trees are located near to the roadside, maximum extension of boom length from the road kerb to the tree to be 5-7m.

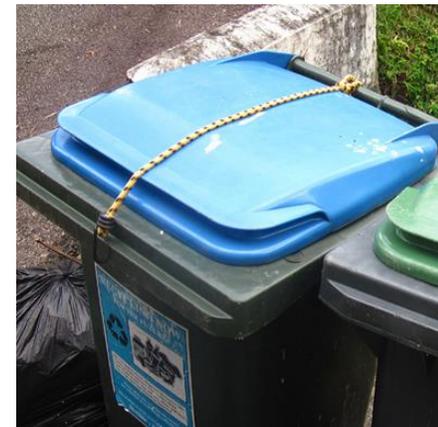
Equip Trash Bins with Buggy cords

- Install Buggy cords on trash bins near nature areas to prevent wildlife from rummaging through it

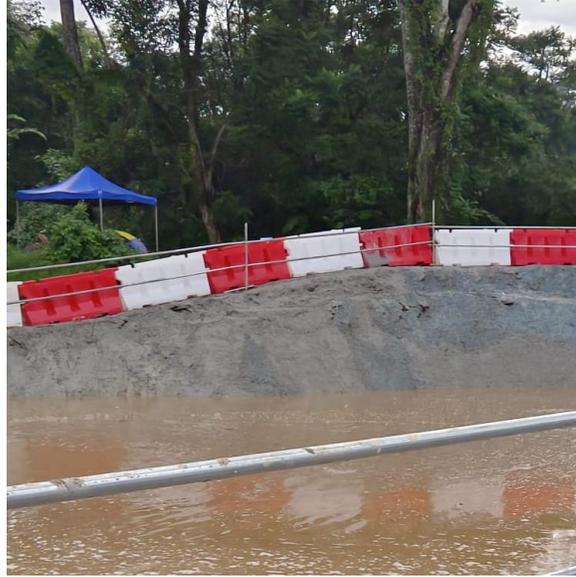
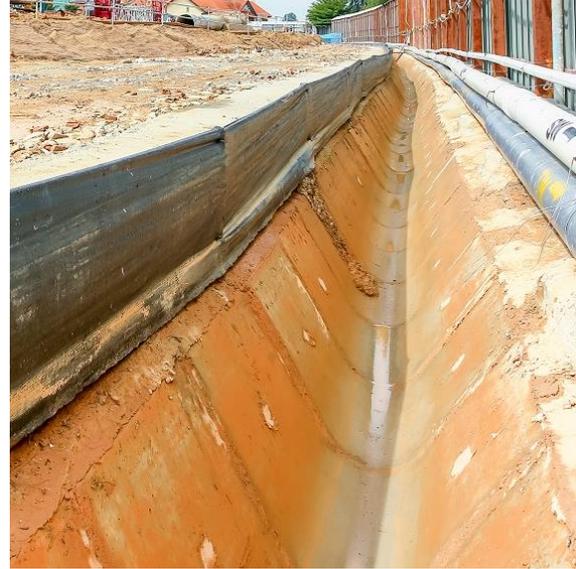
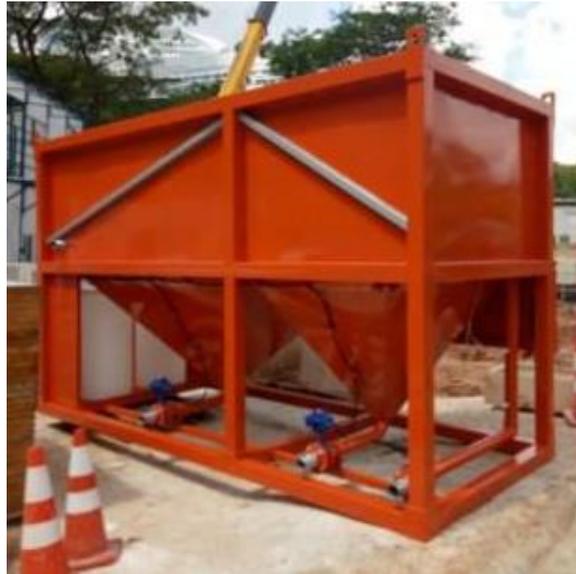
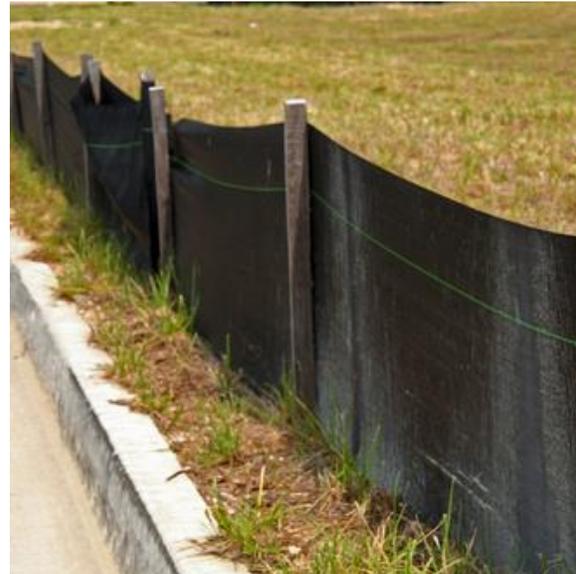
Holding Pond / Detention Tank should have Water Barriers to prevent wildlife from entering

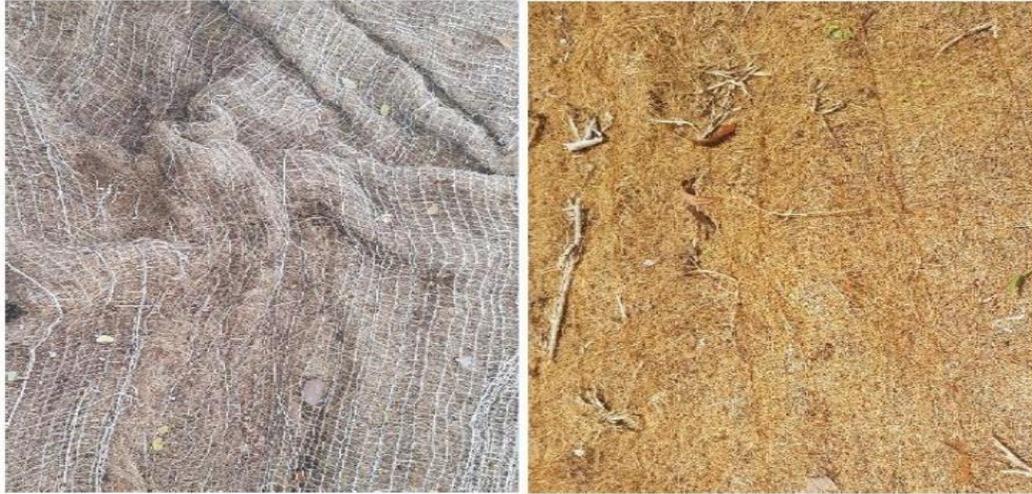
Erosion Control Blankets (ECB)

Only 100% Biodegradable **Erosion Control Blankets (ECBs)** is allowed to be used.

Some examples includes ECBs made of coconut husks

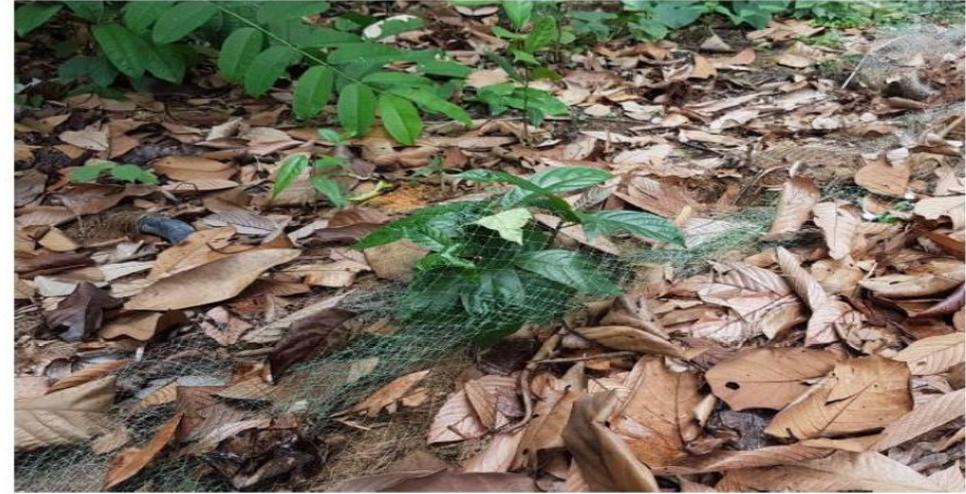
Non-biodegradable **ECBs** such as with nylon nets, could trap and cause injury to small animals (i.e., snakes, pangolins, porcupines, and frogs)

In addition, Non-biodegradable ECBs takes a longer time to break down if left unattended in the forest

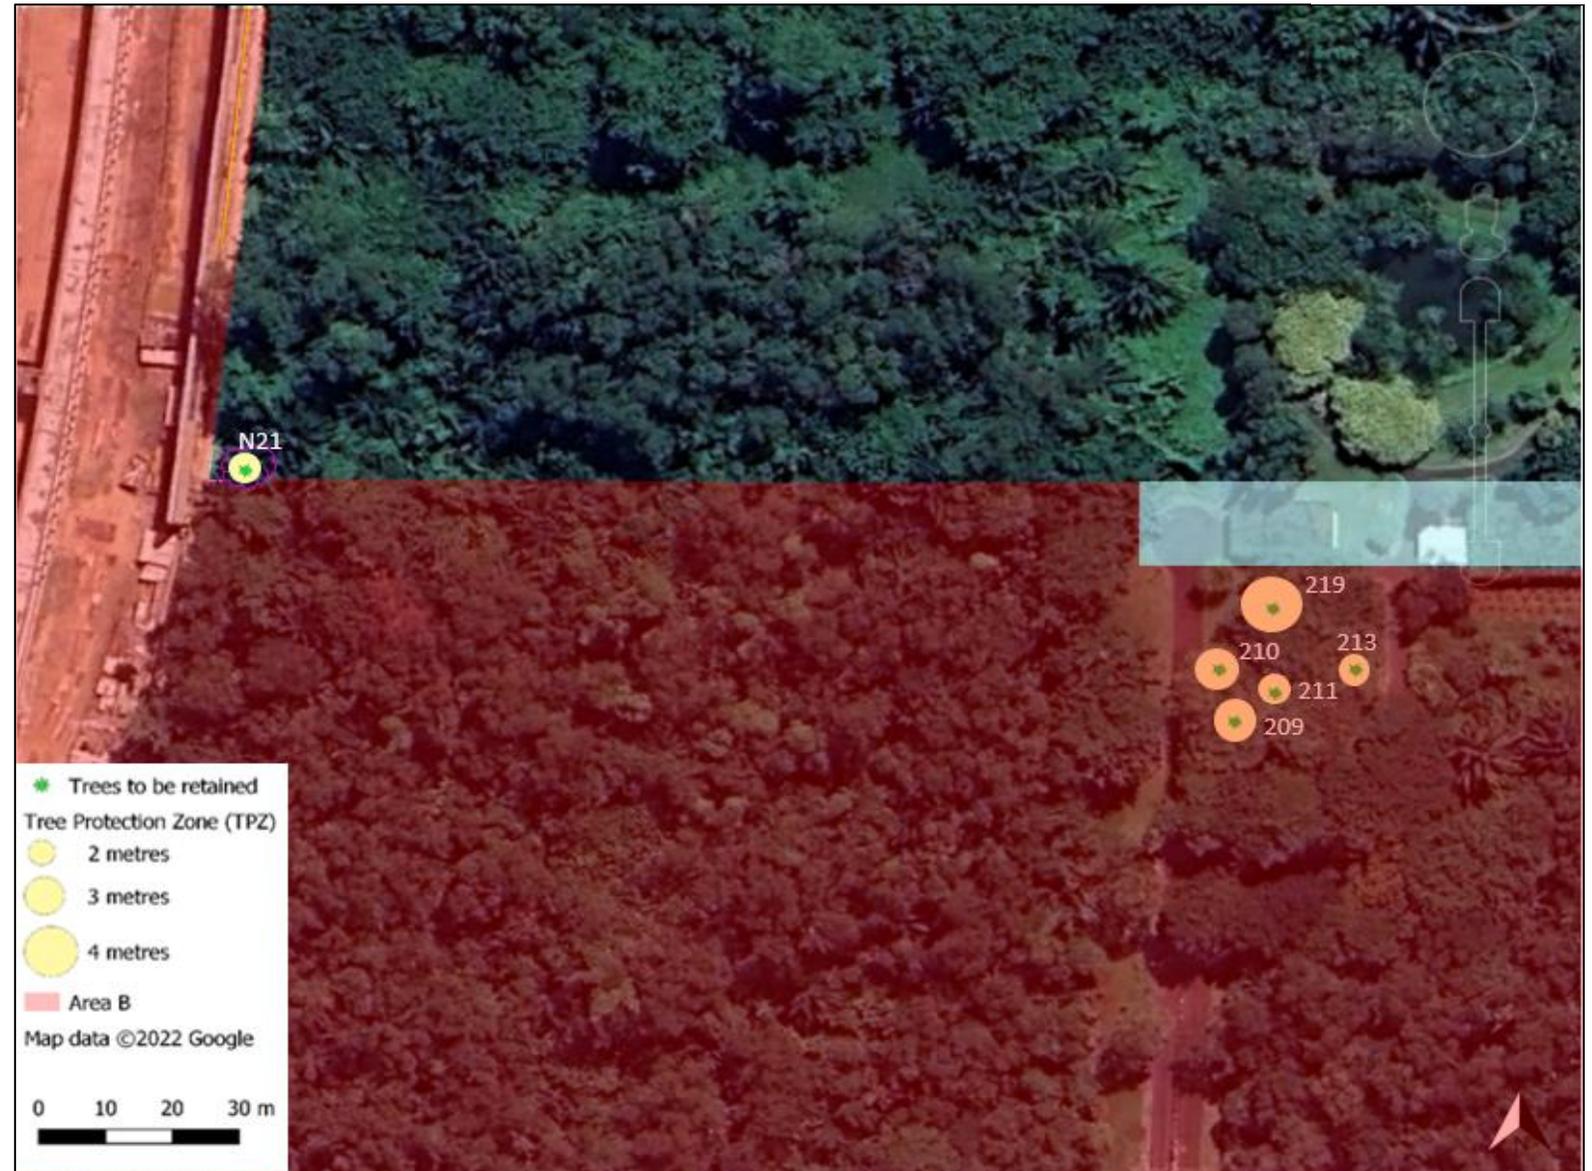
Tree health within the TPZ to be monitored by Arborist

Refer to Arborist Report

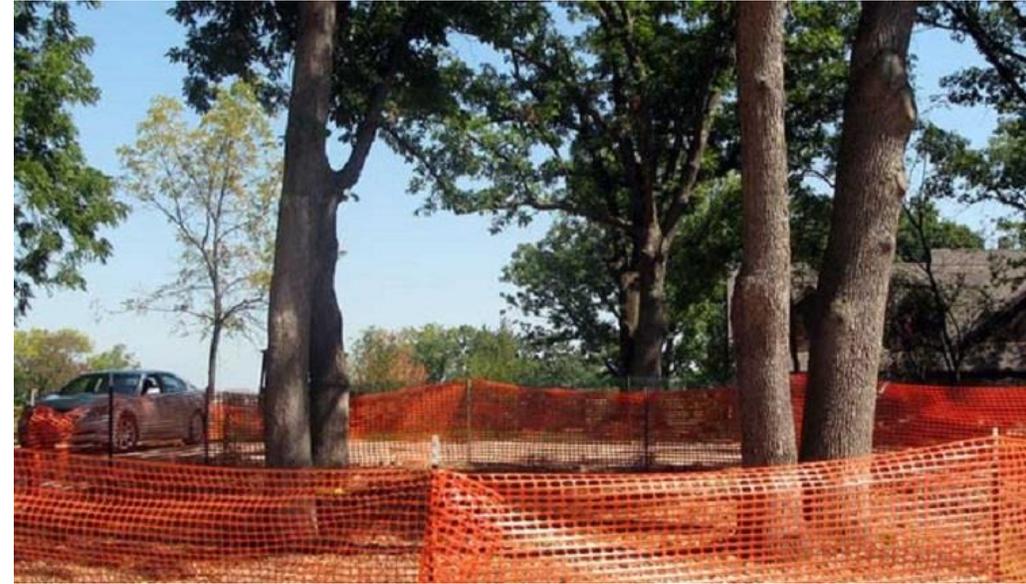
Tree Protection Zone (TPZ)

Installation of fence around TPZ

Tree health within the TPZ to be monitored by Arborist

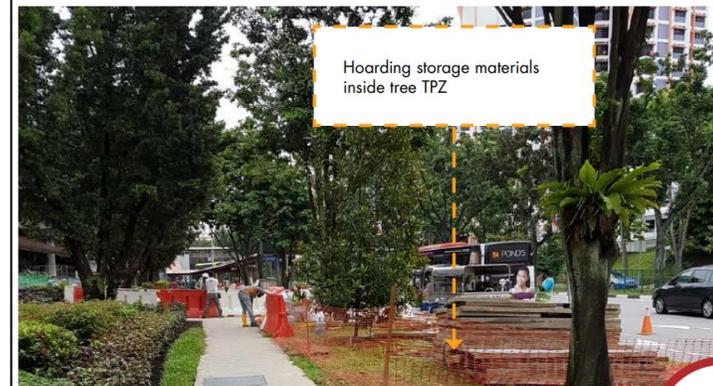
Example of a Poor Tree Protection Hoarding

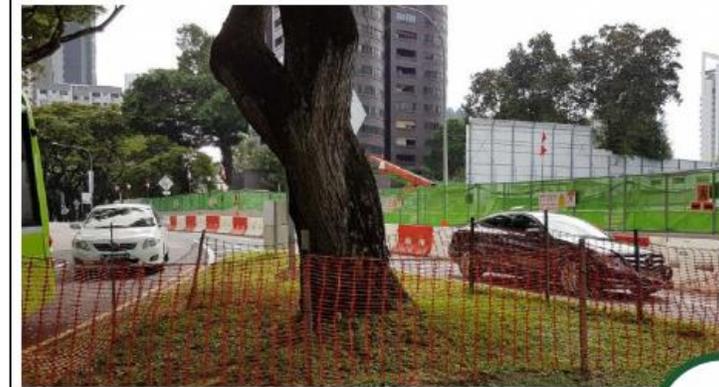
Example of a Good Tree Protection Hoarding

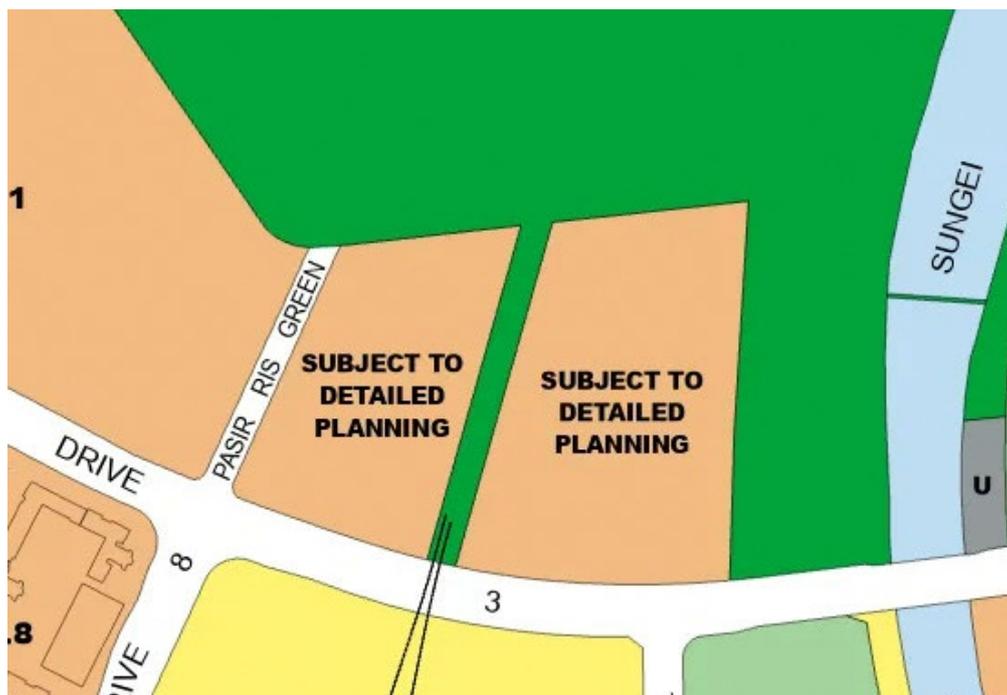
Figure 1. Pasir Ris N5 Phase 2 Residential Development in URA Master Plan 2014

Pasir Ris N5 Phase 2 has been earmarked for residential development in URA's Master Plan since 2014. The future residential development site, bounded by Pasir Ris Green, Pasir Ris Drive 3 and Sungei Tampines, is located in close proximity to Pasir Ris Park and Pasir Ris Mangrove. In 2016, Ramboll Environ Singapore Pte Ltd (Ramboll Environ) conducted a joint Environmental Impact Study (EIS) for Housing and Development Board (HDB)'s residential developments and the Land Transport Authority (LTA)'s track modification project in the same area.

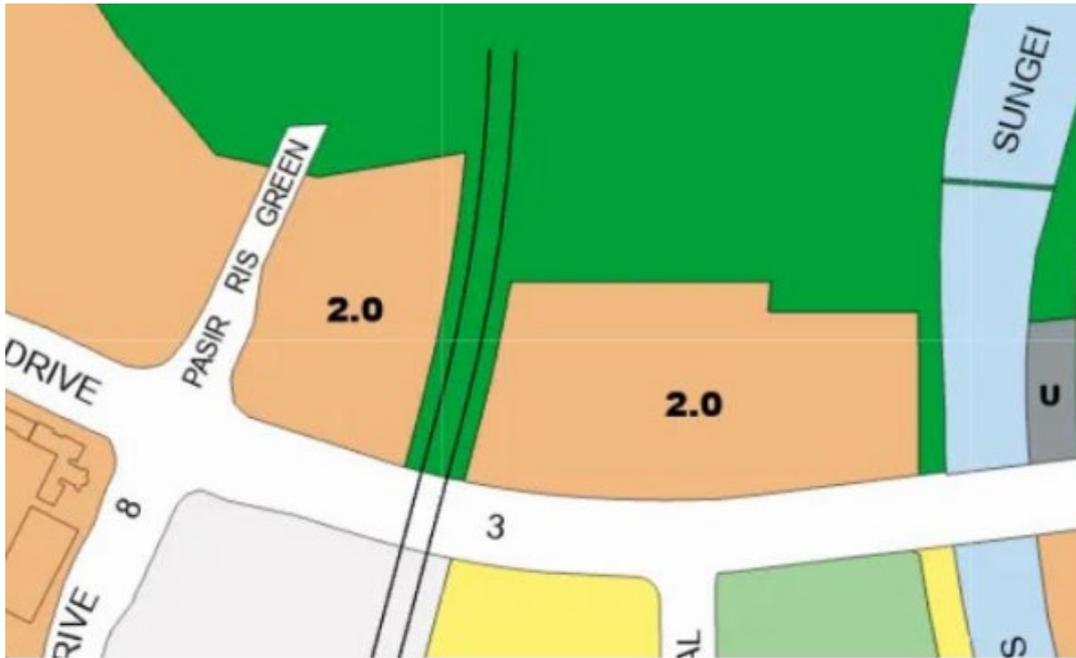
Figure 2. Pasir Ris N5 Phase 2 Residential Development in URA Master Plan 2019

The EIS report provides a baseline assessment of the project site, identifies the sensitive receptors, assesses the potential impacts, and recommends appropriate mitigation measures to reduce the residual impacts to acceptable levels during construction and operation phase. As one of the key mitigation measures implemented at the planning stage, the residential plot near to Sungei Tampines was re-orientated to be pushed further southwards and extended eastwards towards Sungei Tampines. This is to safeguard and retain the mangrove area which falls within the original proposed residential development and to accommodate wildlife corridors, as shown in Figure 2 and Figure 3 below.

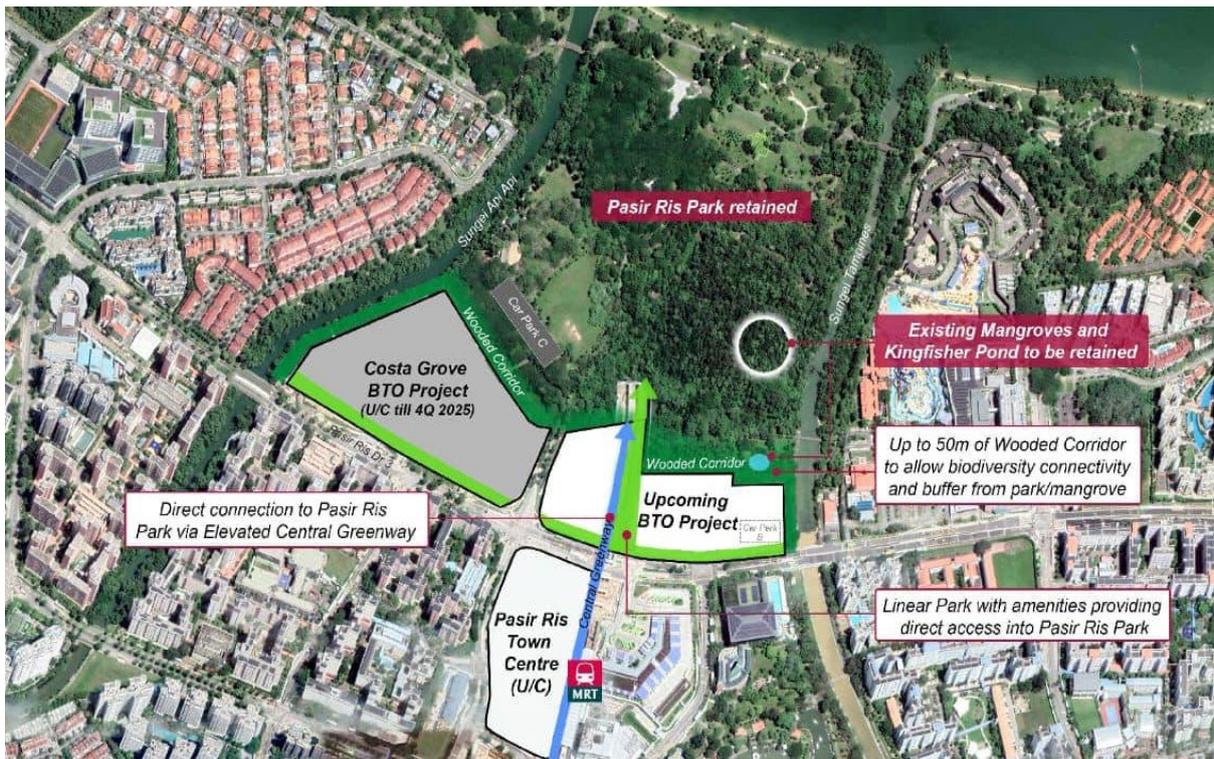
Figure 3. Retained Nature Area and Wildlife Corridors

By re-orientating the plot, a 20m to 50m buffer area is established between the residential development boundary and Pasir Ris Nature Area. The buffer areas will act as a wildlife corridor for local biodiversity interconnectivity (between Sungei Api Api and Sungei Tampines) and as a set-back from construction activities to protect the mangroves.
