Casement windows

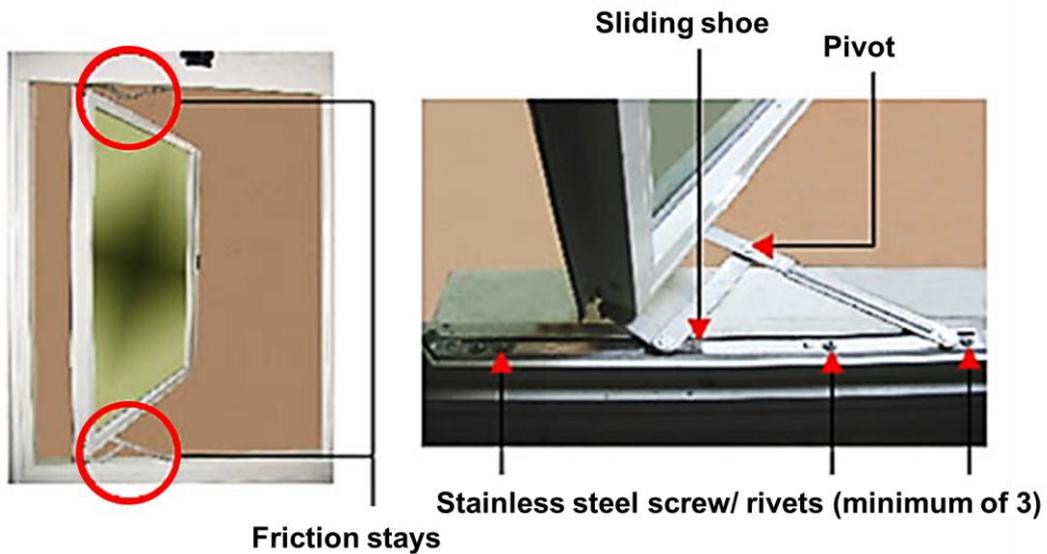
The images below show the different parts of a casement window:

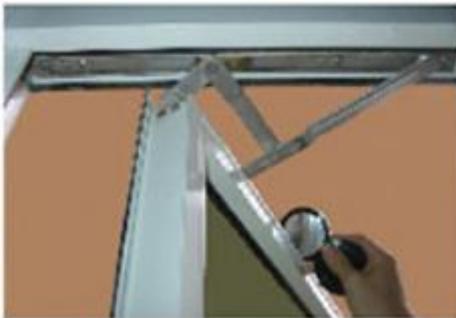
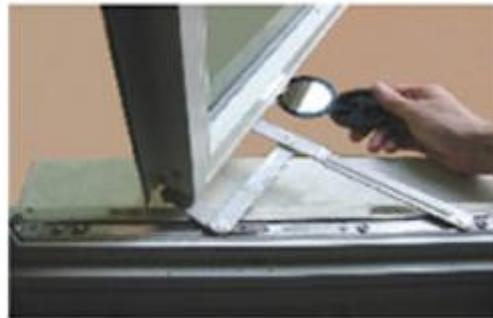
The following table lists the problems of casement windows that pose safety risks. You may use a small mirror to check the stainless steel screws/ rivets on the top and underside of the window panel. Do ensure that the relevant safety requirements are met.

Problems	Solutions/ Requirements
<p>1) Broken, rusty, corroded or non-stainless steel rivets/ screws (usually concerning friction stay)</p> <p>2) Sagged/ bent/ loose friction stay</p>	<ul style="list-style-type: none"> • Engage a BCA-approved window contractor listed with HDB to: <ul style="list-style-type: none"> ○ Replace the existing friction stay with one made of stainless-steel grade 304 or equivalent. ○ Use stainless steel grade 304 or equivalent rivets with a minimum diameter of 4.8mm. For existing casement window (i.e. top hung or side hung), there should be at least 3 rivets/ screws for each side of the window friction stay. For retrofitted/ newly replaced casement window there should be at least 4 rivets/ screws on each side of the friction stay.

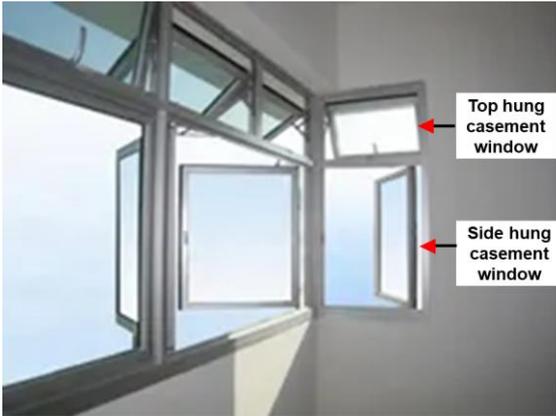
<p>3) Loose screws</p>	<ul style="list-style-type: none"> • Tighten loose screws
<p>4) Deteriorated corner brackets</p>

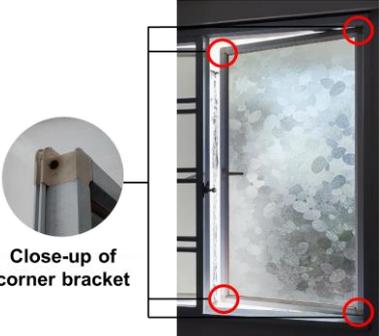
<p>Close-up of corner bracket</p>	<ul style="list-style-type: none"> • Engage a BCA-approved window contractor listed with HDB to replace the deteriorated corner brackets.

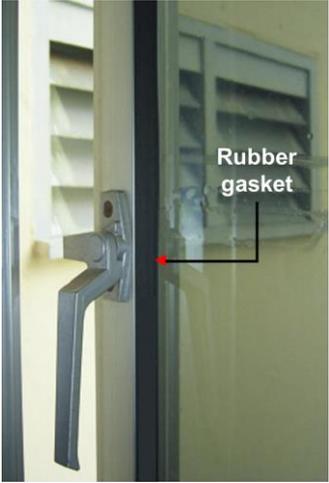
Problems	Solutions/ Requirements
<p>5) Loose rubber gasket</p>

<ul style="list-style-type: none"> • Push the rubber gasket tightly into the groove • Engage a BCA-approved window contractor listed with HDB to replace any brittle/broken gasket with a new strip. Ensure that the new strip is fixed tightly into the inner frame of the glass
<p>6) Cracked or loose glass panels</p>	<ul style="list-style-type: none"> • Engage a BCA-approved window contractor listed with HDB to replace any cracked glass panes and rubber gasket
<p>7) Difficulty in closing window</p>	<ul style="list-style-type: none"> • Clean and remove dirt, debris and any obstruction from the hinge or friction stay (A), hinge track (B) and sliding shoe (C) • Lubricate or grease the hinge track (B), sliding shoe (C) and pivoting point (D) • Ensure friction stays are properly fixed to the aluminium parts • Engage a BCA-approved window contractor listed with HDB to carry out repair if any of the fixtures are missing or become loose

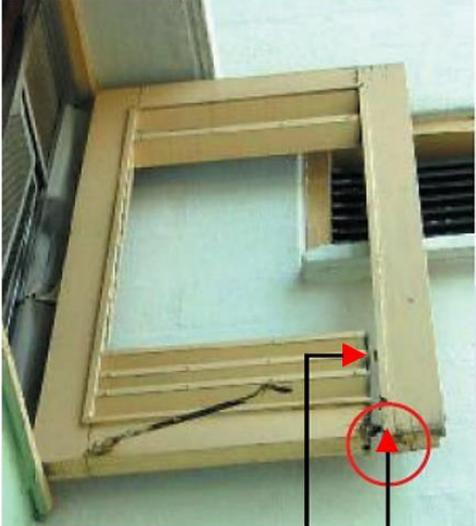
Problems	Solutions/ Requirements
Additional problem for wooden casement windows	
<p>8) Decayed or detached parts</p>

<p>Detached louvres</p> <p>Decayed window parts</p>	<ul style="list-style-type: none"> • Engage a BCA-approved window contractor listed with HDB to replace decayed or detached part(s) • Ensure your window contractor apply for HDB's approval to replace wooden windows with aluminium ones if the decayed parts cannot be repaired. You can log in to My HDBPage to check the application status.
