# Executive Summary

AECOM Singapore Pte Ltd was appointed by the Housing & Development Board (“HDB”) to carry out an Environmental Impact Study (EIS) for the construction and operational phases of proposed housing with supporting amenities and infrastructure in Mount Pleasant area (hereinafter referred to as the “Study Area”). This EIS Report was formed: (1) to inform HDB of major issues according to HDB’s conceptual plan at an early master planning stage; (2) to provide a high-level identification, prediction and evaluation of potential environmental impacts and their acceptability that are likely to arise as a result of the Study Area ; (3) to propose mitigation measures; and (4) to evaluate the acceptability of residual impacts after implementation of these recommended measures.

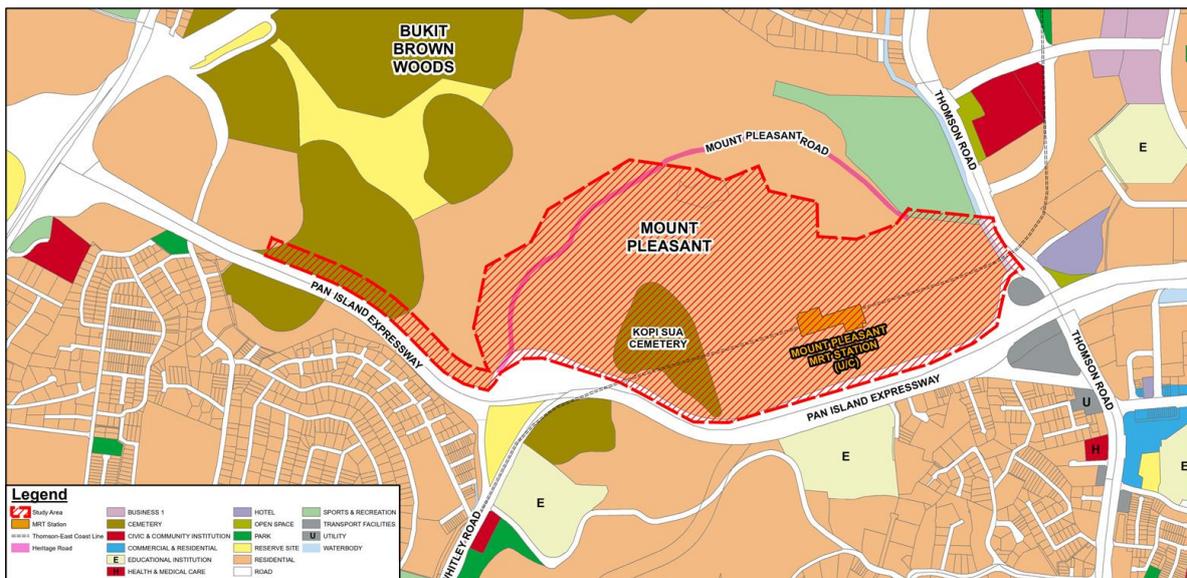
Figure 1 - Gazetted Land Use of the Study Area as per URA Master Plan 2019

The Study Area is bounded by Mount Pleasant Road to the north, Bukit Brown Woods to the west, Thomson Road to the east, and the Pan Island Expressway (PIE) to the south, which is larger than the proposed development area. It covers a total area of approximately 71.6 hectares (ha) (see Figure 1). It is currently a mix of cemetery park land, forested area, institutional recreational spaces and facilities, and the Mount Pleasant MRT and North-South Corridor (NSC) construction areas. The Study Area is predominantly zoned “Residential (Subject to Detailed Planning)” in URA’s gazetted Master Plan 2019, while the Kopi Sua Cemetery is zoned “Cemetery”. The Study Area also covers a portion of Mount Pleasant Road, which is a gazetted heritage road with the Black & White bungalows situated alongside. More details about the project background and surrounding environment are provided in Sections 3 and 5 of the EIS report.

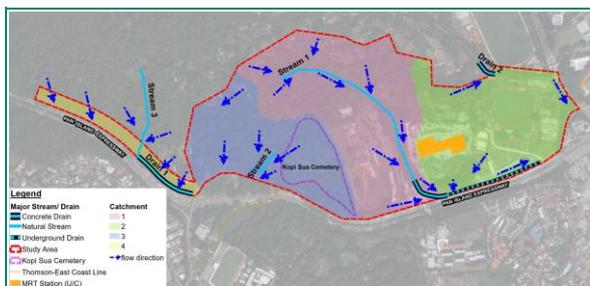
Figure 2 - Existing Waterbodies in the Study Area

- **Hydrology and Surface Water Quality** (see Figure 2) – Two (2) naturalised streams (i.e. Streams 2 and 3) and one (1) partially naturalised stream (i.e. Stream 1), as well as two (2) stormwater drains (i.e. Drains 1 and 2) were identified as watercourses within the four (4) catchment areas. Baseline water quality sampling was conducted at a total of seven (7) sampling locations across the five watercourses. The water quality in all the natural streams were found to be suitable for aquatic life.

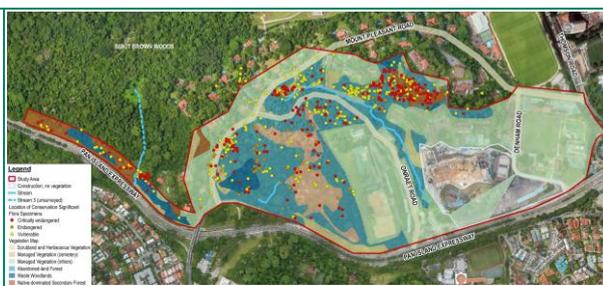
Figure 3 - Distribution of Flora Species of Conservation Significance and Vegetation Types

- **Vegetation Distribution** (see Figure 3) – The Study Area is composed of managed vegetation (46.23%), followed by the abandoned-land forest (25.94%), managed vegetation (cemetery)<sup>4</sup> (5.27%), native-dominated low secondary forest (4.27%), scrubland and herbaceous vegetation (4.12%) and waste woodlands (3.54%). The remaining 10.62% of the Study Area was covered by an existing construction area.

- **Biodiversity, Flora** (see Figure 3) – A total of 378 species of vascular plants (e.g. ferns and flowering plants) was recorded, in which about 23.54% were of true conservation significance<sup>5,6</sup>, located mostly within the native-dominated secondary forest and abandoned-land forest in the Study Area. A total of 225 large trees, palms and bamboos (≥ 3m in girth/spread) were documented within the Study Area with a mix of common and exotic species.

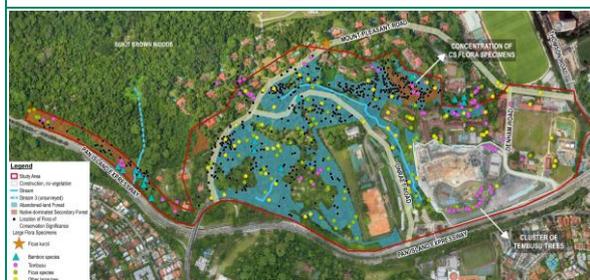
Figure 4 - Key Ecological Receptors in Study Area

- **Ecological Value** (see Figure 4) – The Study Area has a mix of features with low to high ecological values, with medium to high ecological value due to its proximity to the Central Catchment Nature Reserve, as well as the presence of: (1) Native-dominated secondary forest of medium-high ecological value; (2) Abandoned-land forest of medium ecological value; (3) A heritage tree (*Ficus kurzii*) along Mount Pleasant Road; (4) 225 large specimens of trees, palms or bamboos across the site; (5) Bamboo clusters and the critically endangered Lesser Bamboo Bat (*Tylonycteris* sp.); (6) Fauna of conservation significance<sup>5,7</sup> at all three streams.

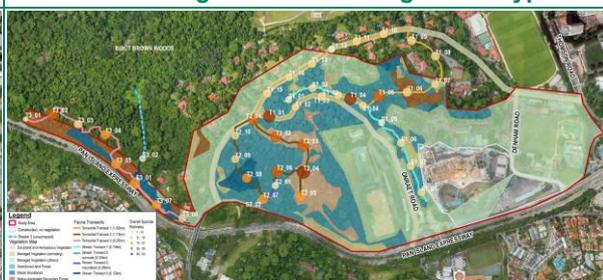
Figure 5 - Overall Number of Fauna Species Recorded at Each Sampling Point along Transects

- **Biodiversity, Fauna** (see Figure 5) – About 35.25% of the 468 species of probable occurrence<sup>7</sup> identified from desktop study were confirmed during the fauna field assessment. The highest species richness was recorded in the cemetery area with managed vegetation. Overall, a total of 14 species of conservation significance<sup>5</sup> were recorded, including one damselfly (i.e. Collared Threadtail<sup>8</sup>), one butterfly (i.e. Common Rose), one reptile (i.e. Asian Softshell Turtle<sup>8</sup>), ten bird (e.g. Crested Goshawk, White-rumped Shama) and one bat species (i.e. bamboo bats<sup>9</sup>).
