## Specialist Consultancy Services for Environmental Impact Assessment (EIA) at Chencharu (Site 1)

Document no: D3886500.EIAS1.F1  
Revision: Rev3

Commissioned by NParks on behalf of HDB  
NParks/F/1/2024

Final EIA Report

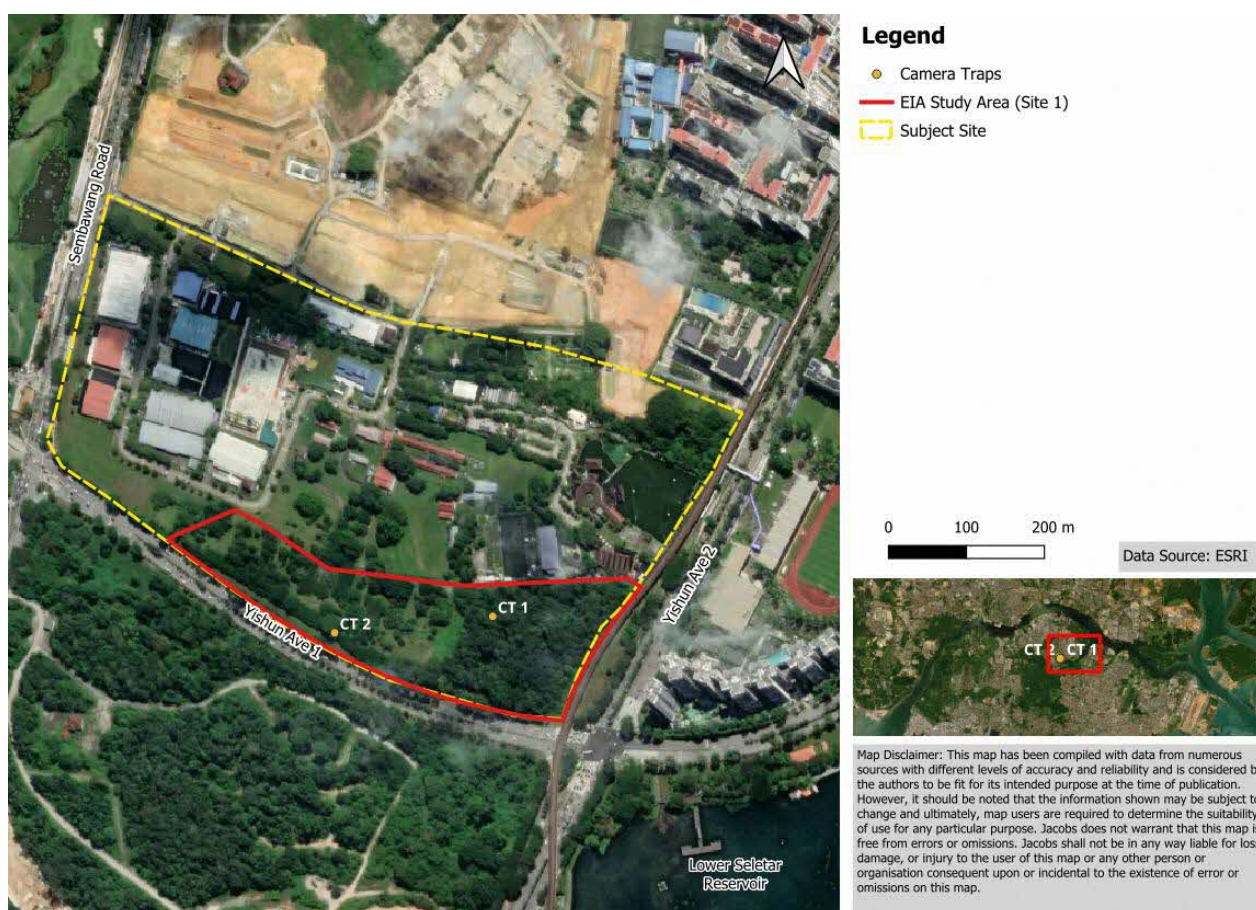
Figure 5-2: Camera Trap Locations in Site 1

Mammals were also surveyed via camera trapping. Two terrestrial camera traps were deployed across Site 1 (**Figure 5-2**). The deployment location was relatively free of vegetation to reduce false triggers and for optimal detection range. Each terrestrial camera trap was set up approximately 20–30 cm above ground (**Figure 5-3**). They operated 24 h a day and were programmed to record one 10 second footage per motion trigger with a 10 second quiet period following each trigger. Each camera trap was deployed for 60 days.

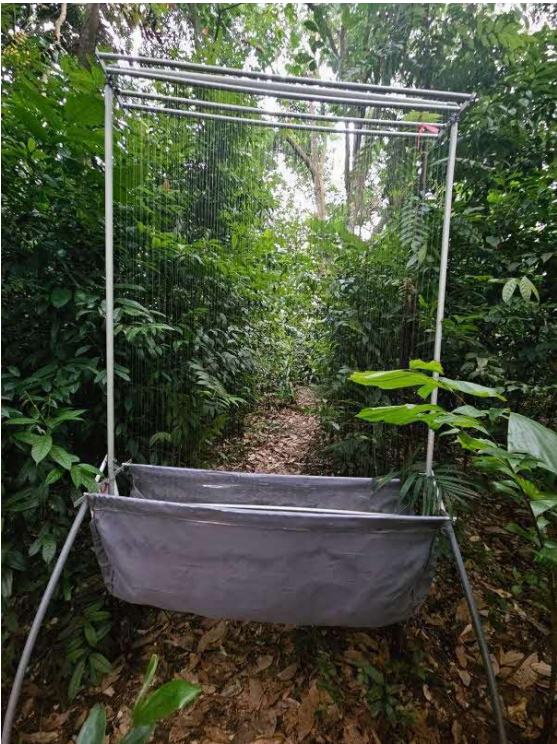
Figure 5-4: Photo of the Harp Trap Set Up

One harp trap (**Figure 5-4**) was deployed strategically at one location at potential flyways across Site 1 (**Figure 5-5**) to improve accuracy of species identification. Harp traps target the smaller insectivorous bats (Microchiroptera). The harp trap was set up between 1730 h–1930 h and the trapping duration occurred between 1930 h–2100 h, during which the trap was repeatedly checked. The trap was left overnight and checked the following morning between 0800 h and 0900 h and removed. No bats were collected.

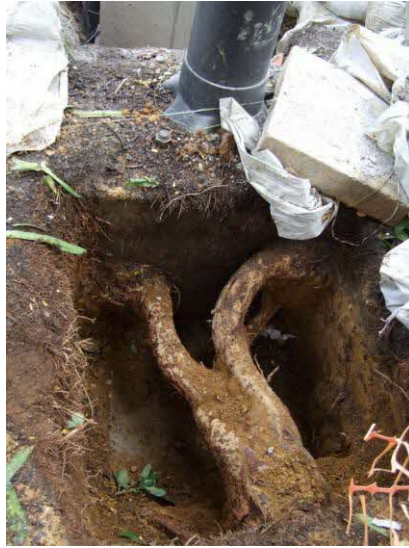
**Figure 2: Trial trench by skilled workers using hand tools exposing root architecture**

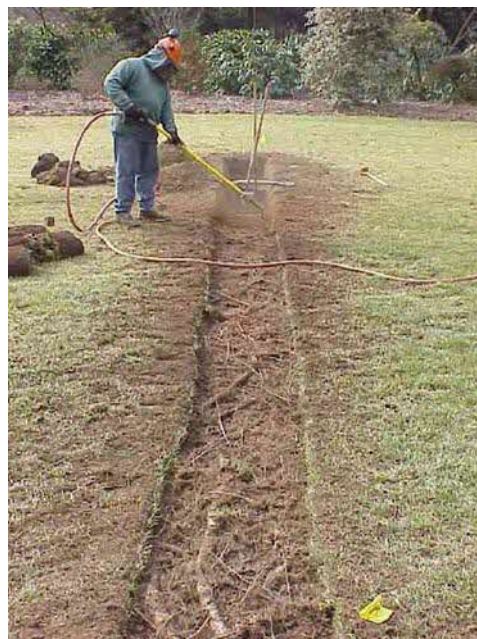
**Figure 10: Root exploratory works using an air spade. Air spading avoids damage of structural and even feeder roots of the tree.**

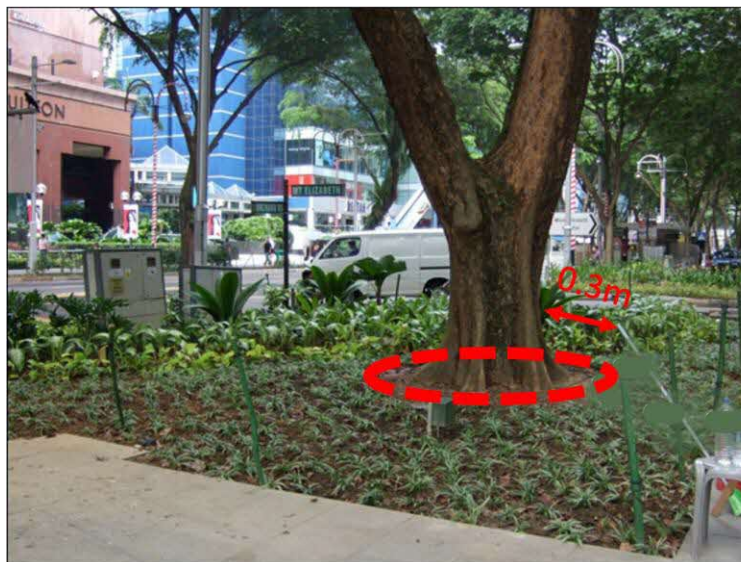
**Figure 10: New plantings at a minimum distance of 300mm (all round) from root collar**
