# Specialist Consultancy Services for Environmental Baseline Study (EBS) on Choa Chu Kang N1

Final Report

Housing & Development Board (HDB)

Project reference: L/025/21  
Project number: 60651709

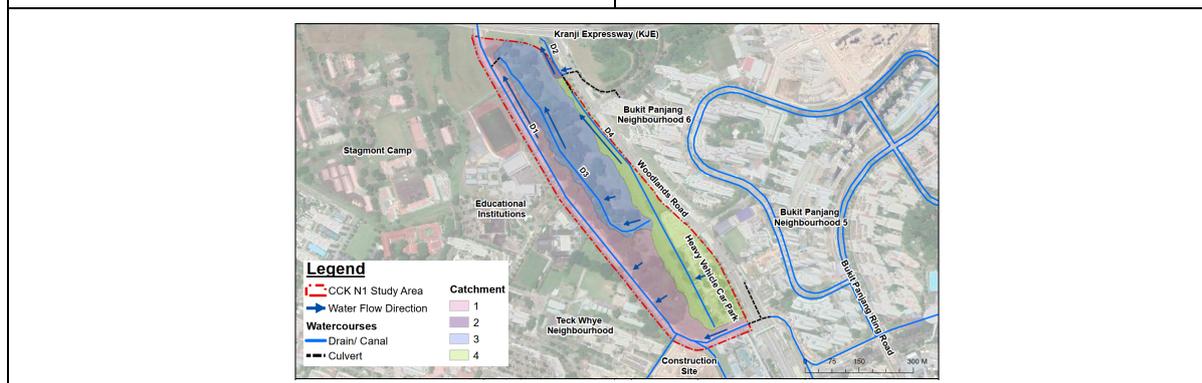
Figure 1-4 Existing waterbodies in the Study Area

- **Hydrological Conditions** (see Figure 1-4) – Four (4) water catchment areas within the vicinity of the Project mainly contribute to four (4) watercourses within the Study Area. The perennial Pang Sua Canal D1 is located along the western and southern lengths of the Study Area. Perennial concrete drain D2 is located at the northeast corner of the site. Ephemeral concrete drain D3 cuts across the centre of the site, discharging into Pang Sua Canal D1 through a culvert. Ephemeral concrete drain D4 located along the eastern section of the Study Area.

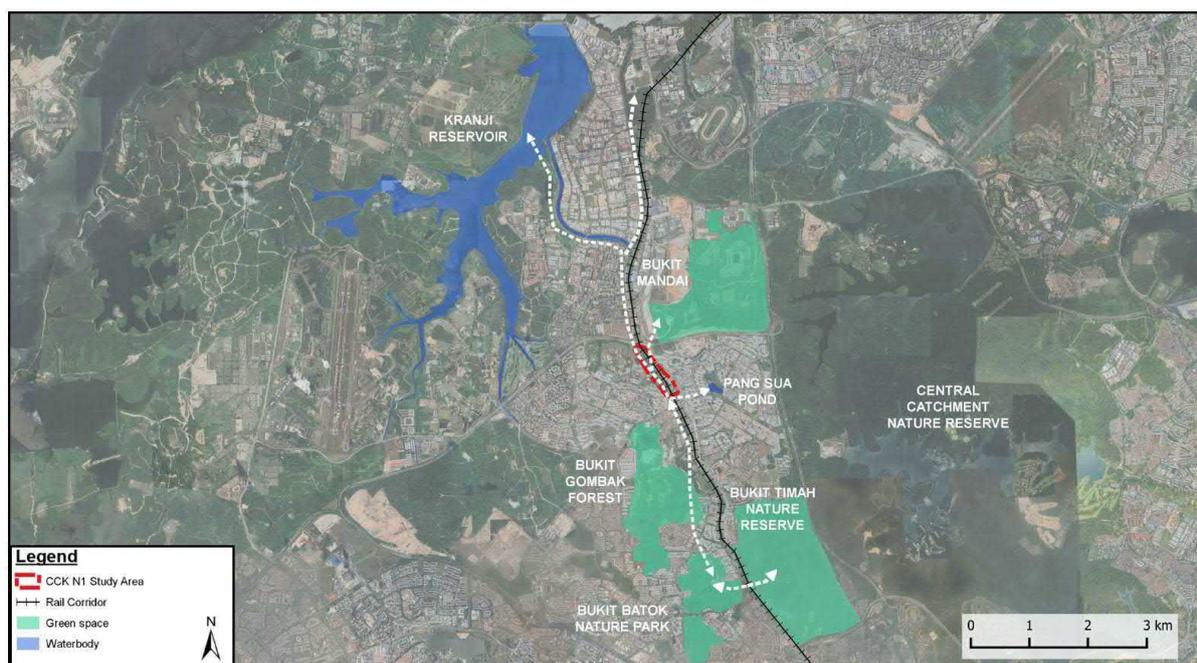
**Figure 1-5 Site Context and potential connectivity between Study Area and other green patches in proximity**

The 21.7 ha Study Area, Choa Chu Kang N1, is also known as the Sungei Pang Sua Woodland [P-10; P-11]. It is “an important part of the Green Rail Corridor between Hill View in the south and Stagmont Ring in the north, as it is the only wooded area in-between” [P-11]. The Study Area is also considered as “a conducive stepping stone” [P-10] (i.e., habitat patches in a landscape that facilitates movement of species between other forested patches [P-33]) and “a conduit for wildlife dispersal or movement” [P-10] that could facilitate the dispersal of fauna to the surrounding green spaces, such as Bukit Mandai forest to the northeast and Bukit Gombak forest to the south (Figure 1-5), and to other larger fragmented habitats, including Bukit Timah Nature Reserve (BTNR) in the southeast, and Mandai Mangrove and Mudflats in the north [P-10], hence, enhancing the ecological connectivity across the landscape.

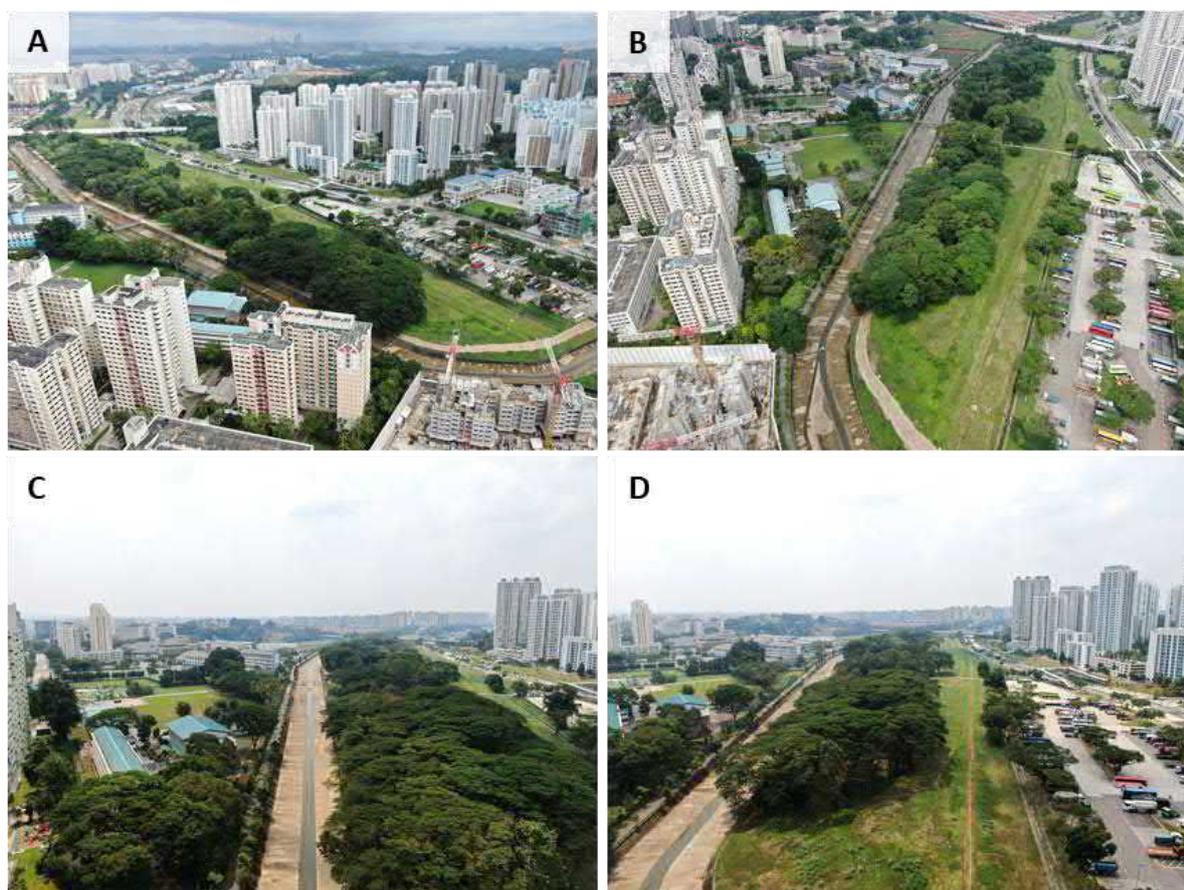
The Pang Sua Canal and PUB's existing drainage reserve are located in the west and south of the Study Area. The canal flows from south to north of the Study Area (Figure 4-3B and Figure 4-3C). The Rail Corridor also passes through the Study Area, close to the east boundary of the site (Figure 4-3D). It is currently a linear stretch of managed turf (Figure 4-3D). There are also built-up areas within the site, which includes a heavy vehicle car park and a now-defunct bus terminal (Figure 4-3D), which are located at the south-eastern portion of the Study Area.

**Figure 4-3 Photos of existing site conditions in the Study Area: (A) Aerial View of the whole site, (B) Aerial View of the Pang Sua Canal located in the west and south of the site, (C) Aerial view of Pang Sua Canal and trees along western section of the site, (D) Aerial view of Rail Corridor alignment, heavy vehicle carpark and now-defunct bus terminal**

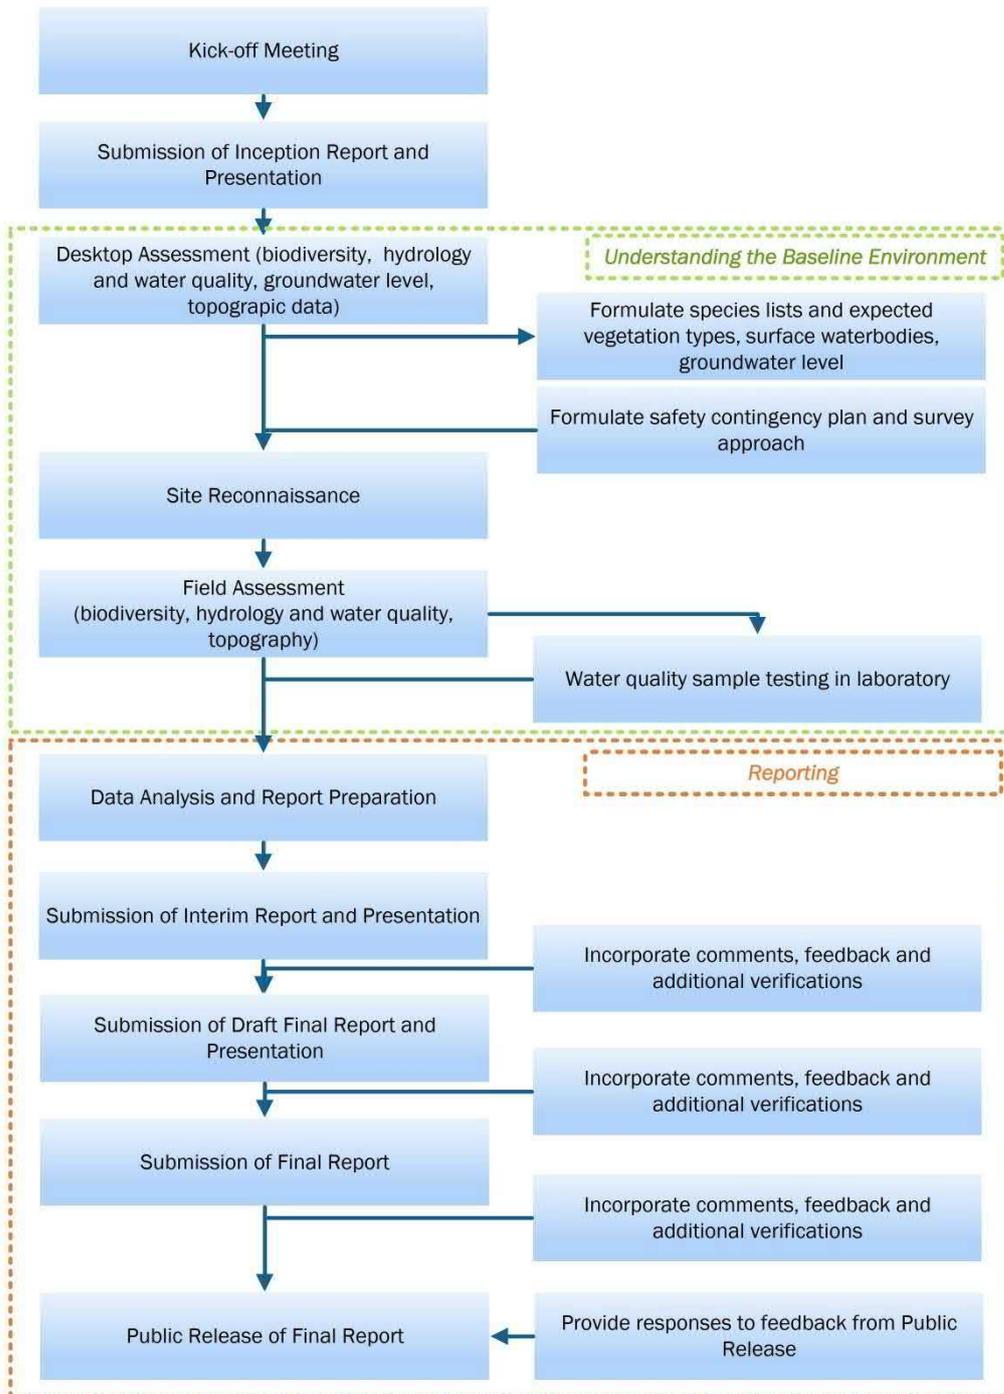
Figure 6-1 Detailed approach for the EBS

Figure 6-1 below provides the detailed approach applied for this study.

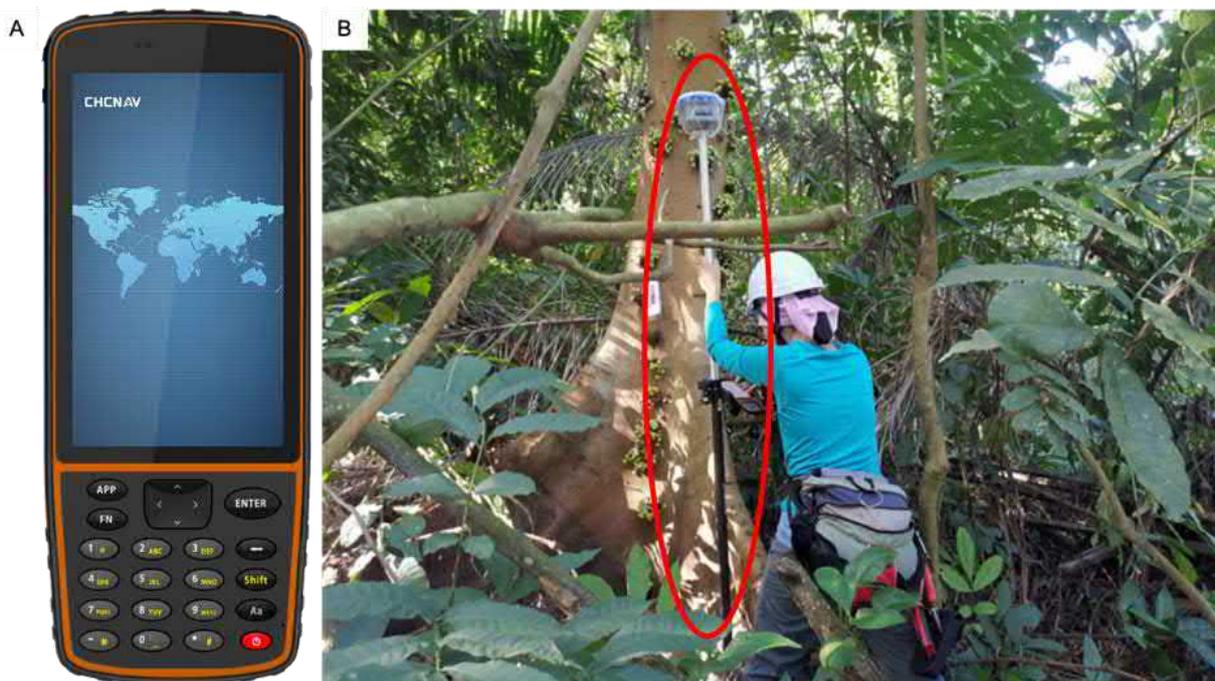
Figure 7-1 (A) CHC® Navigation HCE320 GNSS data controller (Source: Geo-Matching.Com); (B) how it is used in the field

Mapped specimens were tagged with a unique serial number on site; this includes all trees, single-stemmed palms, and strangling *Ficus* species of  $\geq 0.3$  m girth. Single-stemmed palms are defined in this study as having one obvious and erect stem. Geographic locations, girth/spread and heights were also recorded. Differential Global Positioning System (DGPS) receivers (CHC® Navigation HCE320 GNSS data controller with the CHC® Navigation i90 Pro GNSS receiver and Leica DISTO™ D510 rangefinder; Hi-Target Qmini A5 High Precision Handheld data controller with the Hi-Target V-90 GNSS receiver and Leica DISTO™ D510 rangefinder) (Figure 7-1 and Figure 7-2)—which records locations with accuracy of  $\pm 1$  m and less—were used to record geographic locations of the specimens using the SVY21 plane coordinate system. This local datum gives a more accurate representation of the areas of coverage in Singapore compared to a global datum and is used by the Singapore Land Authority (SLA) (SLA, 2015 [W-1]). Where there are clusters of specimens of the same species occurring within 1–2 m of each other, only one specimen was tagged, and its location marked using the DGPS.

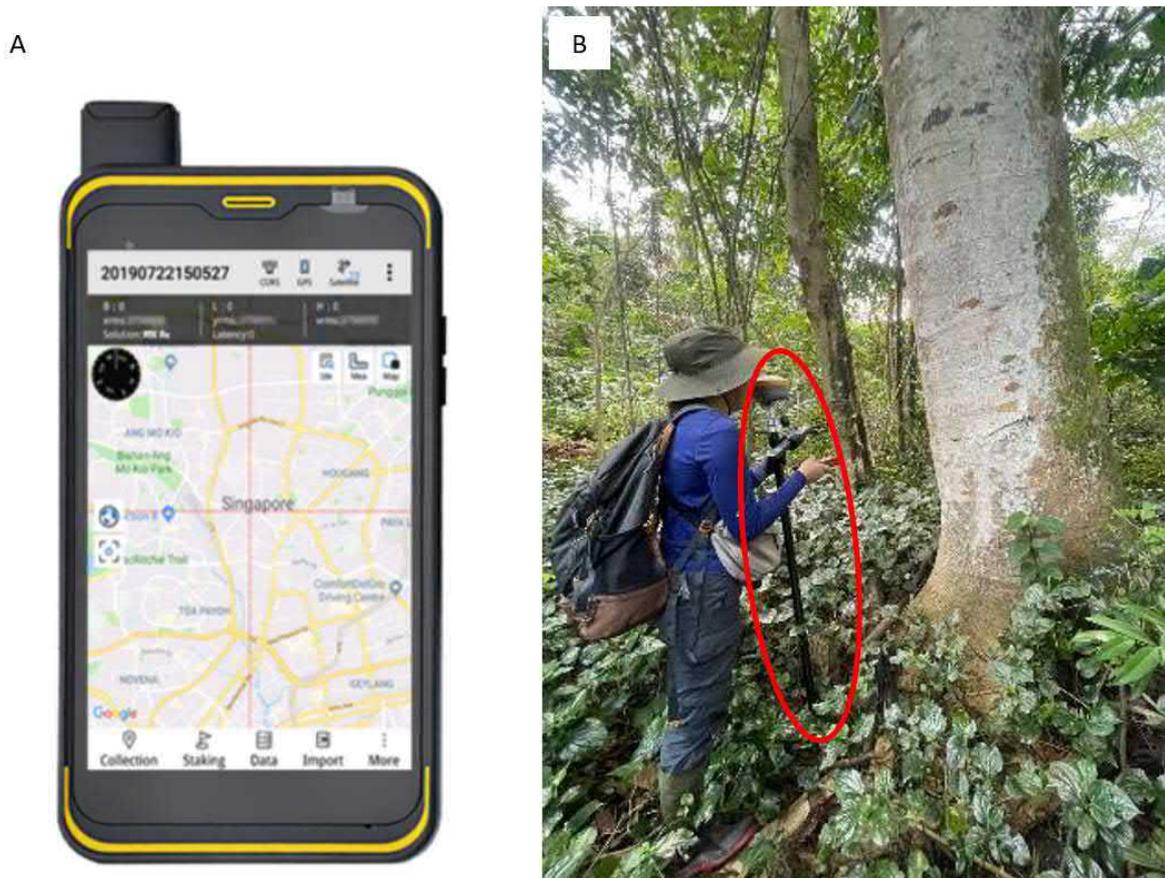
Figure 7-2 (A) Hi-Target Qmini A5 High Precision Handheld data controller (Source: Geo-Matching.Com; (B) how it is being used in the field

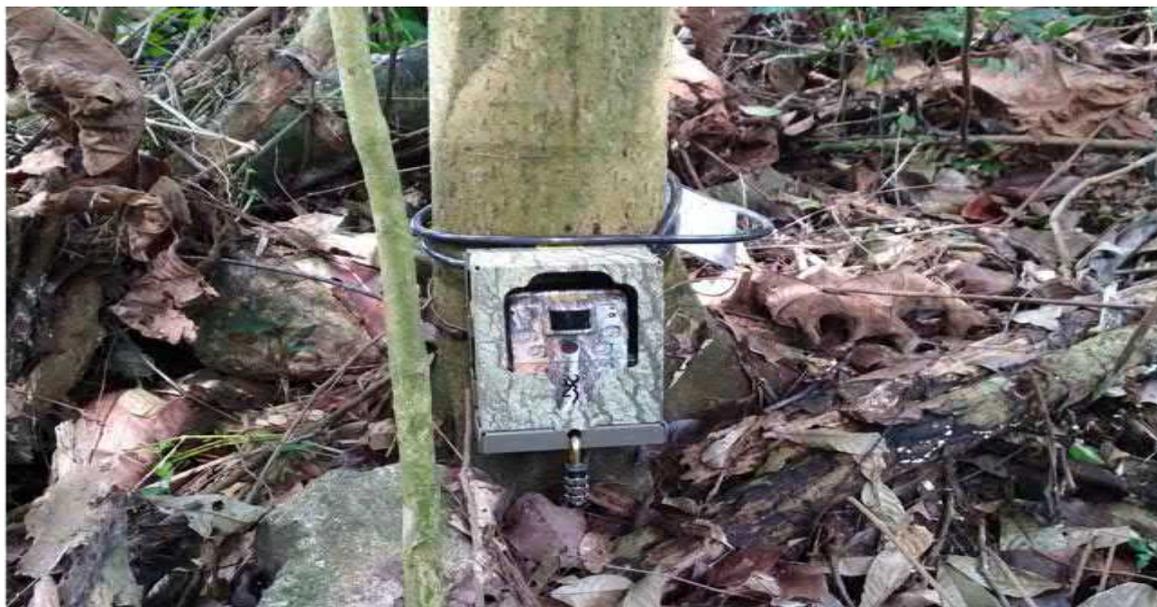
**Figure 7-5 Example of a camera trap setup**

Camera traps were equally distributed across the Study Area (Figure 7-4). One camera trap was deployed within each grid, which amounted to four camera traps. Each camera trap was set up at approximately 20–30 cm above ground (Figure 7-5). They operated for 24 hours a day and were programmed to record 10-second footage per motion trigger with a 10-second quiet period following each trigger. Each camera trap was deployed for 60 days. The camera trap model used is Browning Dark Ops HD Pro X BTC-6HDPX.

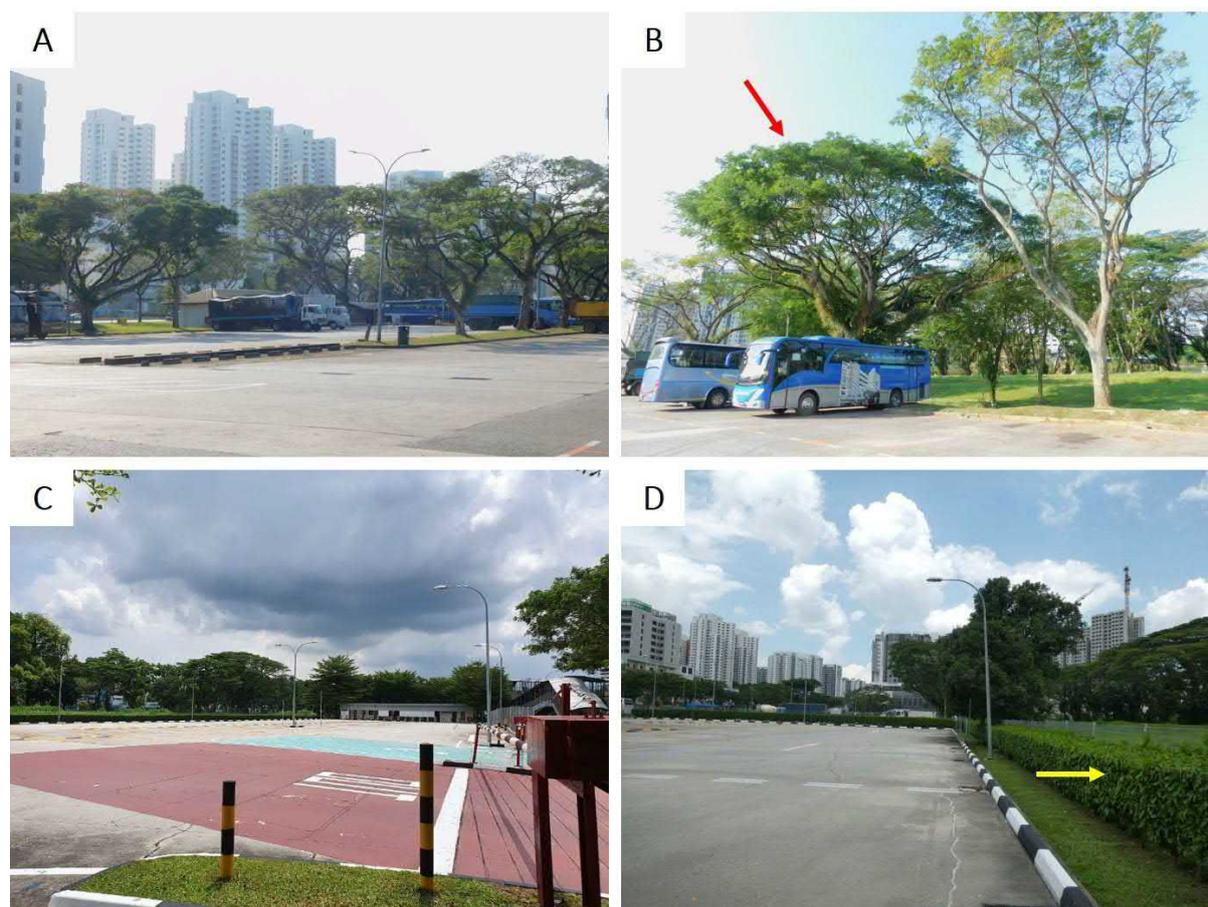
**Figure 7-8 Infrastructure in CCK N1 Study Area. (A–B) *Samanea saman* (red arrow) planted within and along the boundary of the heavy vehicle carpark, respectively; (C) Overview of the defunct bus terminal; (D) *Baphia nitida* hedge (yellow arrow) along the boundary of the defunct bus terminal.**

Infrastructure within the Study Area includes a heavy vehicle carpark and a defunct bus terminal. Both areas are located beside each other at the south-east portion of the Study Area. Numerous exotic trees such as raintree (*Samanea saman*) were seen planted within and along the boundary of the heavy vehicle carpark. Clusters of an exotic shrub species, camwood (*Baphia nitida*), alongside Madagascar almond (*Terminalia mantaly*) were planted along the perimeter of the bus terminal (Figure 7-8).

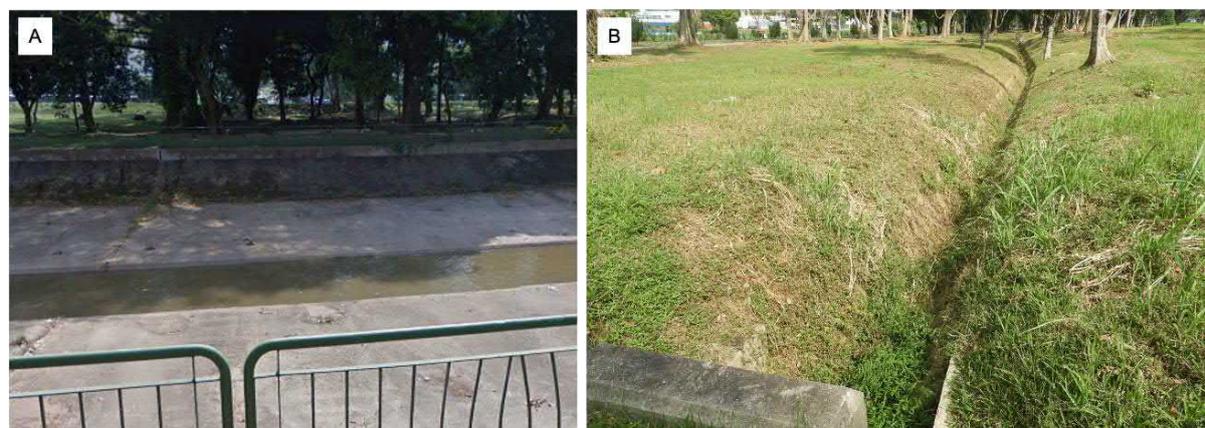
**Figure 7-9 Watercourses present within the Study Area – (A) large canal (D1) and (B) concrete drain (D3).**

A large canal and three (3) concrete drains (Figure 7-9) were present within the Study Area as discussed in Section 8. One of the concrete drain (Figure 7-9B), which cuts across the centre of the Study Area, was unshaded and partially vegetated, and was found to be mostly dry during the survey period, although shallow water puddles were occasionally observed after rain. The other two concrete drains are located near the east of the Study Area.

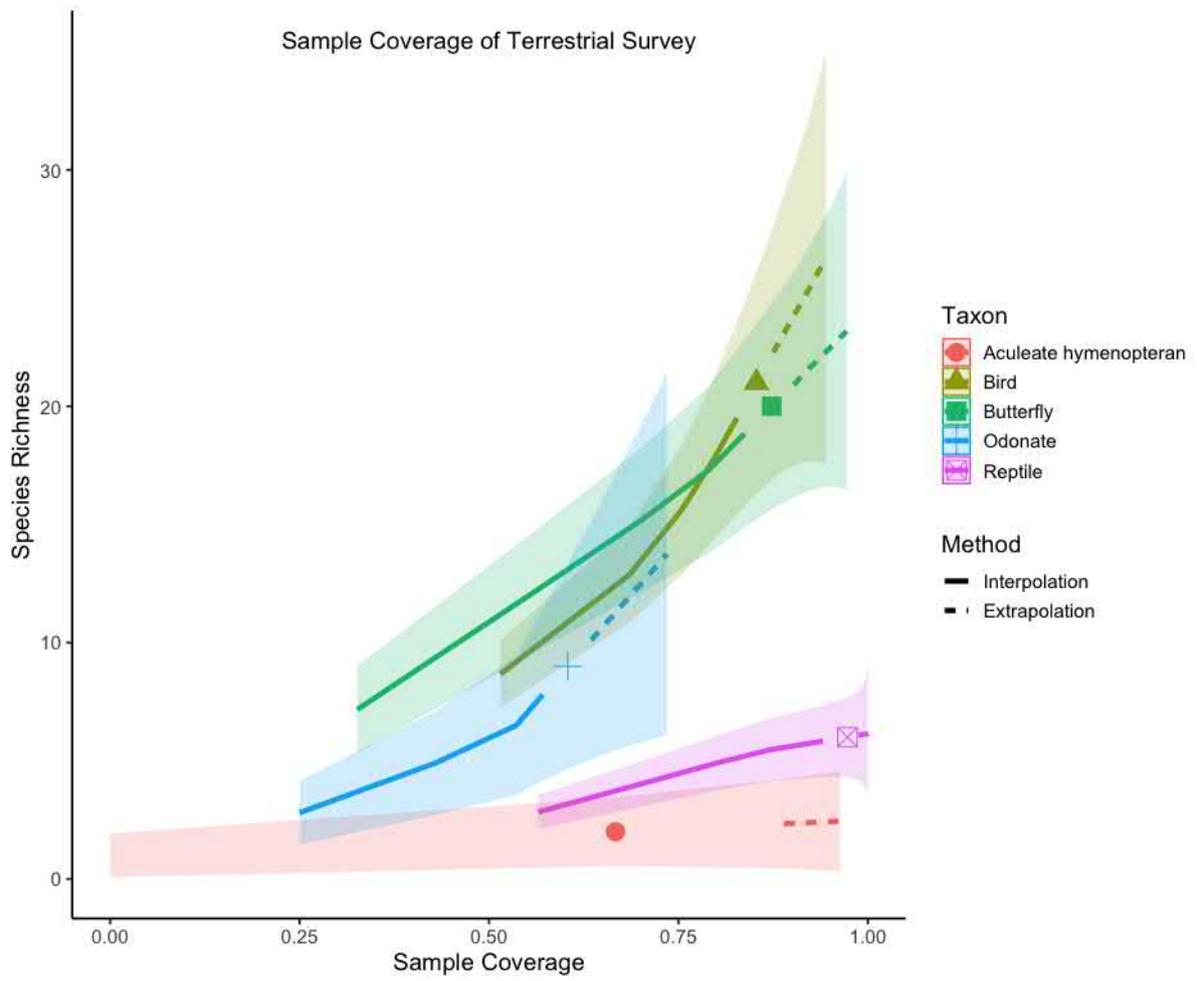
Figure 7-17 Taxon sampling curve for terrestrial sampling route

Faunal group	Sample coverage (%)	Observed richness	Estimated richness (± s.e)
<b>Terrestrial sampling route</b>			
<b>Odonates</b>	60.4	9	29.4 ± 7.6
<b>Aculeate hymenopterans</b>	66.7	2	2.5 ± 1.1
<b>Butterflies</b>	87.3	20	24.1 ± 4.1
<b>Reptiles</b>	97.3	6	6.1 ± 0.5
<b>Birds</b>	85.3	21	23.4 ± 19.0
<b>Aquatic sampling points</b>			
<b>Amphibian</b>	81.0	3	3.8 ± 1.7
<b>Fish</b>	77.8	2	5.4 ± 3.5

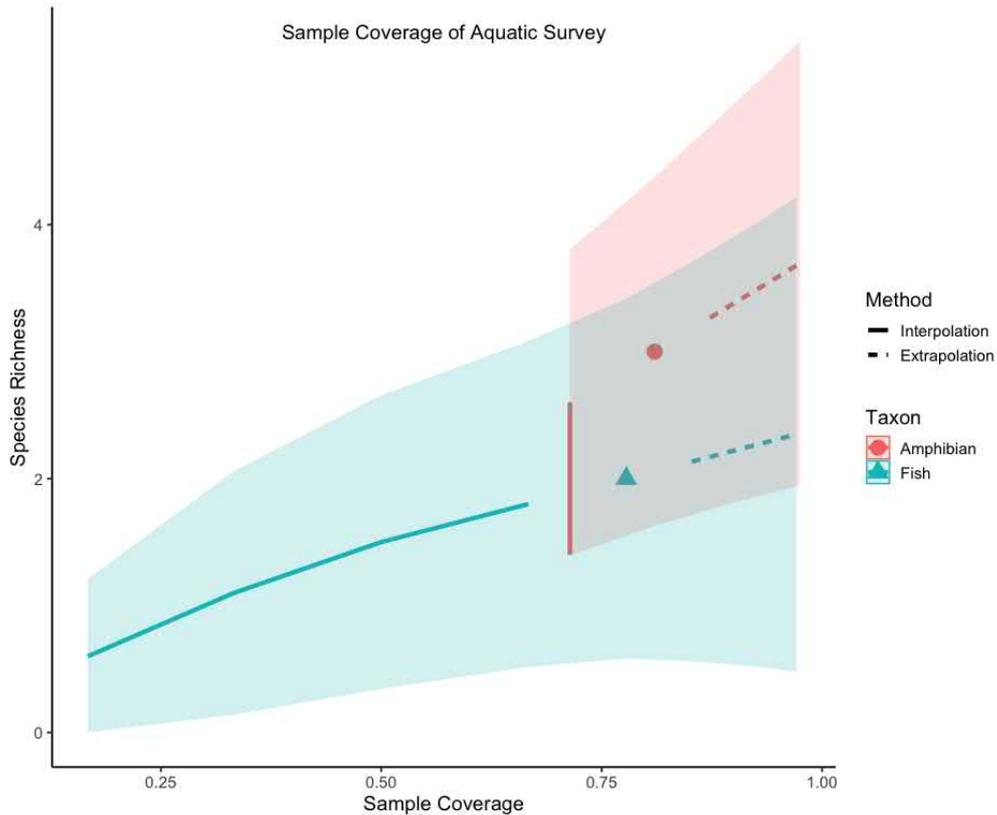
Figure 7-18 Taxon sampling curves for aquatic sampling points

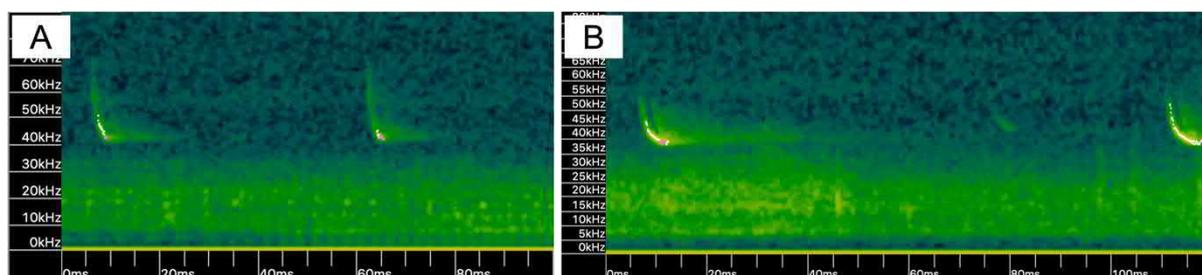
**Figure 7-26 Spectrogram of (A) Asiatic yellow house bat (*Saccolaimus saccolaimus*) and (B) Whiskered myotis (*Myotis muricola*)**

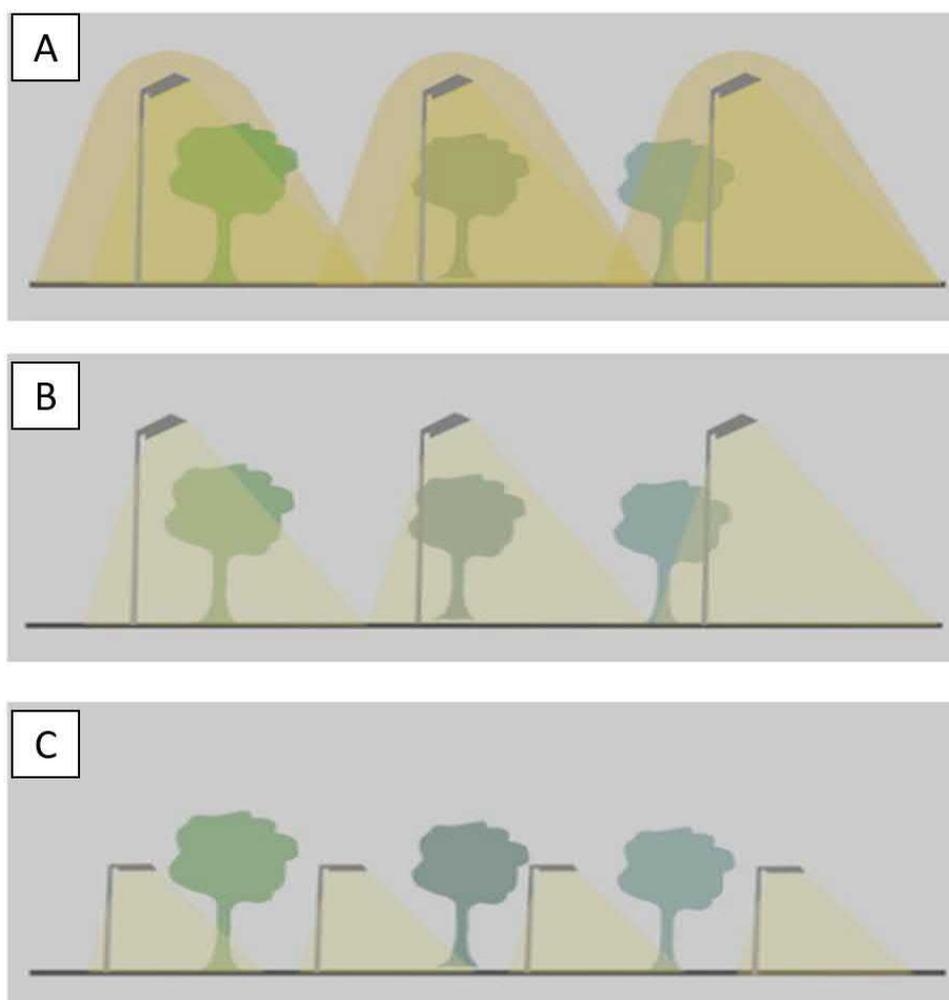
**Figure 7-28 Combined effect of shielded lighting fixtures and short poles on reducing light trespass: A) lights with unshielded light fixtures; B) light fixtures with shield; C) light fixtures on short poles which cut-off light trespass and keep adjacent areas dark [P-43].**

- a. Use wildlife-friendly light properties or features to minimise light spills, i.e., the light that falls outside the area intended to be lit).
- b. Optimising the placement of lights by providing lighting only on the area intended, and keeping lights close to the ground.
- c. To set suitable configuration of location, height and orientation of the lights. Street lights can be faced towards the 'urban' areas instead of the proposed corridor, wherever possible. By lowering the height of light pole, it would reduce the volume of illuminated space in the canopies of trees, which would cause less disturbances to wildlife that dwells in tree canopies at night such as birds, and arboreal animals (Figure 7-28) [P-43]. This can be enhanced further by incorporating 'shielded' design of lighting fixtures, which helps to control the amount of light trespass of a certain area (Figure 7-29).

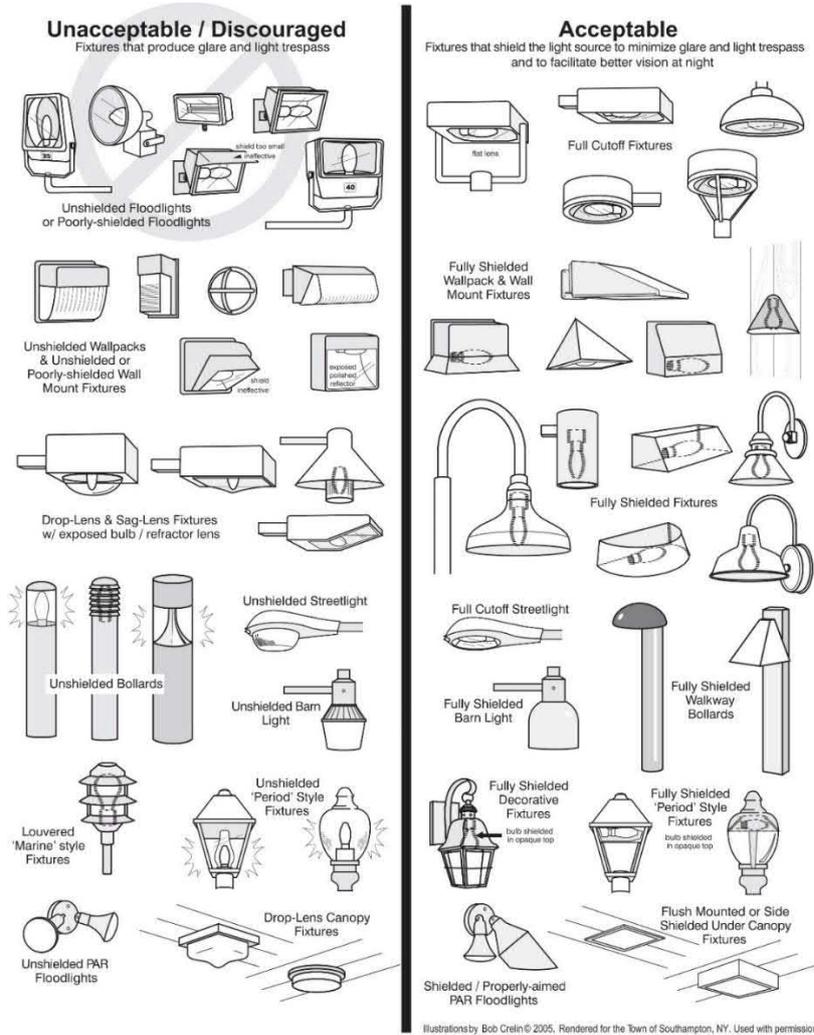
Figure 7-29 Example of acceptable lighting fixtures that helps to minimise light trespass and unacceptable lighting fixtures [W-19]

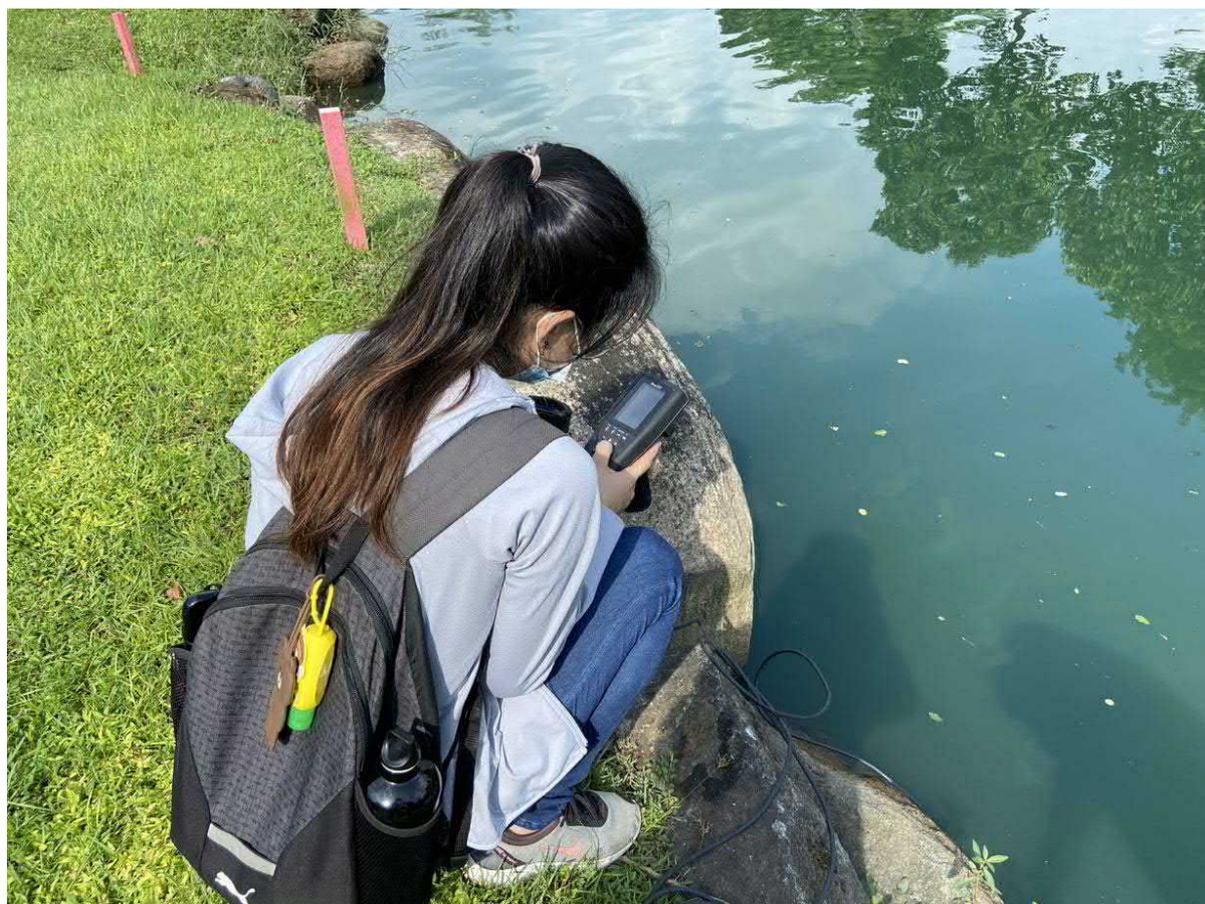
Figure 8-1 An example of in-situ water quality measurement (AECOM ©)

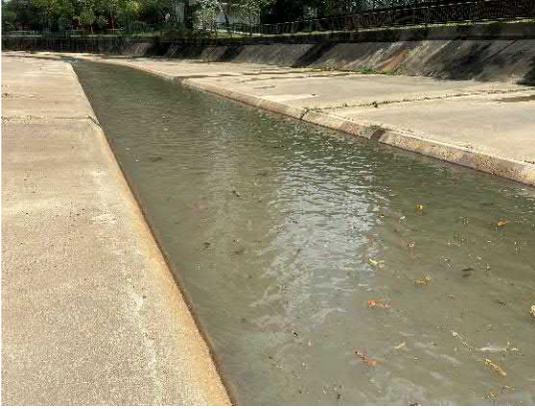
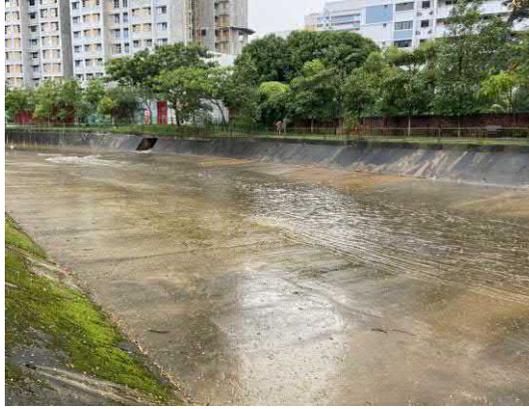
Watercourses	Bank Characteristics	Water Flow Conditions	Photos	
<p><b>Pang Sua Canal D1</b></p> <p>Wide concrete canal</p> <p>Estimated canal length within the Study Area is 860m.</p>		<ul style="list-style-type: none"> <li>• Originates from confluence of upstream drainage networks collecting surface runoff from surrounding residential area (refer to Figure 8-4) before reaching the Study Area, and it drains into the Kranji Reservoir eventually.</li> <li>• Perennial flow</li> </ul> <p><b>During dry weather condition:</b></p> <ul style="list-style-type: none"> <li>• <u>Upstream</u>: slow water flow observed of approximately 0.2 - 0.4 m/s</li> <li>• Approximately 16 – 18.5 cm depth and an approximate width of 500 cm, at time of survey</li> <li>• <u>Midstream</u>: slow water flow observed of approximately 0.2 - 0.6 m/s</li> <li>• Approximately 16 - 23 cm depth and width of 500 cm at time of survey</li> <li>• <u>Downstream</u>: slow dry weather flow of approximately 0.25 - 0.6 m/s</li> <li>• Approximately 18 - 20 cm depth and an approximate width of 500 cm, at time of survey</li> <li>• Water was clear and no smell</li> </ul> <p><b>During wet weather condition (at surveyed time):</b></p> <ul style="list-style-type: none"> <li>• <u>Upstream</u>: slow water flow observed of approximately 0.79 m/s</li> <li>• <u>Midstream</u>: Water flow observed of approximately 1.56 m/s</li> </ul>	<b>WQ3 (upstream)</b>

<p>During Dry Weather</p>

<p>During Wet Weather</p>

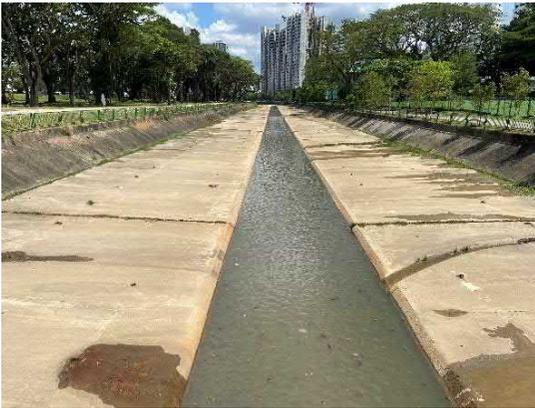
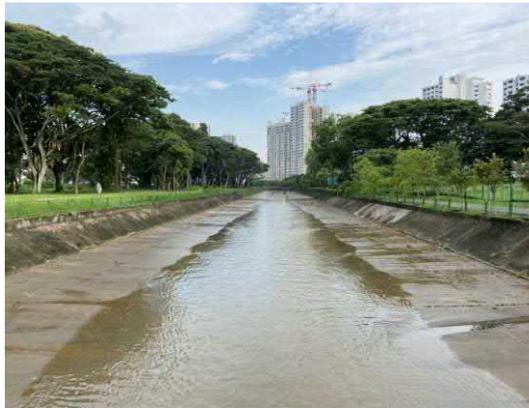
<b>WQ2 (midstream)</b>	
			<p>During Dry Weather</p>

<p>During Wet Weather</p>

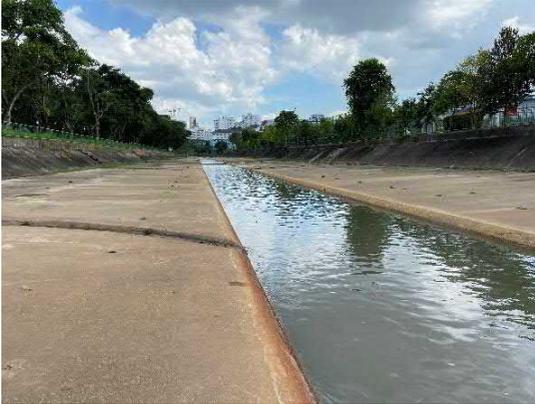
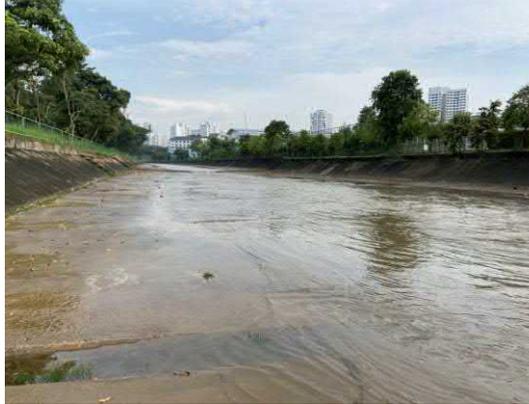
<b>WQ1 (downstream)</b>

Watercourses	Bank Characteristics	Water Flow Conditions	Photos	
		<ul style="list-style-type: none"> <li>Approximately 25 m width and cover the entire depth of the canal at time of survey</li> <li><u>Downstream</u>: Water flow of approximately 1 m/s</li> <li>Approximately 10.5 m width at time of survey</li> <li>Water was clear and no smell</li> </ul>	<p style="text-align: center;">During Dry Weather</p>

<p style="text-align: center;">During Wet Weather</p>

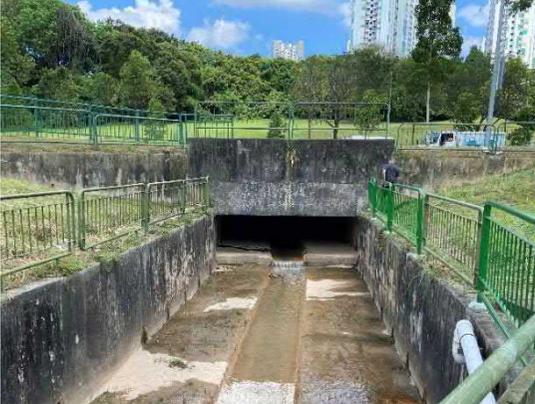
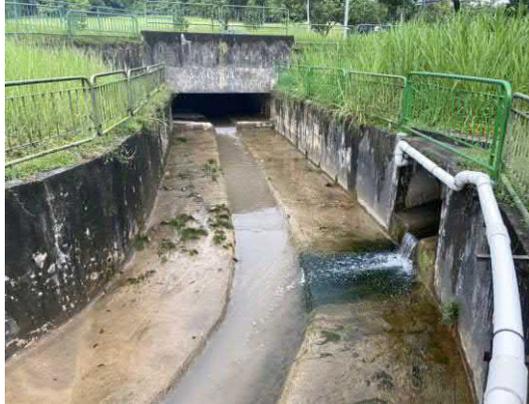
<b>D2</b>	Concrete drain with artificial banks	<ul style="list-style-type: none"> <li>Originates from vegetated area inside the Study Area and surrounding residential area in the east outside of the Study Area, flowing next to Woodlands Road, along the northeast boundary of the Study Area.</li> <li>Perennial flow</li> </ul> <p><b>During dry weather condition:</b></p> <ul style="list-style-type: none"> <li>Slow water flow observed of approximately 0.08 - 0.4 m/s</li> <li>Approximately 5 - 7 cm water depth and width of 100 cm at time of survey.</li> <li>Water was clear and has no smell</li> </ul> <p><b>During wet weather condition:</b></p> <ul style="list-style-type: none"> <li>Slow water flow observed of approximately 0.6 m/s</li> <li>Approximately 14 cm water depth and width of 120 cm at time of survey</li> <li>Water was clear and has no smell</li> </ul>	<b>WQ4</b>

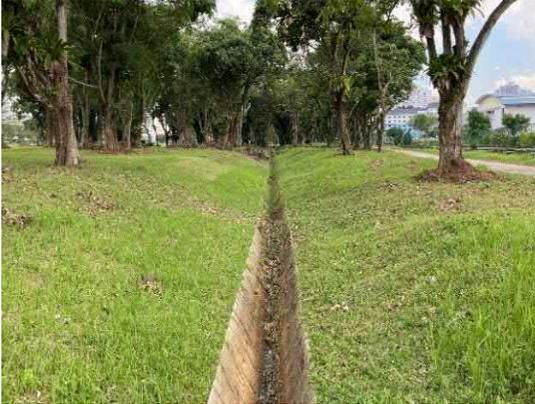
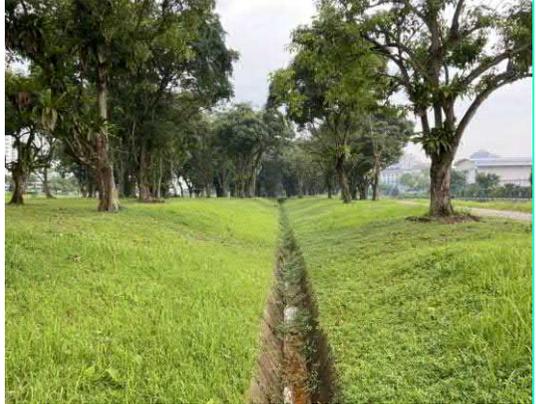
<b>D3</b>			<b>WQ5</b>

Watercourses	Bank Characteristics	Water Flow Conditions	Photos	
	Concrete drain within Study Area.	<ul style="list-style-type: none"> <li>• Originates from vegetated area within the Study Area</li> <li>• Ephemeral flow</li> </ul> <p><b>During dry weather condition:</b></p> <ul style="list-style-type: none"> <li>• No flow observed</li> </ul> <p><b>During wet weather condition:</b></p> <ul style="list-style-type: none"> <li>• Slow water flow observed of approximately 0.29 m/s</li> <li>• Approximately 1 cm water depth and width of 20 cm at time of survey</li> </ul>	<p style="text-align: center;">During Dry Weather</p>

<p style="text-align: center;">During Wet Weather</p>

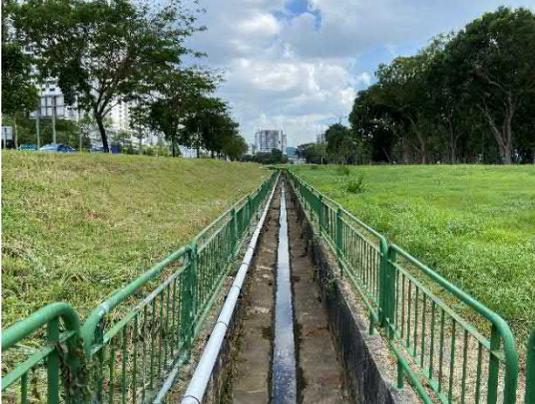
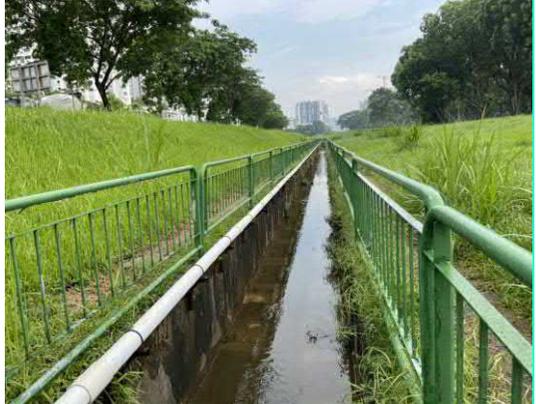
D4	Concrete drain with artificial banks	<ul style="list-style-type: none"> <li>• Originates from the heavy vehicle car park within Study Area, flowing towards the north along the eastern part of the Study Area and discharging water to D2.</li> <li>• Ephemeral flow</li> </ul> <p><b>During dry weather condition:</b></p> <ul style="list-style-type: none"> <li>• Almost no flow</li> </ul> <p><b>During wet weather condition:</b></p> <ul style="list-style-type: none"> <li>• Slow water flow observed of approximately 0.43 m/s</li> <li>• Approximately 15 cm water depth and width of 1.5 m at time of survey</li> <li>• Water was clear and has no smell</li> </ul>	<b>WQ6</b>

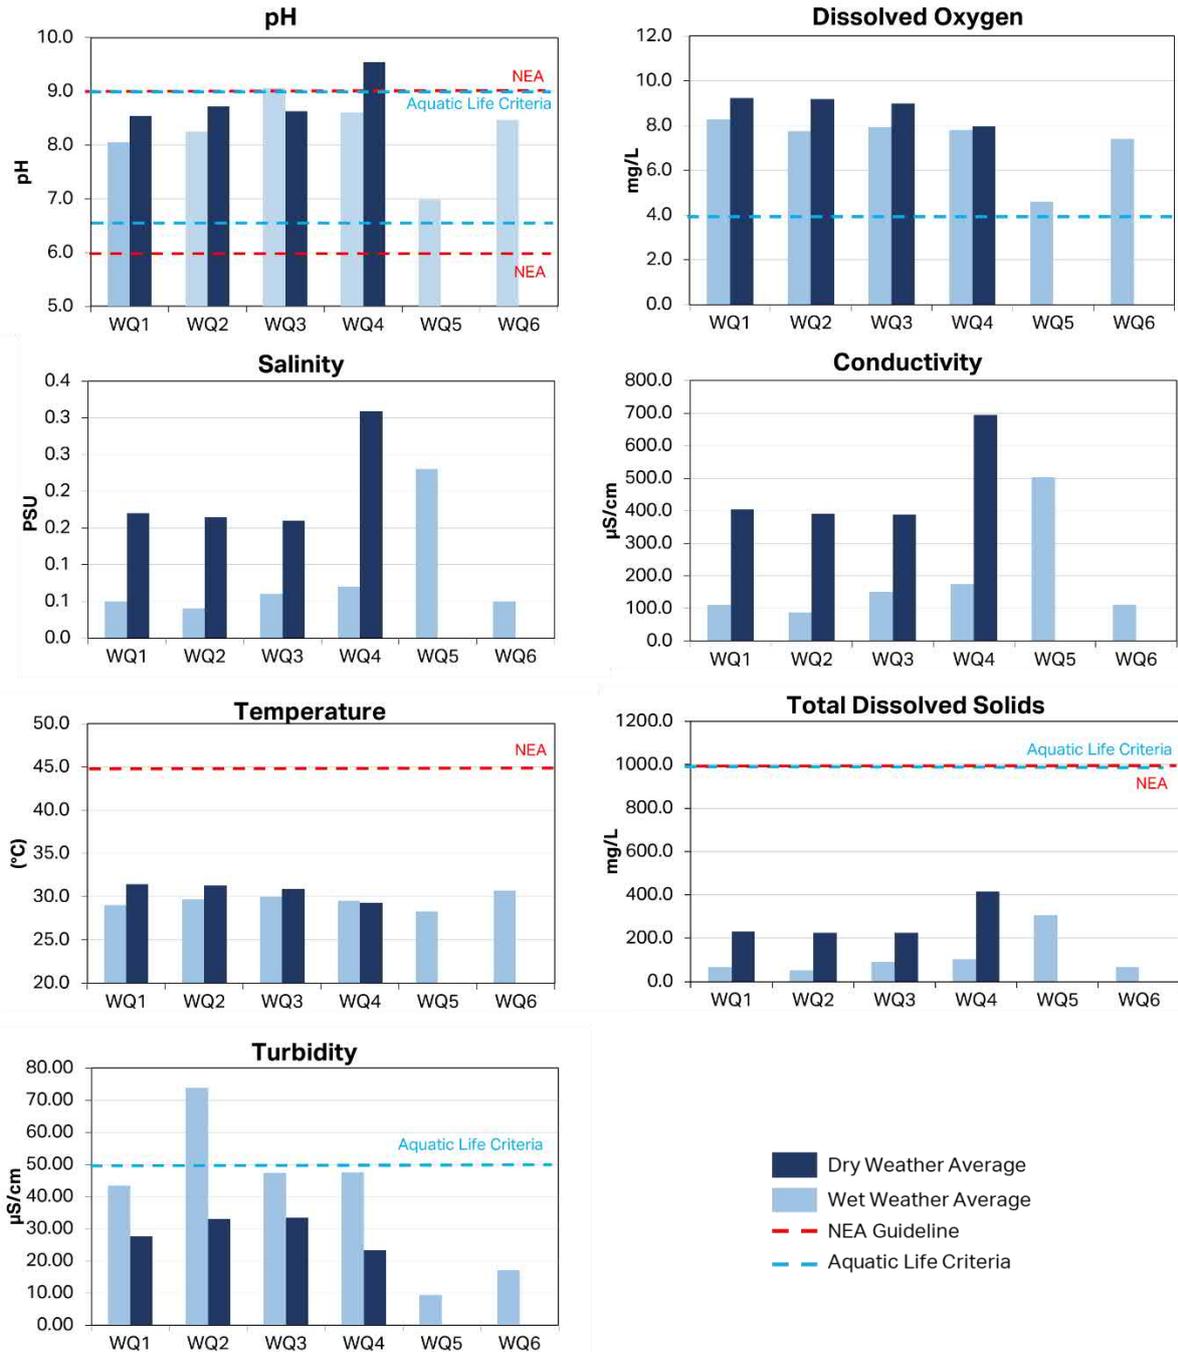
**Figure 8-6 Average monitoring results of in-situ parameters for dry and wet weather conditions**

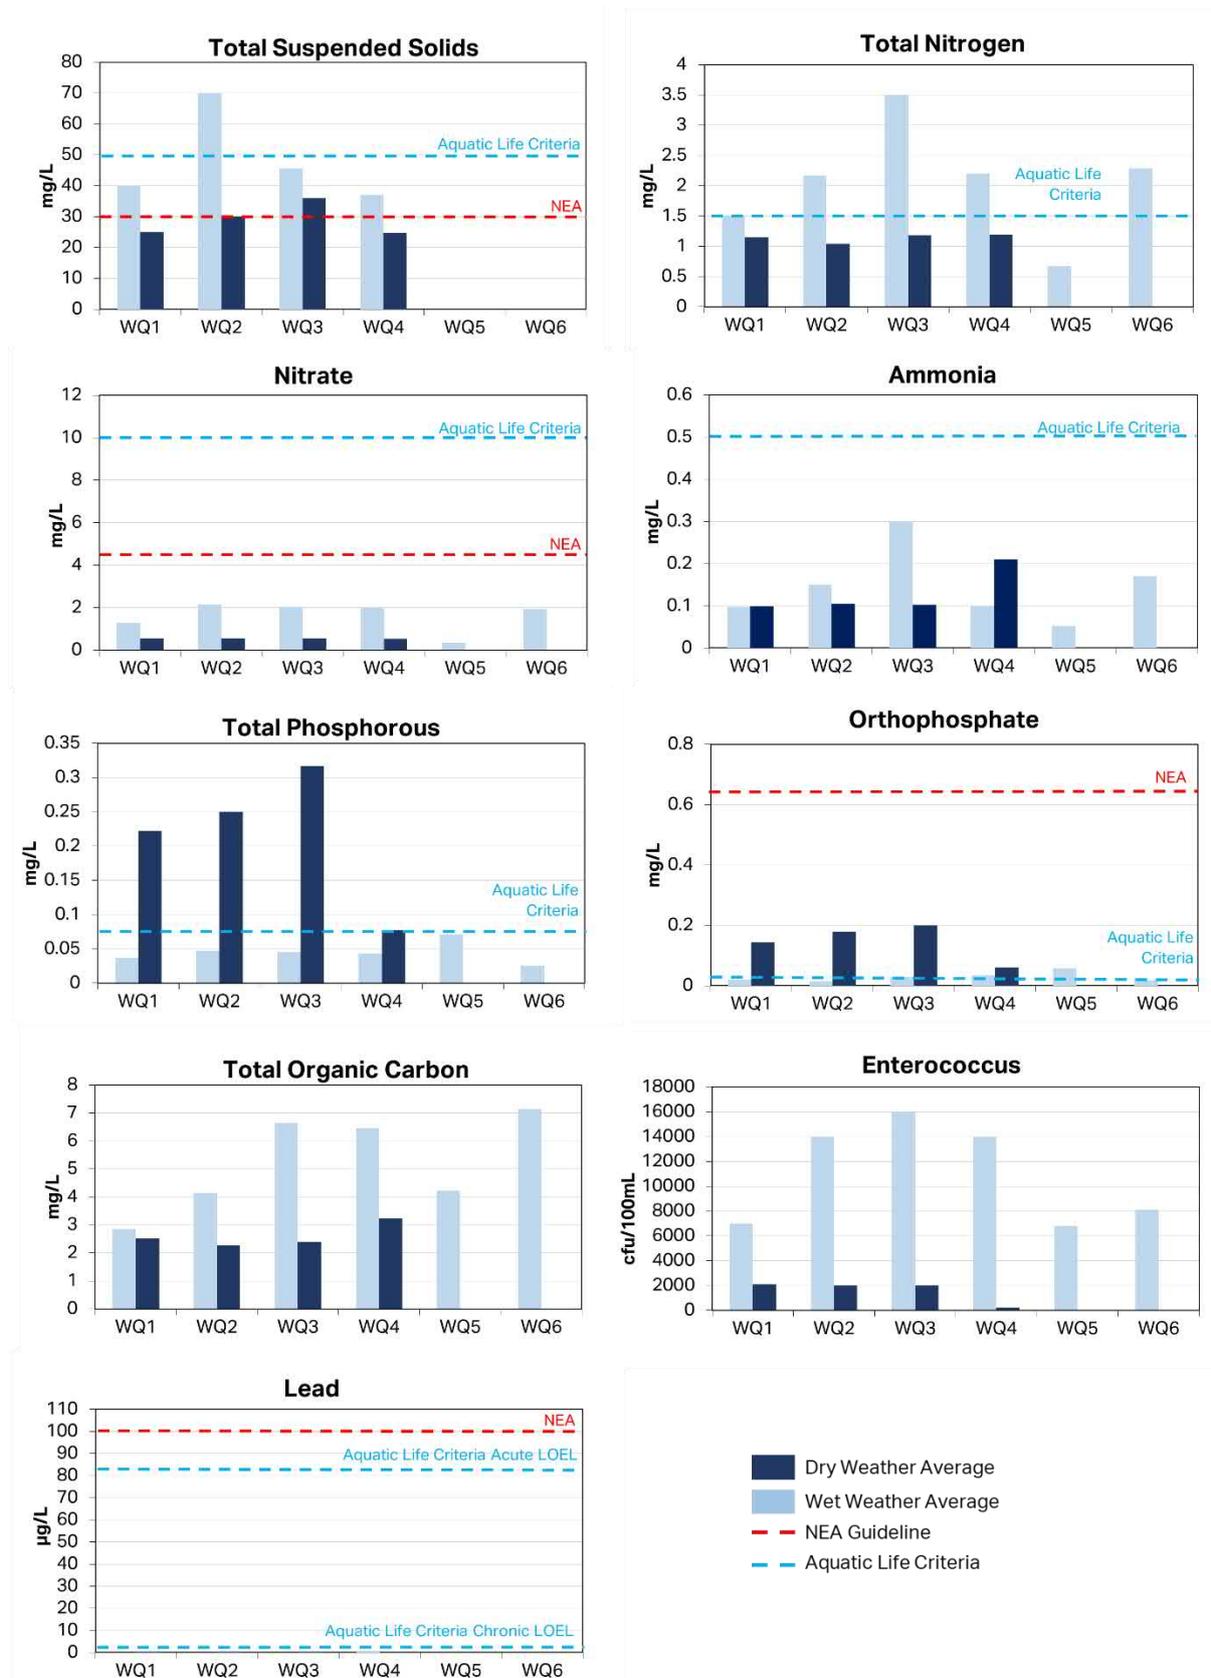
Figure 8-7 Average monitoring results of ex-situ parameters for dry and wet weather conditions
