# Specialist Consultancy Services for Environmental Impact Assessment (EIA) at Woodlands Neighbourhood 1

Final Report

Housing & Development Board (HDB)

Project reference: L/074/23  
Project number: 60705888

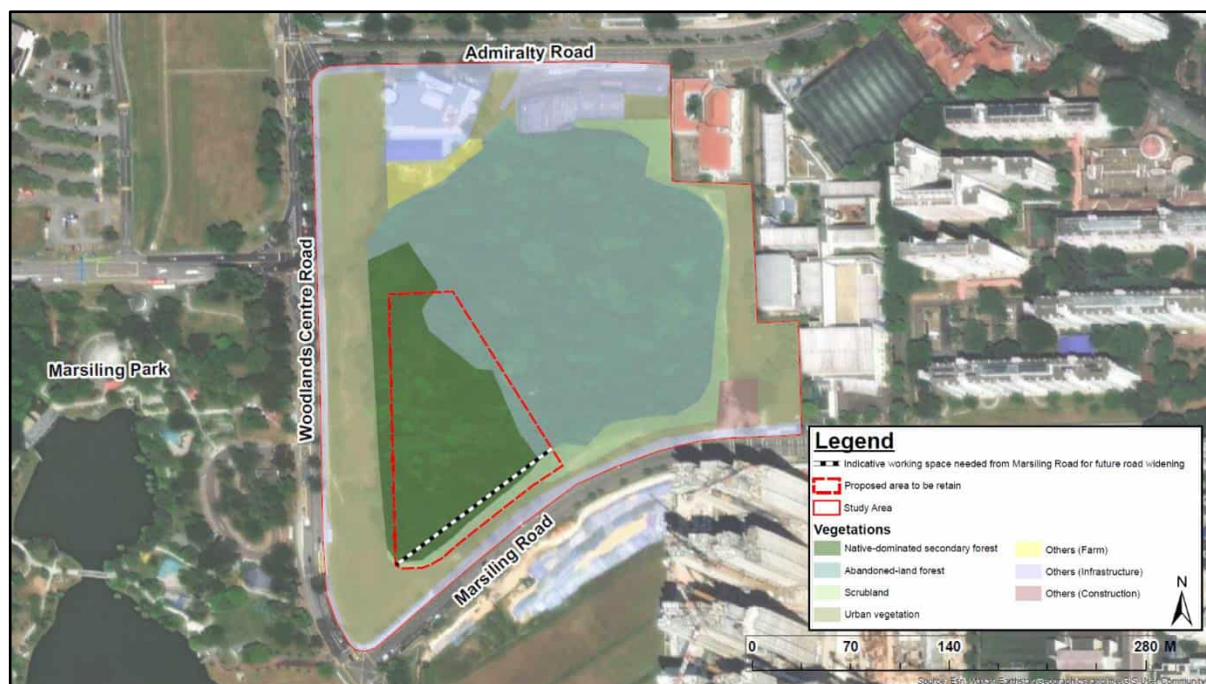
Figure 1.5 Proposed area to be retained

The main mitigation measures for biodiversity are implemented based on the mitigation hierarchy in the following order: (1) avoidance, (2) minimisation, and (3) enhancement/rehabilitation as well as compensation. Under avoidance, an area of high ecological value (AHEV) is recommended to be avoided from development. However, based on the recommendation in Section 7.4.4.1, not all of AHEV will be retained due to development plans. Ultimately, only about 90% of the AHEV (i.e., native-dominated secondary forest) will be retained. The area proposed to be retained also included a 15m buffer from the last line of native trees within the native-dominated forest patch. This helps to reduce the impact for habitat loss, plant mortality, loss of/reduction in habitats and food sources and overall connectivity for the fauna species.

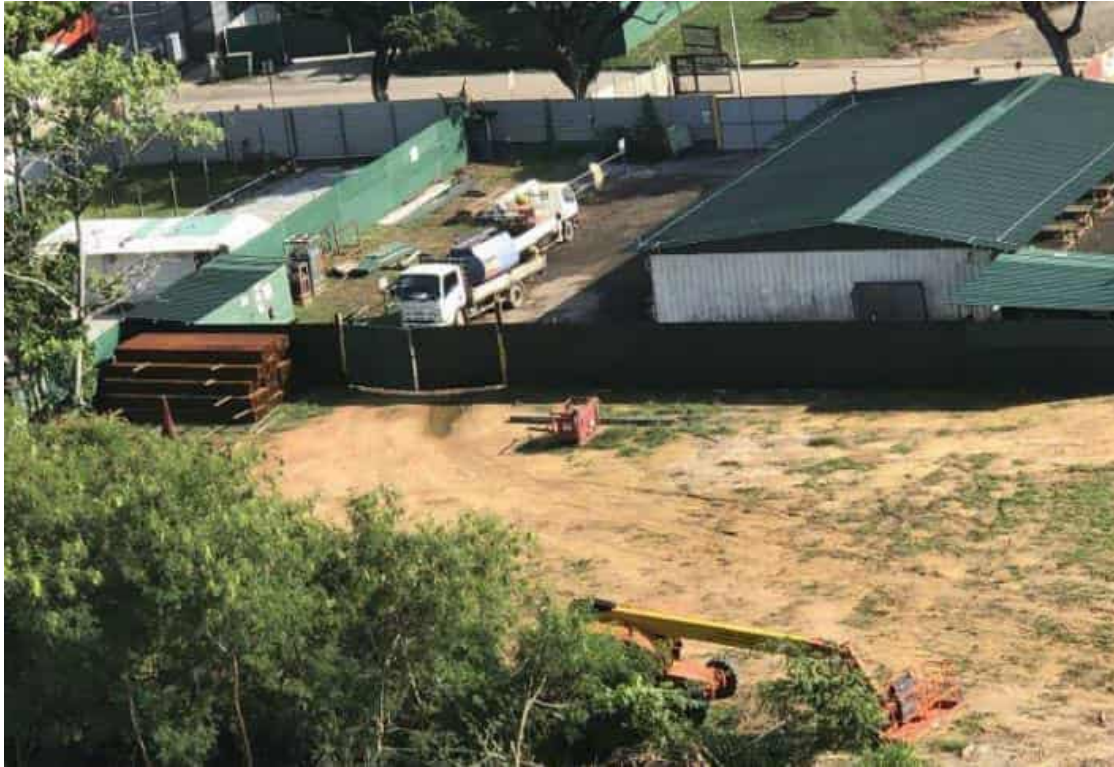
Removal of the trees, turf and other vegetation and topsoil from the site is also planned to be carried out during site clearance as the majority of the site will experience land use change (i.e., construction of residential developments and accompanying infrastructure). This will be done by using excavators and/ or bulldozers. It should be noted that prior to removal of vegetation, arboriculture assessment of the trees should be carried out and selected trees should be transplanted. Furthermore, wildlife specialists should be consulted to develop and carry out and pre-felling inspection and wildlife shepherding, as necessary.

**Figure 3.3.1 An example of site clearance at construction worksite in Singapore (Construction Site near Bedok Reservoir, Digital Photograph)**

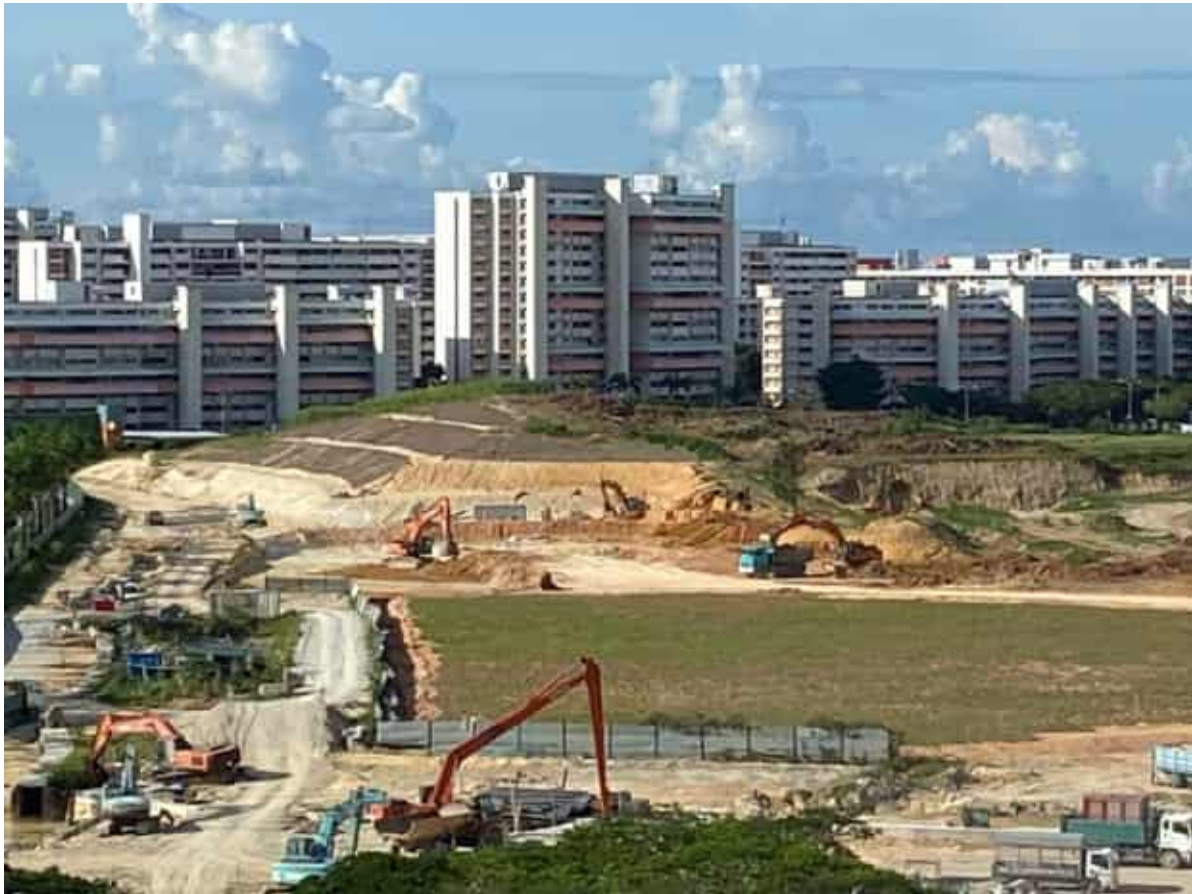
**Figure 3.3.2 An example of site levelling at construction worksite in Singapore (AECOM®)**

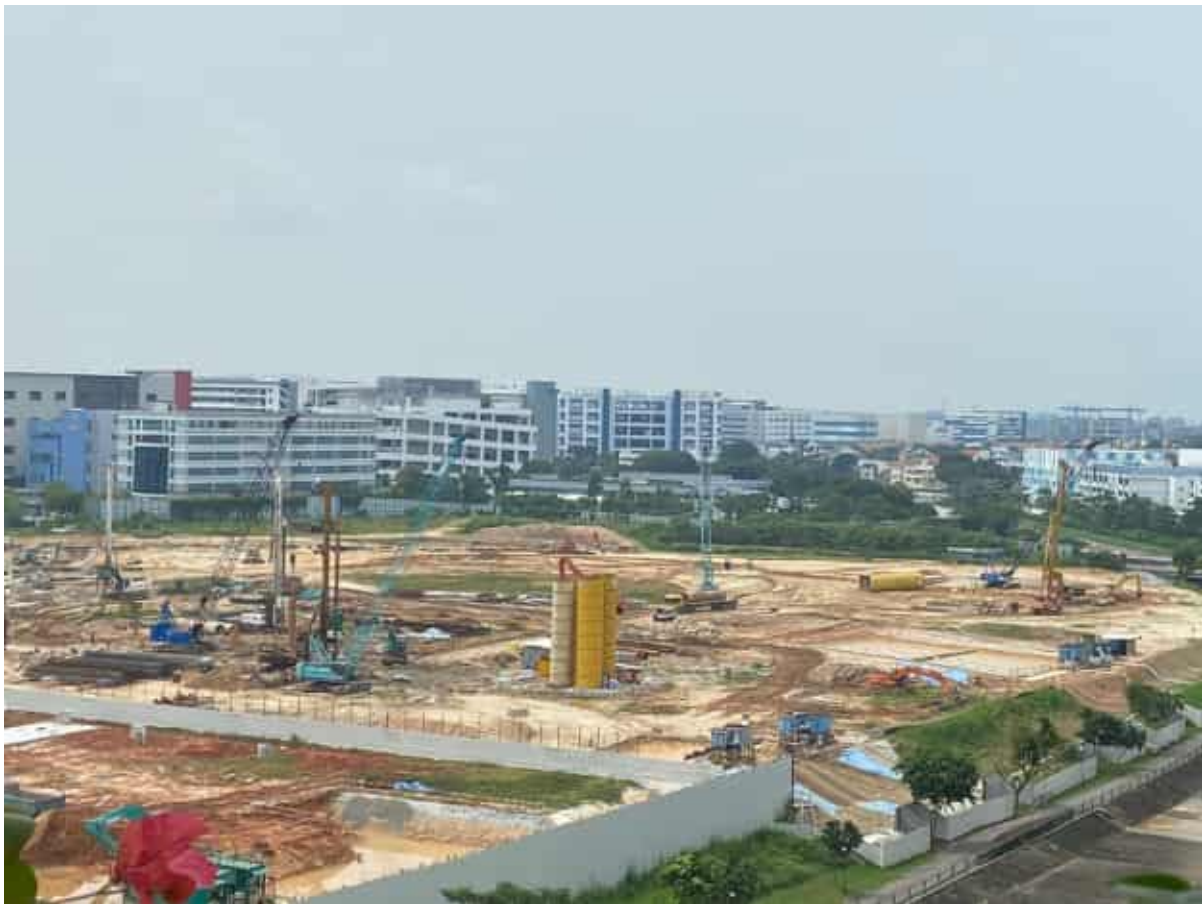
Figure 3.3.3 An example of piling/ foundation works in Singapore (AECOM ©)

To seal the pile foundation, a pile cap is necessary. For this, steel waler and struts are required to hold the temporary formworks to proceed with pile cap concreting. The steel is delivered with a 40-feet trailer where hot works (e.g., welding of steel beams, brackets, etc.) may be required with the usage of welding equipment. Hoisting of waler and struts is carried out using an excavator with lifting appliance.

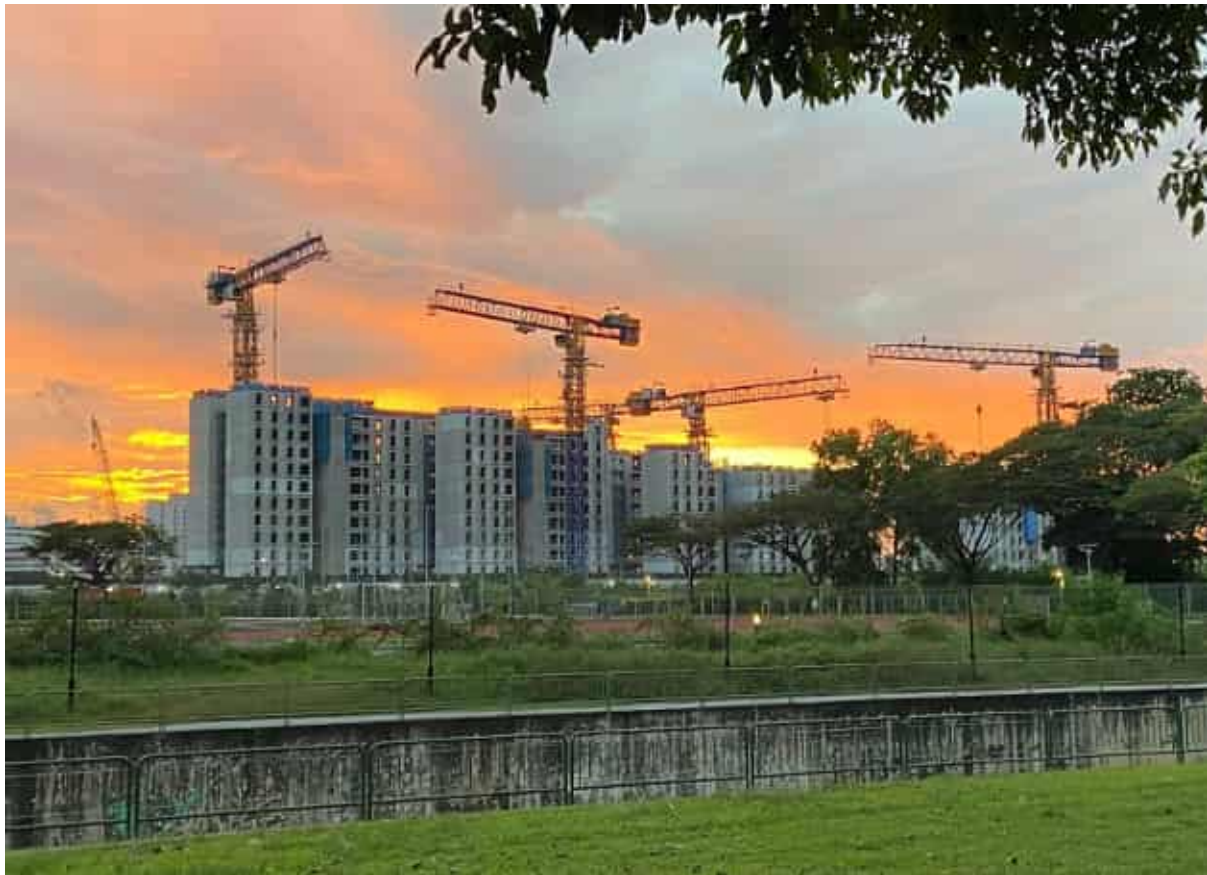
The completion of residential superstructure is generally followed by finishing works, such as interior plastering, exterior plastering, waterproofing and tiling, mechanical/ electrical/ plumbing (MEP) rough-in a ceiling installation, painting, lift installation, exterior glass walls, windows and doors installation, as well as setting up building systems (i.e., electrical, plumbing, air-conditioning, etc.).

**Figure 3.3.4 An example of superstructure construction works in Singapore (AECOM ©)**

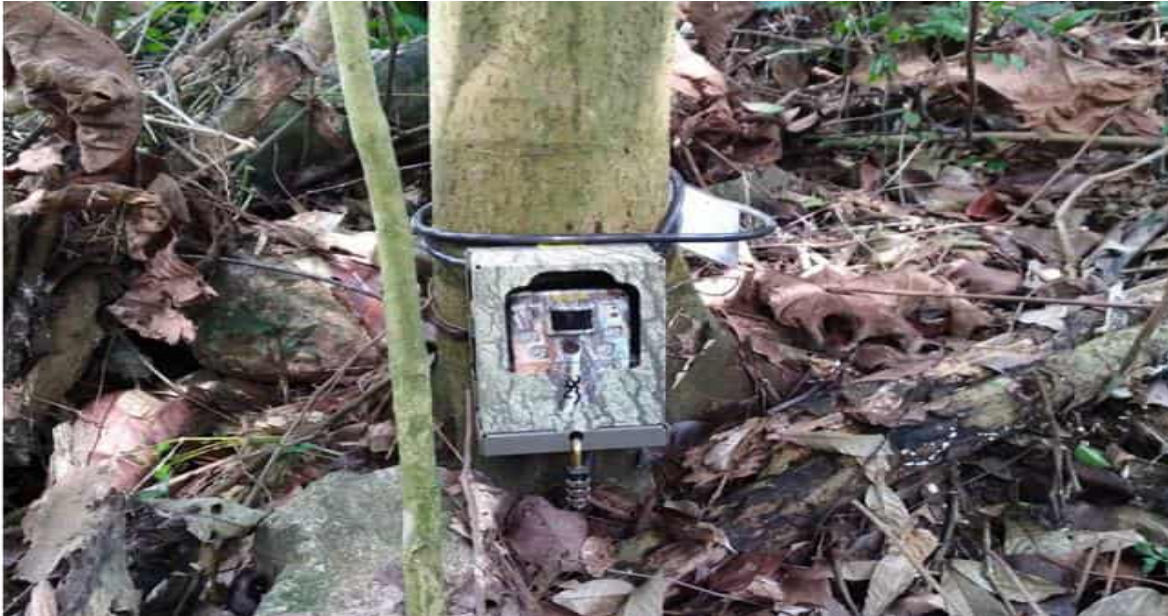
Each camera trap was set up at approximately 20–30 cm above ground (Figure 5.2.2). They operated 24 hours a day and were programmed to record 10-second footage per motion trigger with a 10-second quiet period following each trigger. Each camera trap was deployed for 60 days.

**Figure 5.2.2 Example of a camera trap setup**

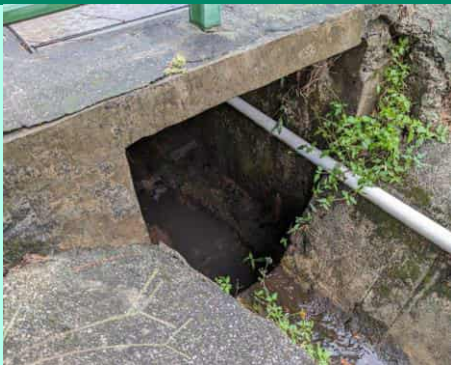
| S/N | Monitoring Location | Justification | Photo of Monitoring Location |
|---|---|---|---|
| <b>WQ1</b> | Junction of the watercourses in the vicinity of the Project site | To capture surface water quality of the water within concrete drains outside of the Project site, where it has a potential to be discharged from the Project Site during construction and operational phases. | |

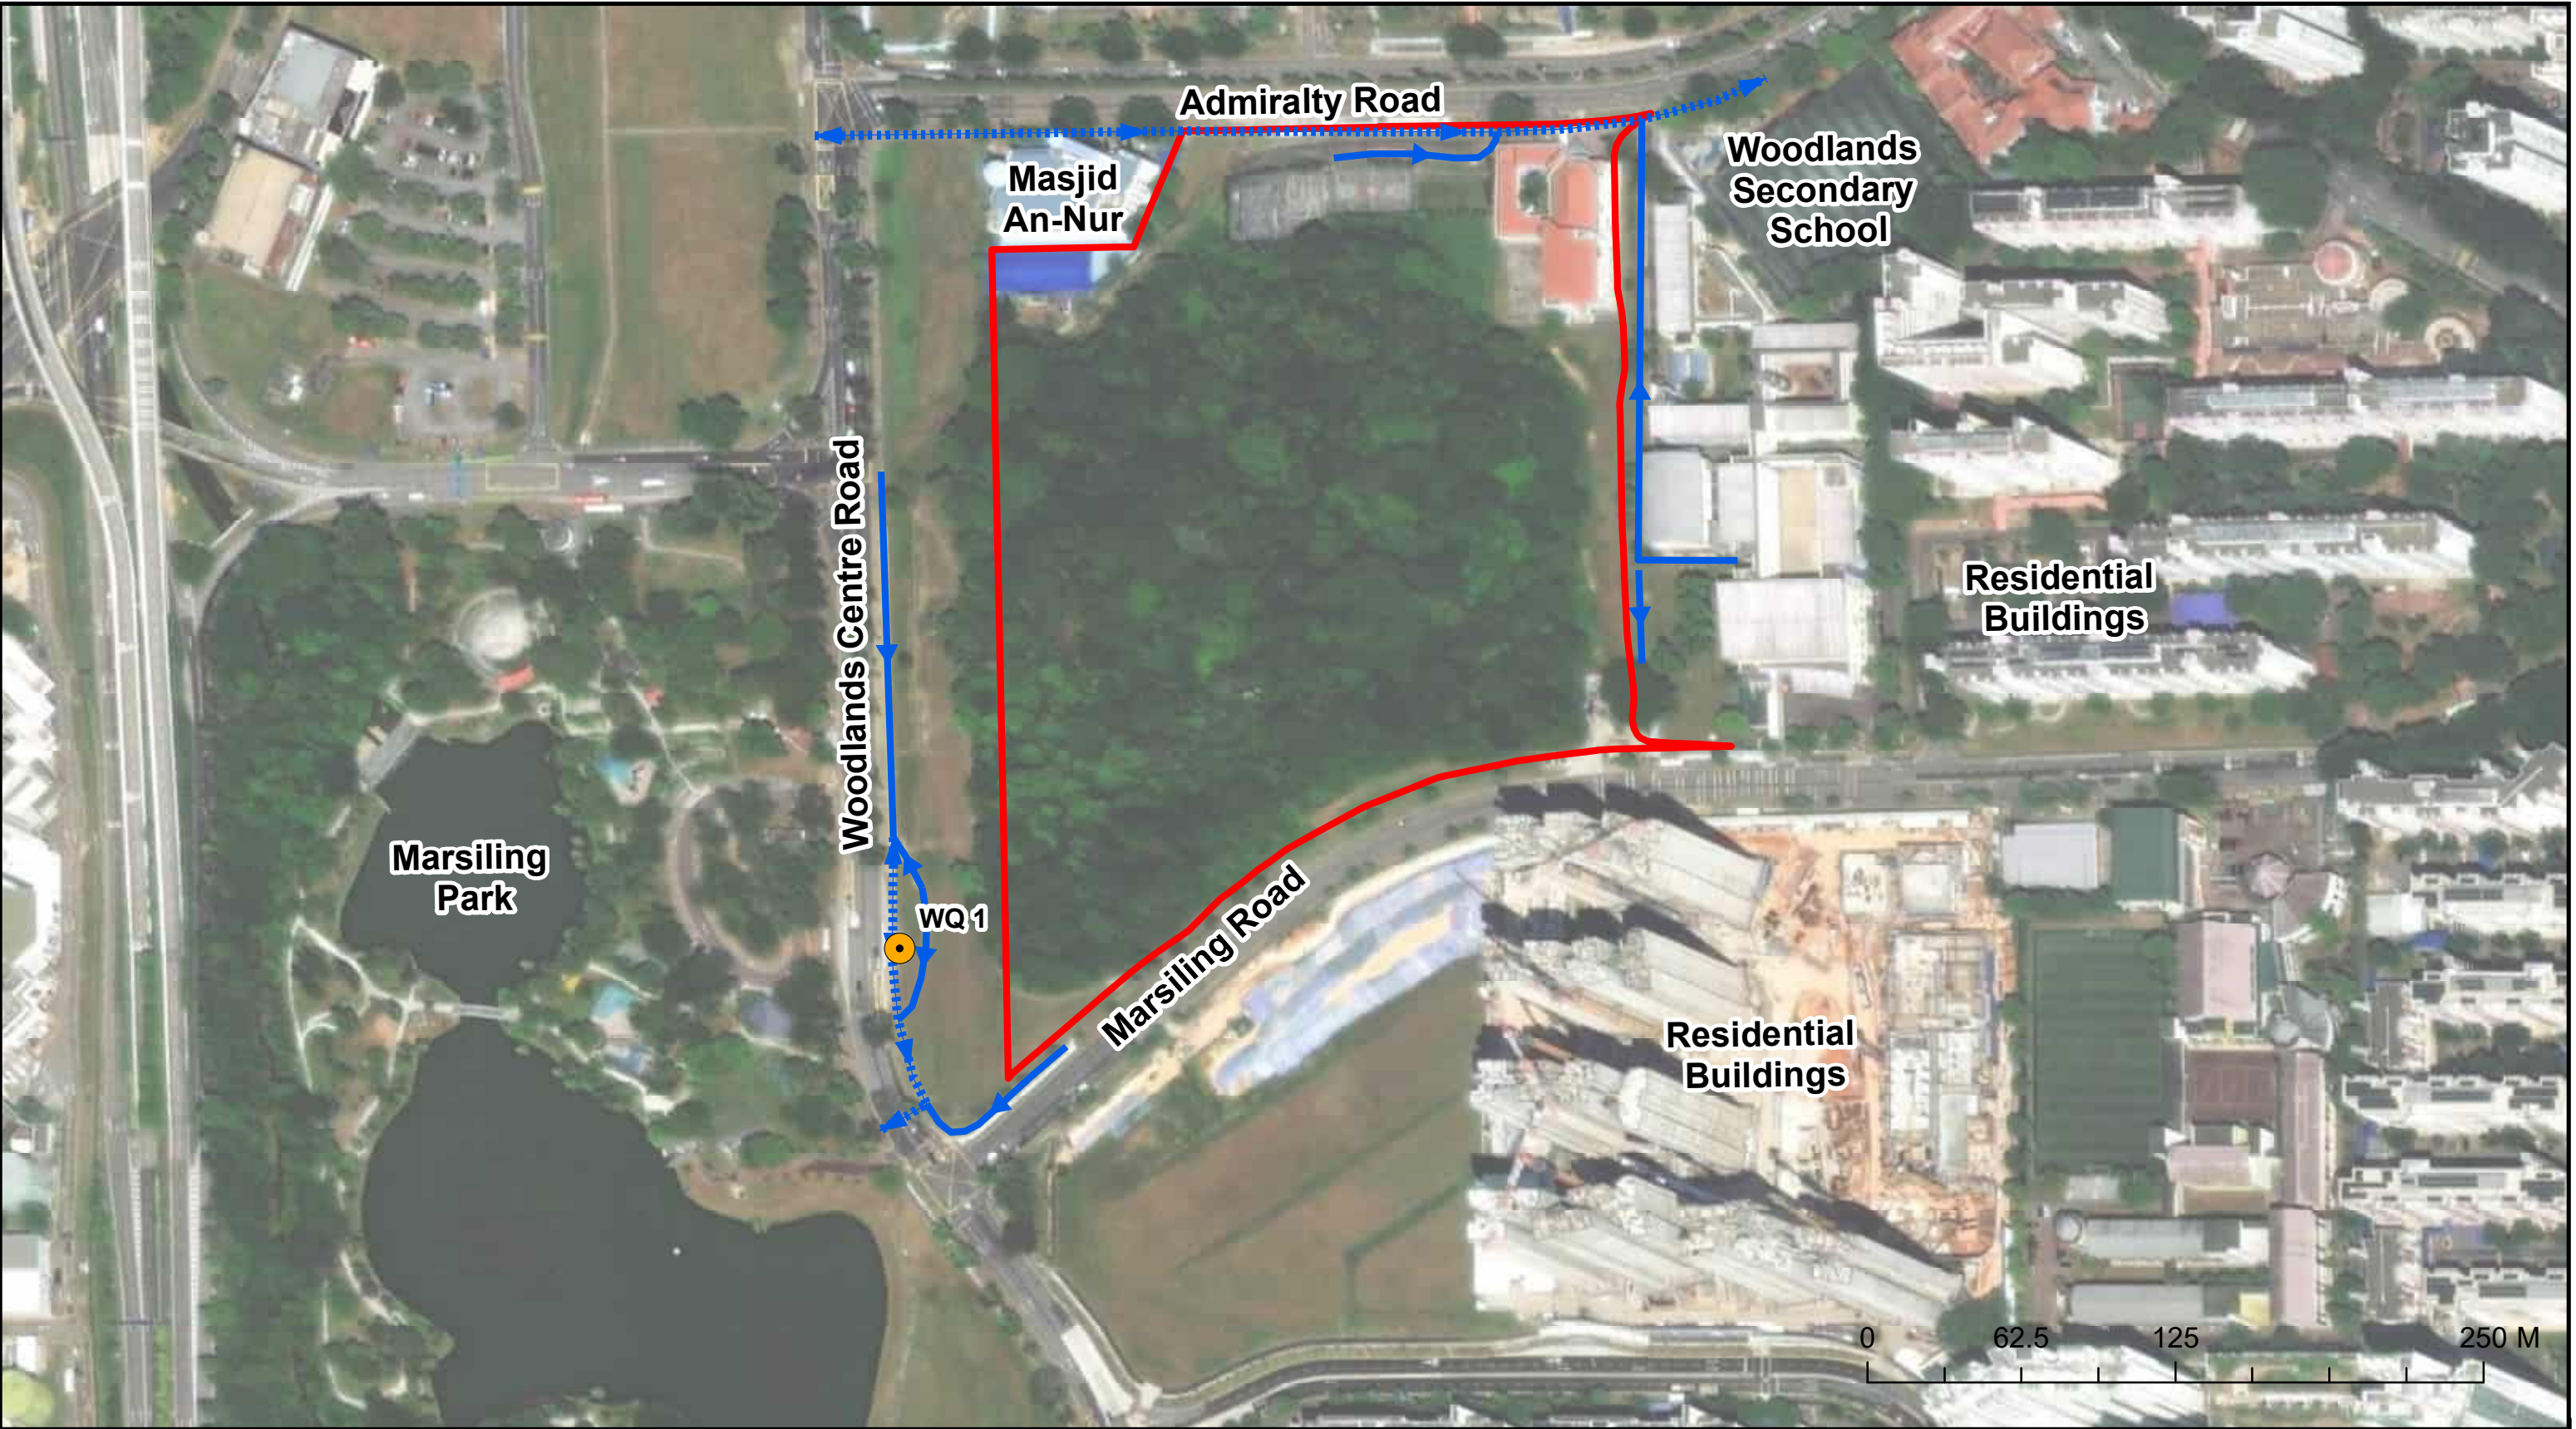
| | | | | | | | | | HDB Endorsement : NA | Project Title :<br><br>SPECIALIST CONSULTANCY SERVICES<br>FOR ENVIRONMENTAL IMPACT AS-<br>SESSMENT (EIA) AT<br>WOODLANDS N1 | | | Figure Title :<br><br>Surface water quality sampling location | | |

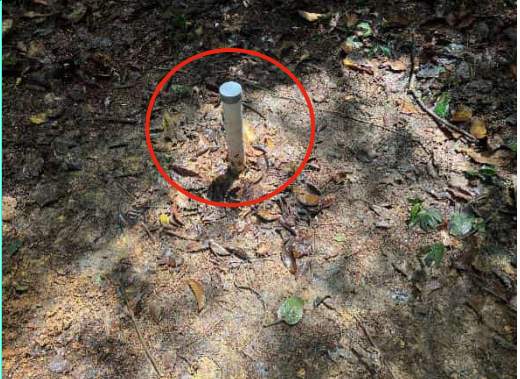
| S/N | Monitoring Location | Justification | Photo of Installed Monitoring Well |
|---|---|---|---|
| <b>MW01</b> | Located at the northwest in the vicinity of man-made structures | <ul style="list-style-type: none"> <li>To determine the hydrogeological conditions of the Study Area (i.e., Project site)</li> <li>To ascertain the presence of possible pollutants in the underlying groundwater that may impact the local vegetation and downstream waterbodies</li> </ul> | |

All the boreholes were advanced down to 8 meters below ground surface (bgs) by using the hand auger. All boreholes were converted into temporary groundwater monitoring wells to enable groundwater sampling. One (1) groundwater sample was collected from each monitoring well for laboratory analysis.

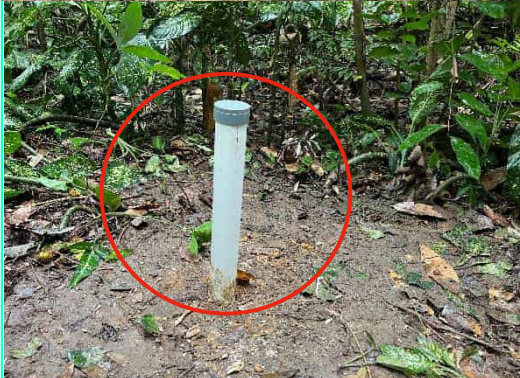
| S/N | Monitoring Location | Justification | Photo of Installed Monitoring Well |
|---|---|---|---|
| <b>MW02</b> | Located within eastern portion of Project site, which was urbanised historically and is in the vicinity of currently urbanised areas. | | |

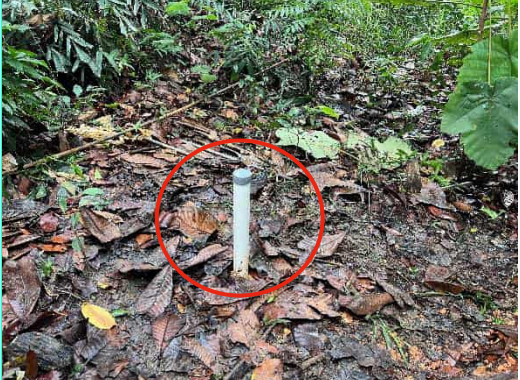
| S/N | Monitoring Location | Justification | Photo of Installed Monitoring Well |
|---|---|---|---|
| <b>MW03</b> | Located at the southwestern portion of the Project site, towards Marsiling Road. | | |

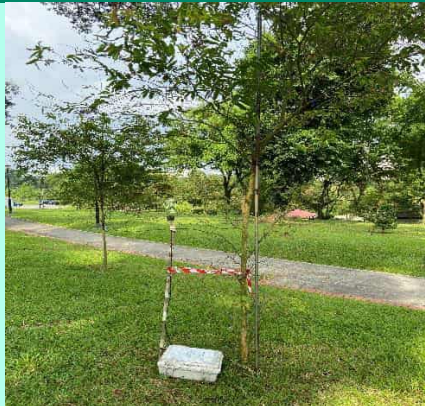
| S/N | Monitoring Location | Justification | Photo of Monitoring Location |
|---|---|---|---|
| NM01 | Marsiling Park | Marsiling Park is an ecologically sensitive site within the western side of Study Area. The selected location represents the environment of the ecologically sensitive site. The baseline noise level was dominated by the traffic noise from Woodland Centre Road. | |

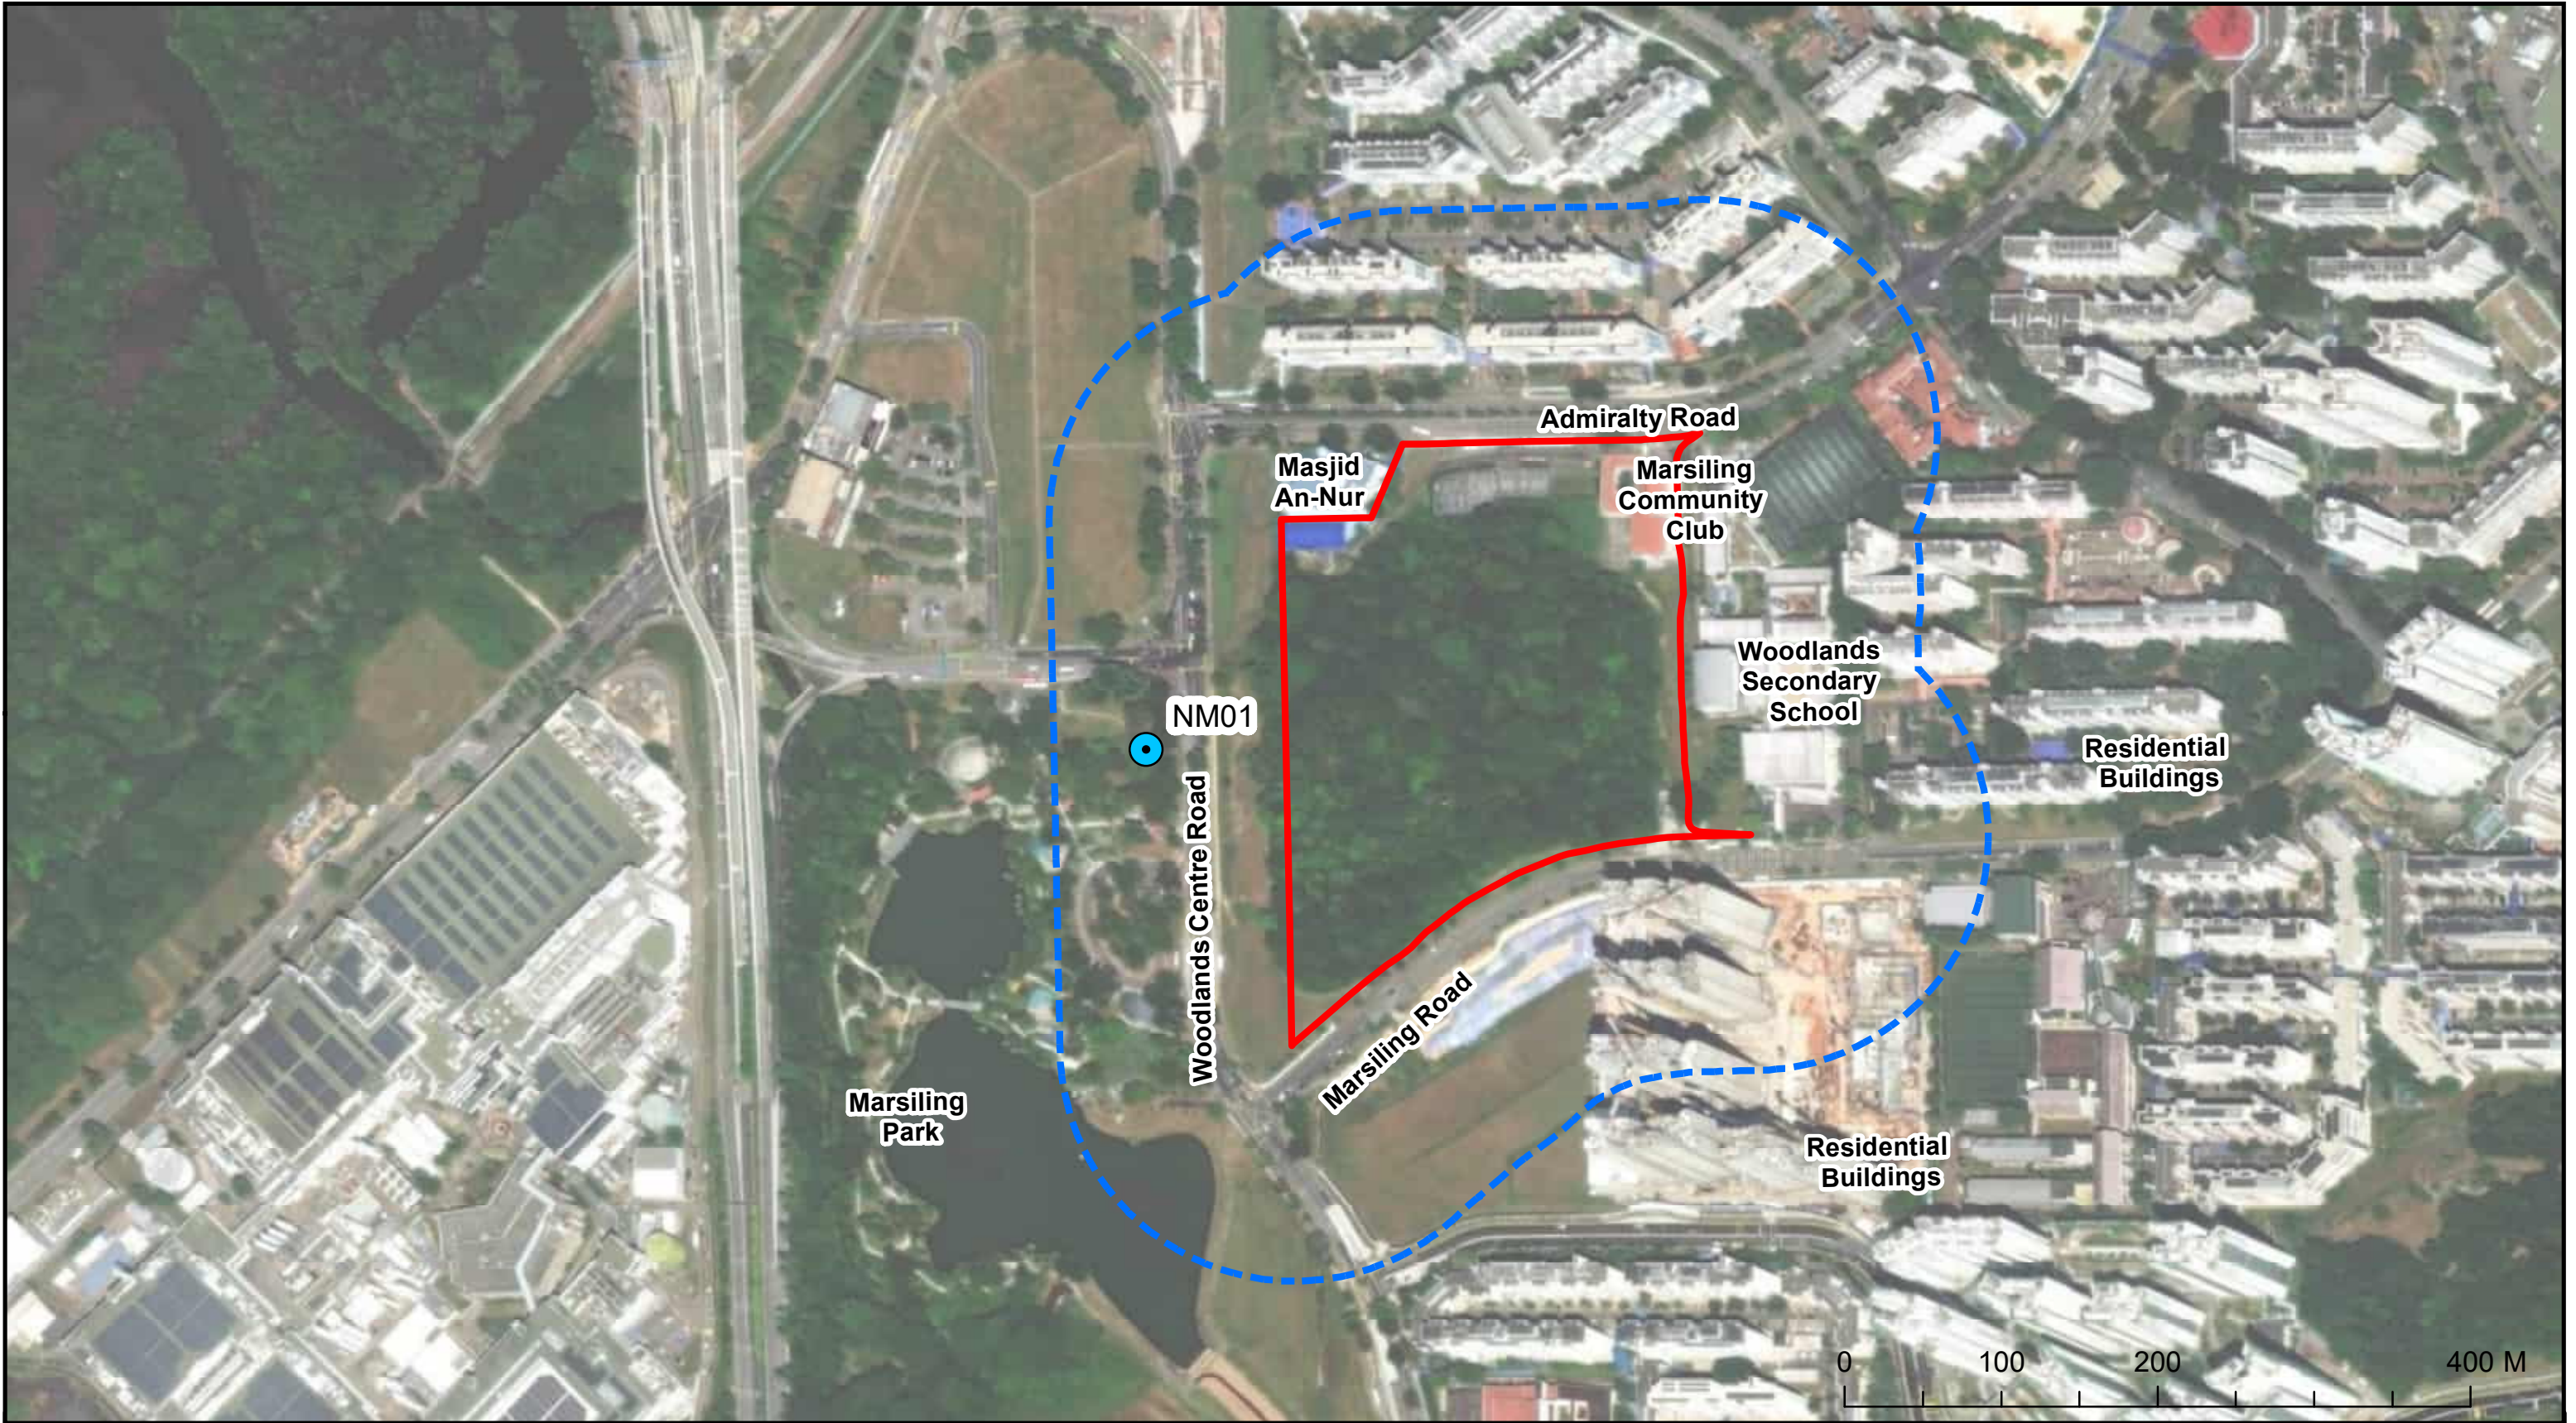
| | | | | | | | | | | Project Title :<br><br>SPECIALIST CONSULTANCY SERVICES FOR ENVIRONMENTAL IMPACT ASSESSMENT (EIA) AT WOODLANDS N1 | Figure Title :<br><br>Airborne Noise Monitoring Locations | |

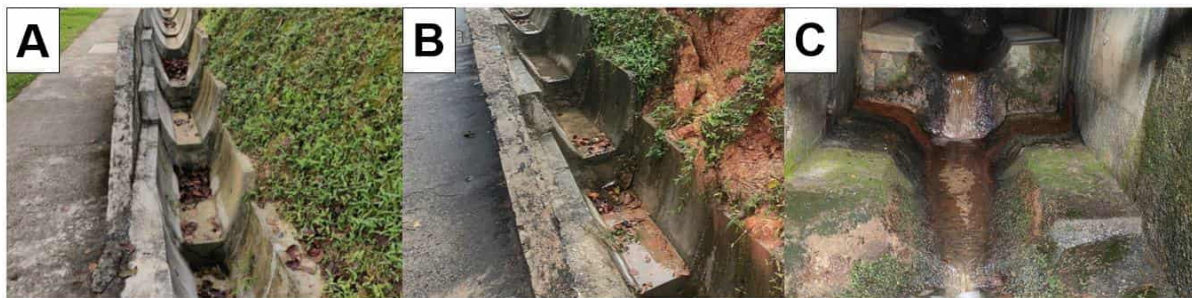
**Figure 6.5.2 Photographs of drain D1 during (A) dry weather; (B) wet weather conditions; and (C) discharge point during wet weather conditions (underground)**

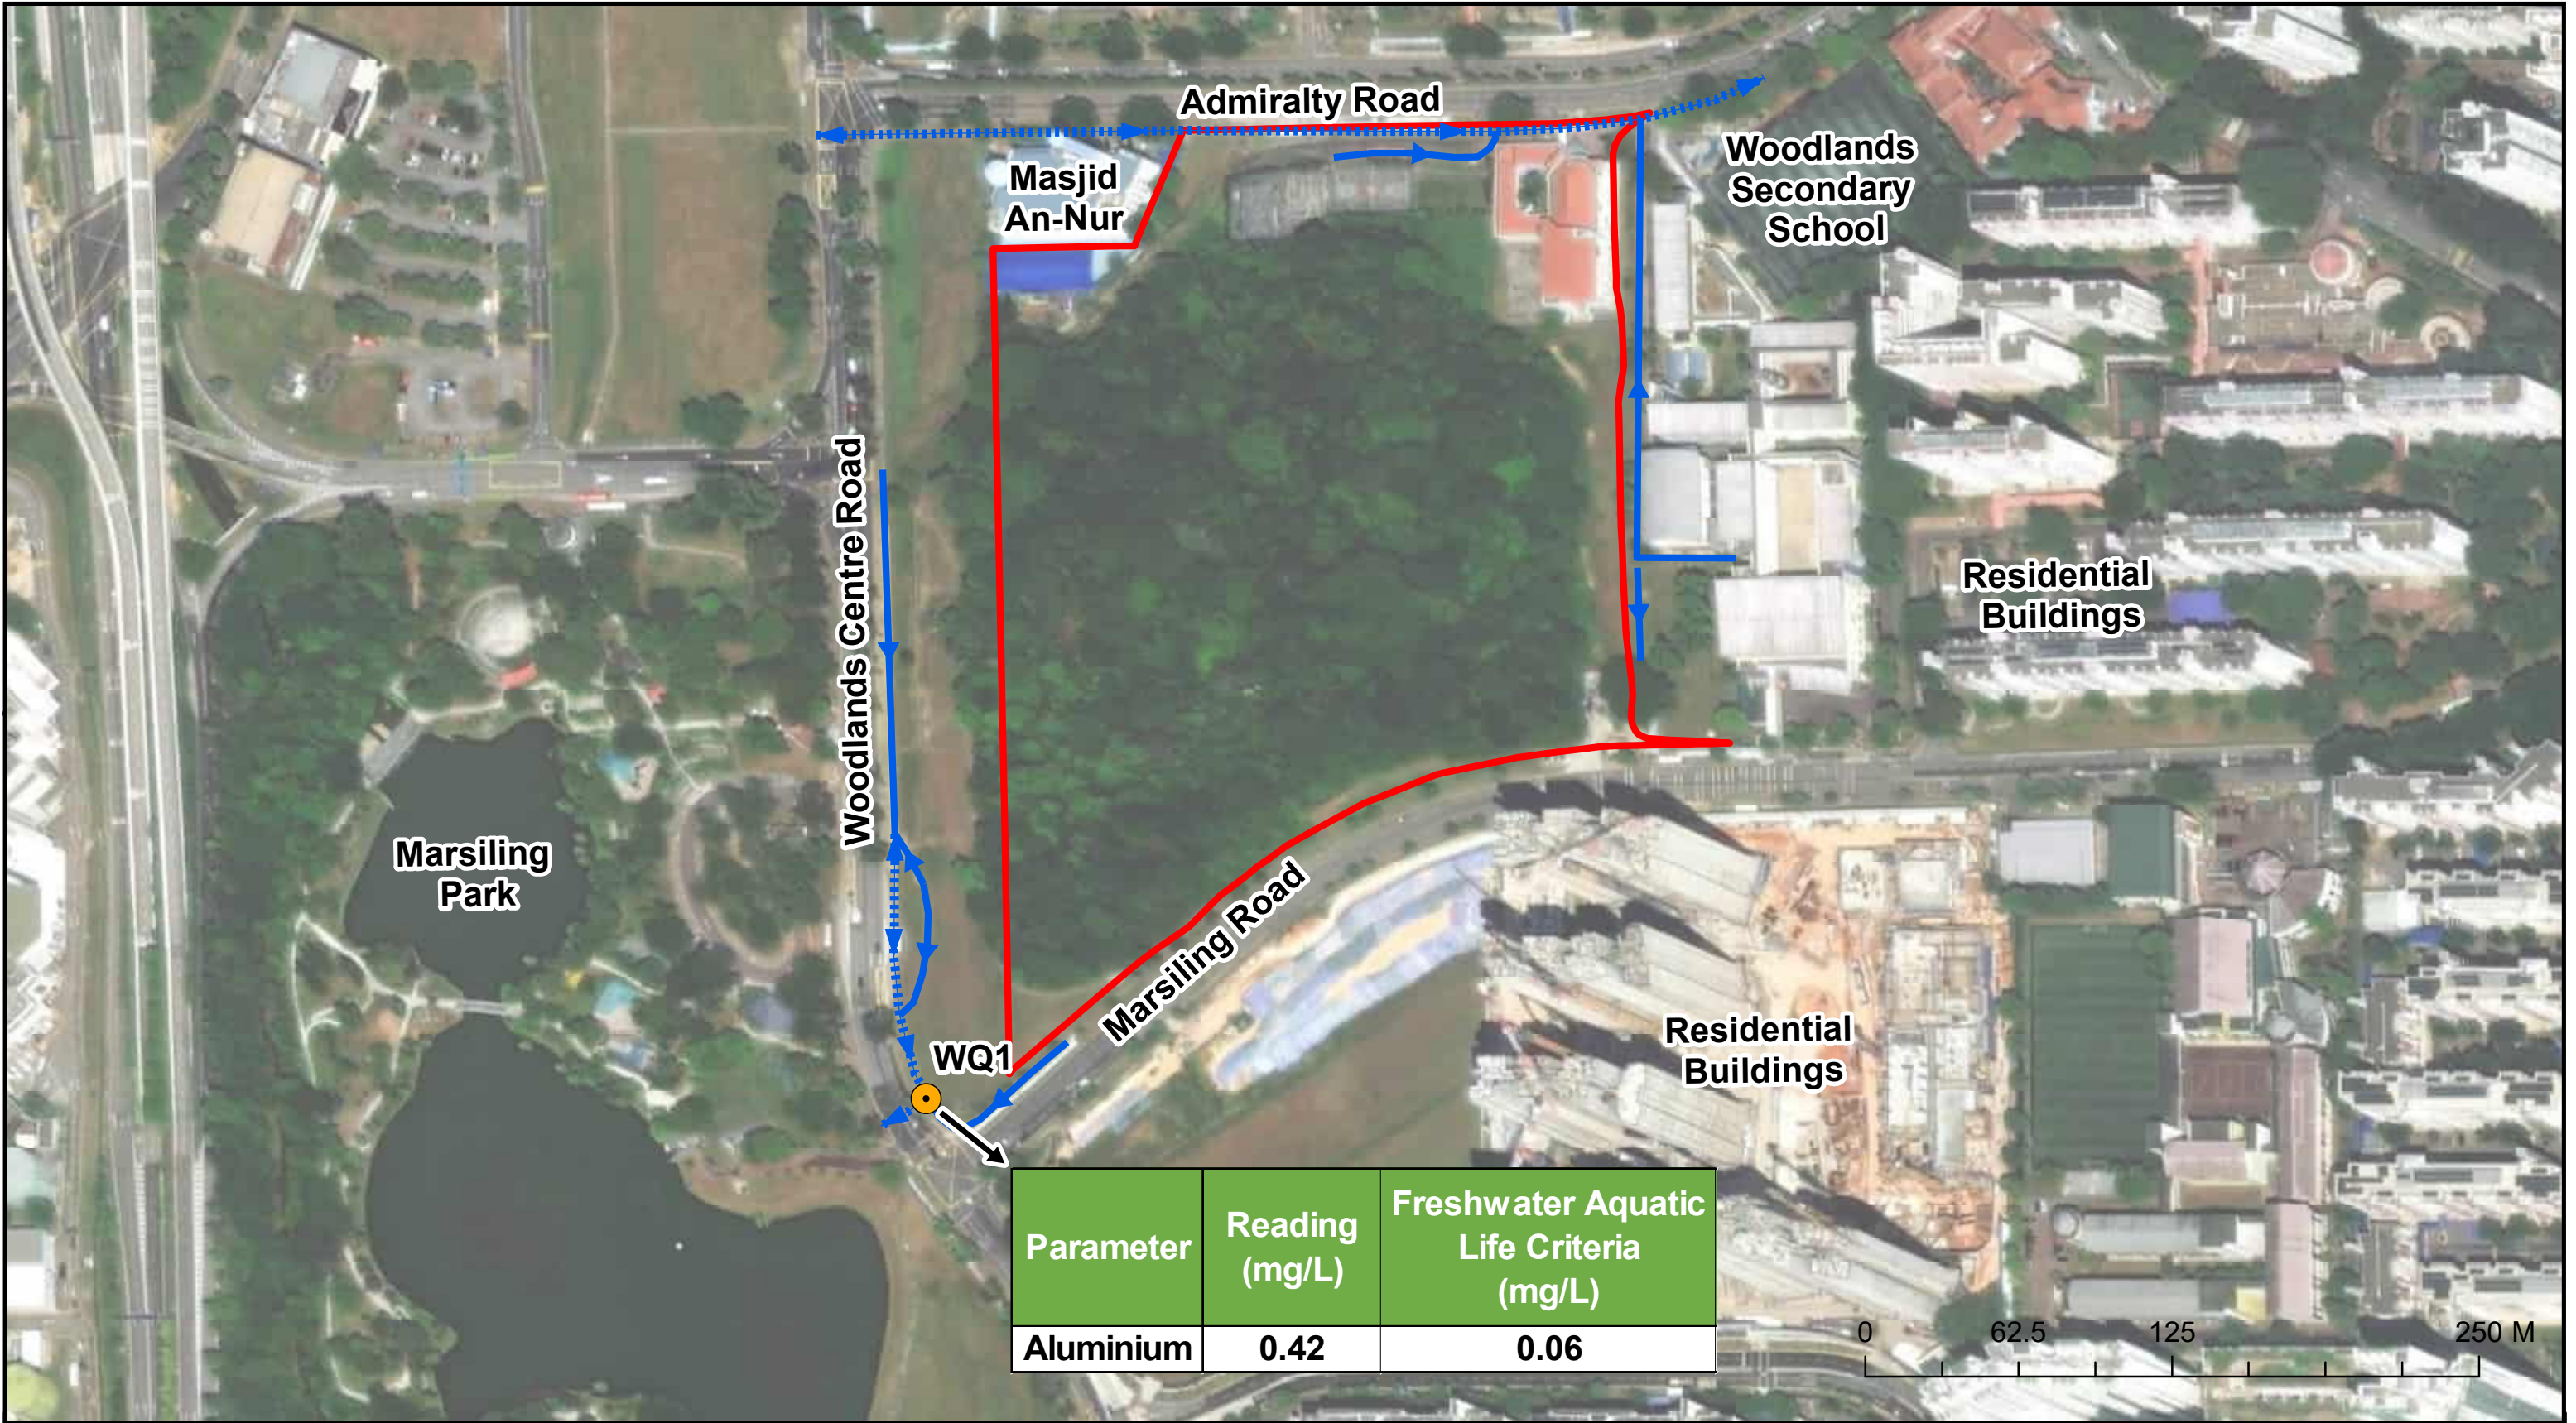
Water quality sampling location and aluminium exceedance are shown in Figure 6.5.9.
