# Specialist Consultancy Services for Environmental Impact Assessment (EIA) at Woodlands Neighbourhood 1

Final Report

Housing & Development Board (HDB)

Project reference: L/074/23  
Project number: 60705888

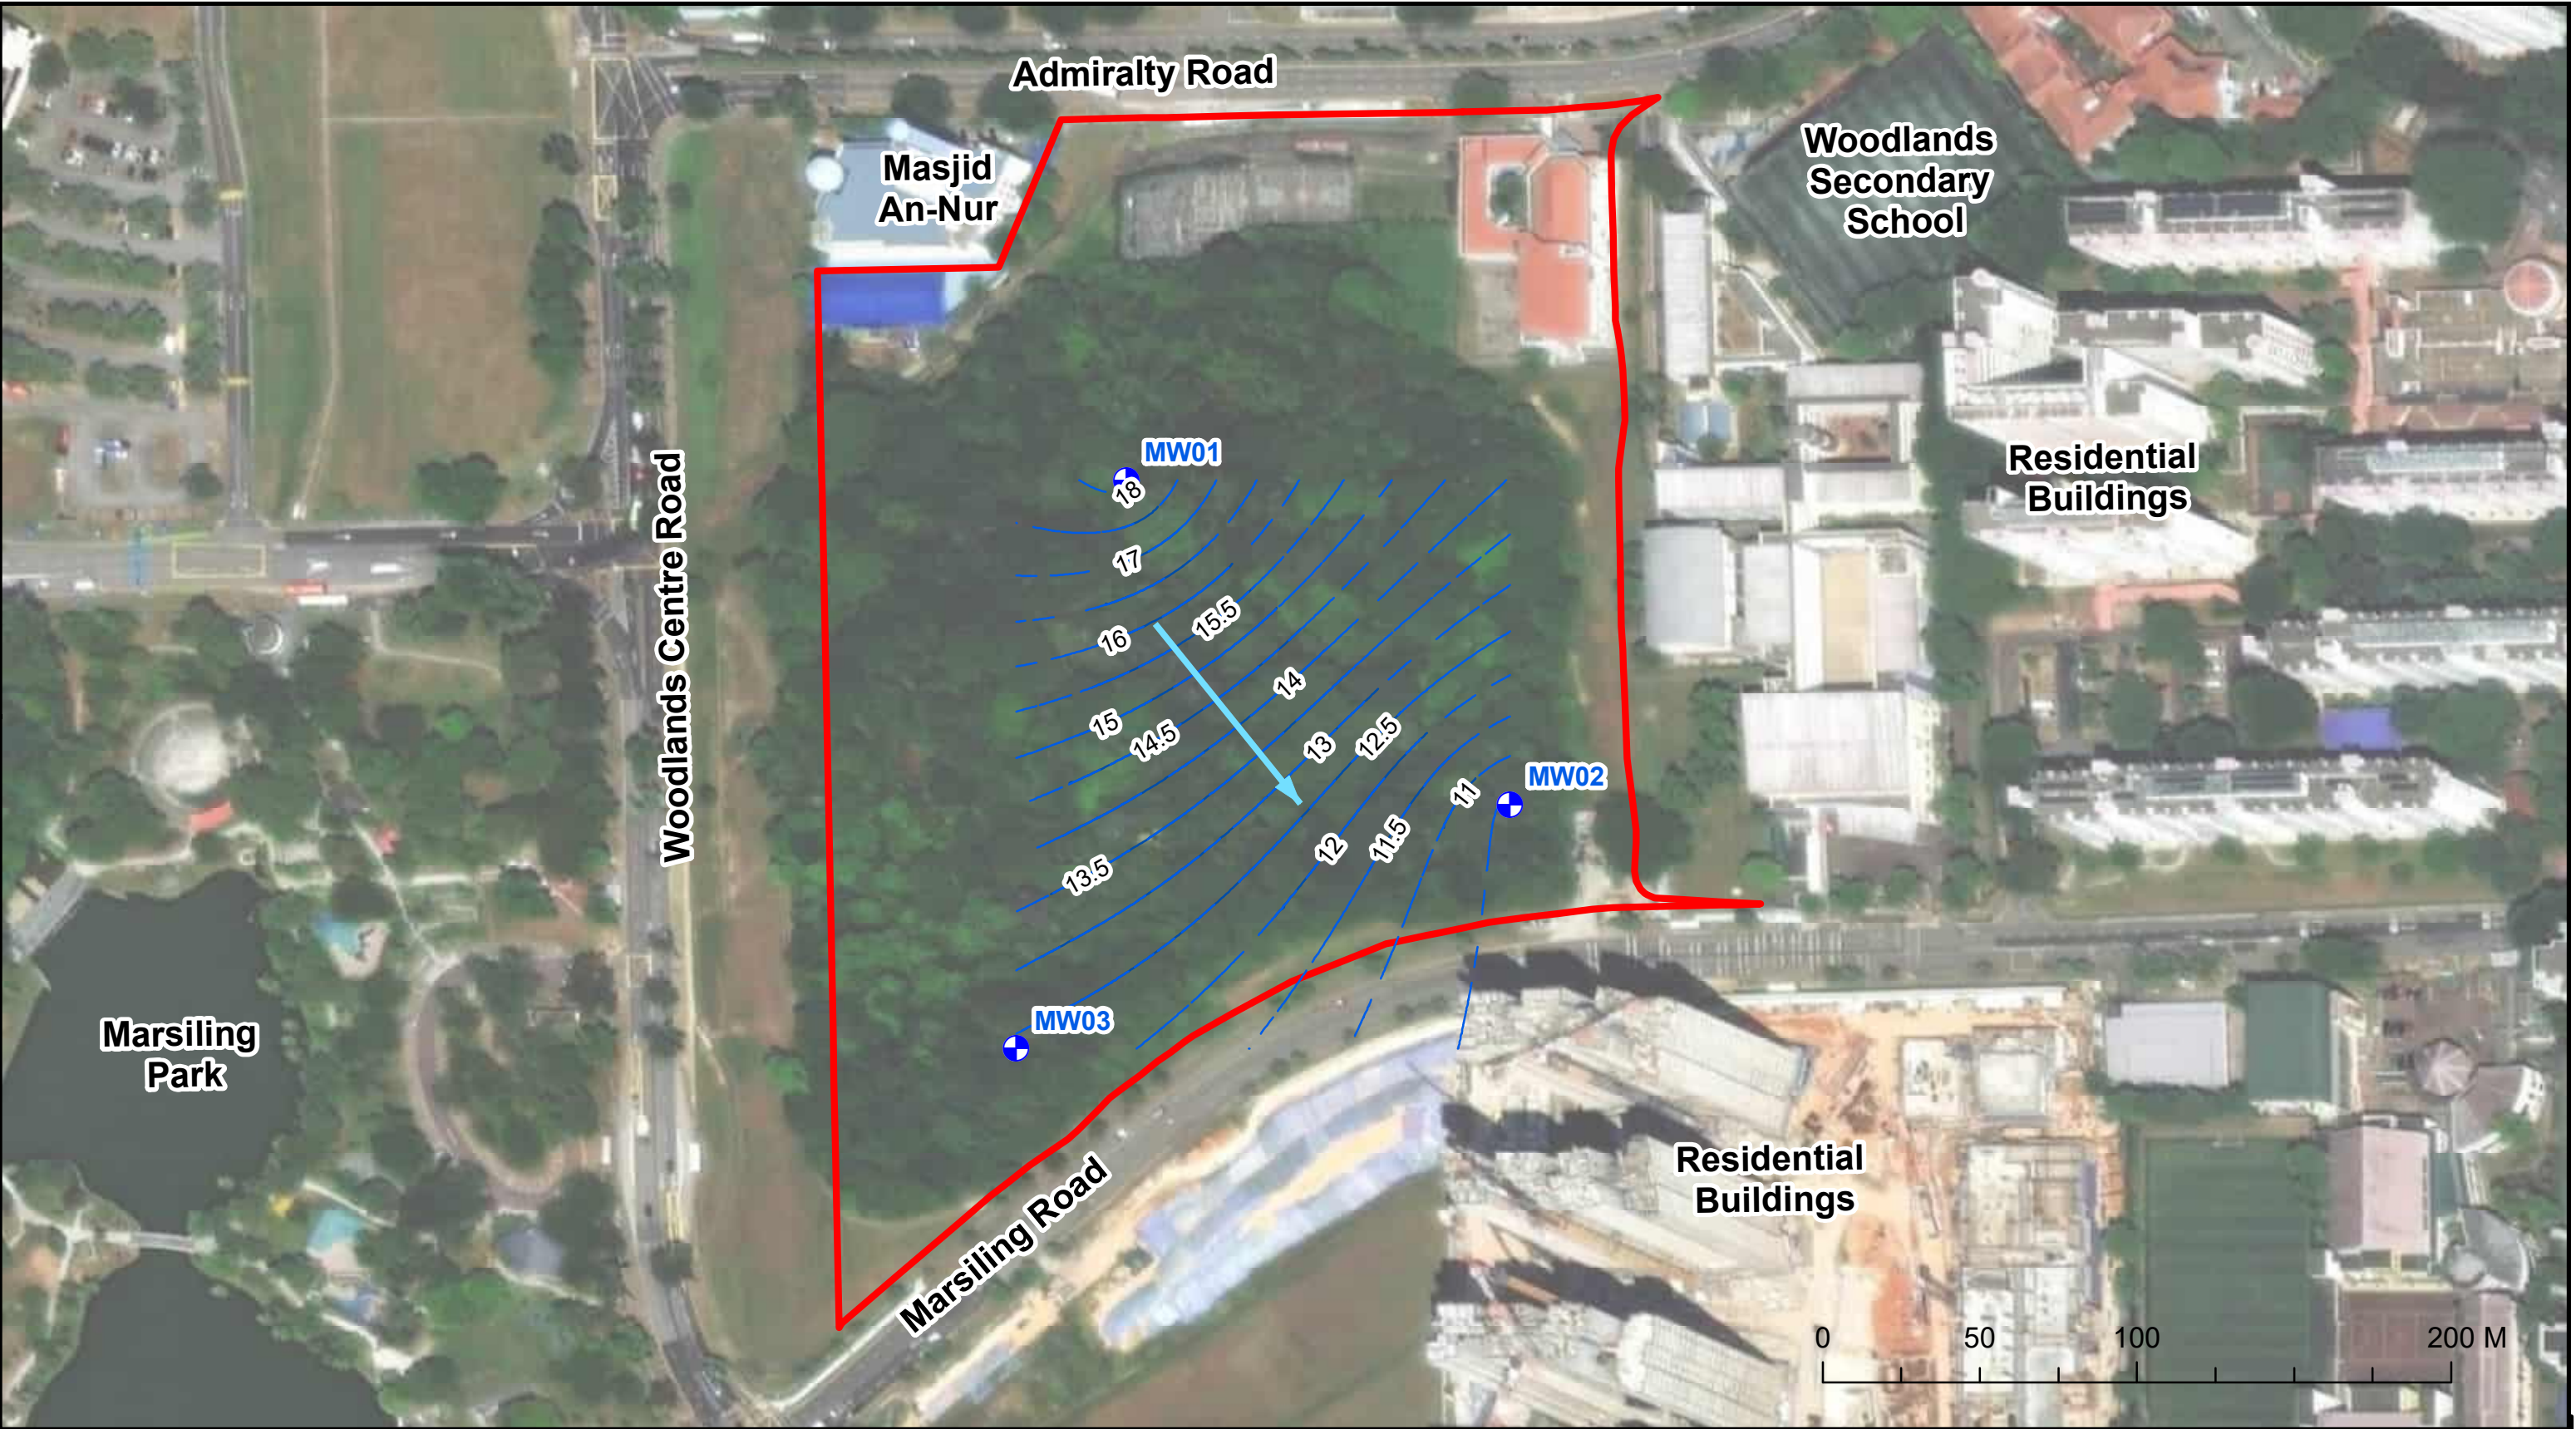
Groundwater seepage velocity is calculated to be 1.1 metres per year (m/yr) with an interpolated radial flow direction from the central portion of the Site. Based on the groundwater elevation contour maps (Figure 6.5.10) the topography of the site indicates the supposed groundwater flow direction within the Project site, which demonstrates a flow direction towards the southeastern.

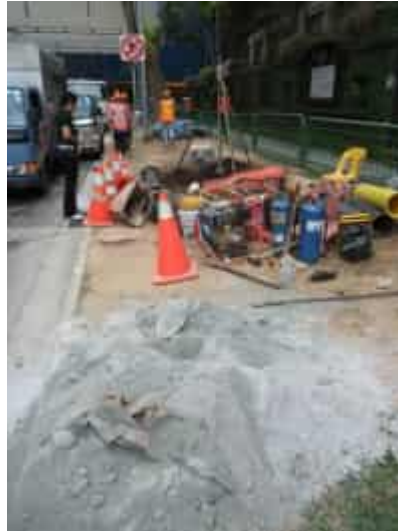
Figure 1: Construction material and heavy machinery are prohibited within the TPZ

- No ground disturbance, grading, trenching or other construction activities shall occur within the TPZ except as specified and/or approved by the attending arborist or authority.
- No construction material, debris, machinery (e.g. generators) or other construction waste shall be stored within the TPZ. Weight and presence of these materials increases

soil compaction and reduces the area exposed for water infiltration and gaseous exchange.

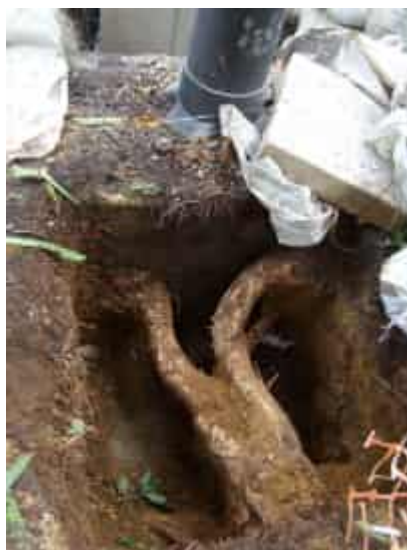
Figure 2: Trial trench by skilled workers using hand tools exposing root architecture

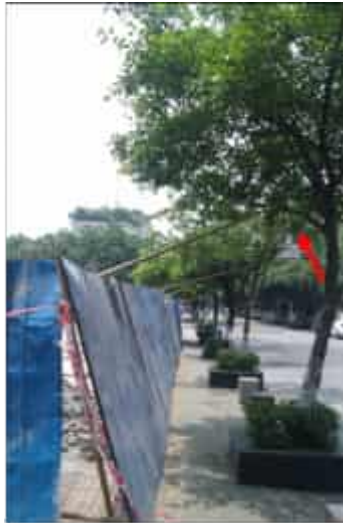
Figure 3: Using tree as anchor may damage its bark.

- Nailing, tying or pasting of materials on trees is prohibited. The tree shall not be used

as an anchor for supporting structures during the construction.

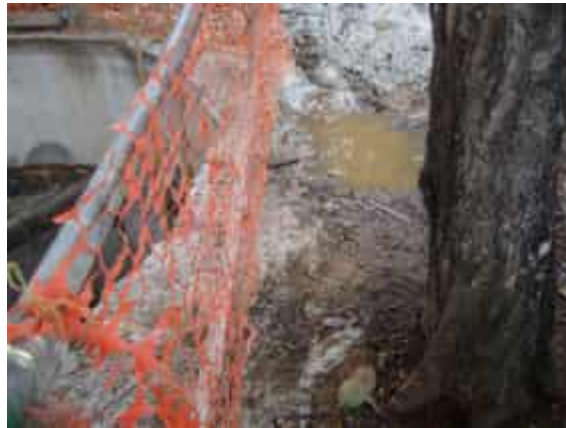
Figure 5: Construction cement deposited at tree base.

Canvass sheets/Eco-mat must be laid on the existing soil near the tree in view of soil protection during the demolition, drilling or other construction activities pertaining to concrete structures.

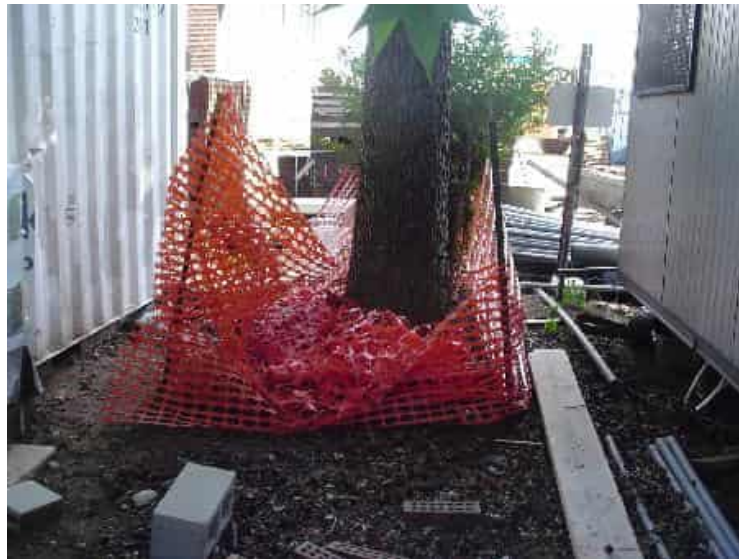
Figure 7: Inappropriate installation/maintenance of TPZ during construction.

**No removal of the TPZ will be permitted under any circumstances.**

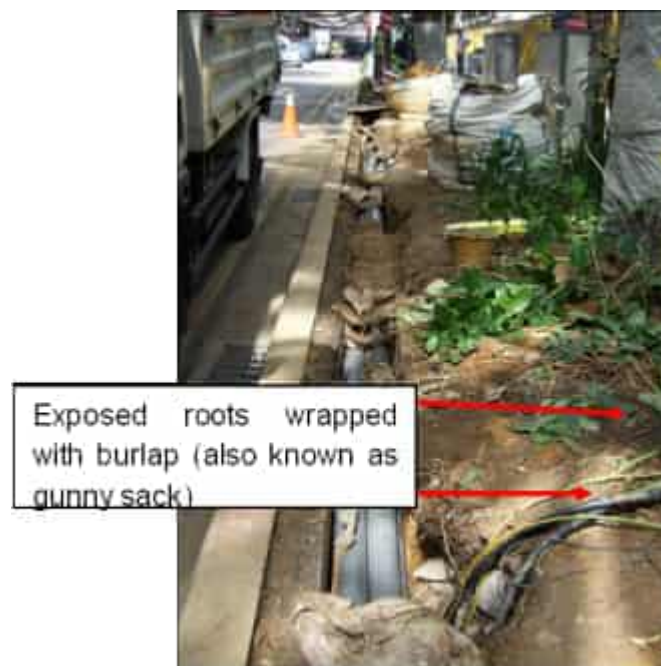
Figure 9: Tunneling under roots.

No roots greater than 0.2m in diameter shall be cut without approval of the attending Arborist. Tunneling under roots is the approved alternative. Prior to excavation for foundation/footing/walls, or grading or trenching within the TPZ, roots shall be severed cleanly outside the TPZ to the depth of the planned excavation. When roots must be cut, they shall be cut cleanly with a sharp saw to sound wood and flush with the trench site.

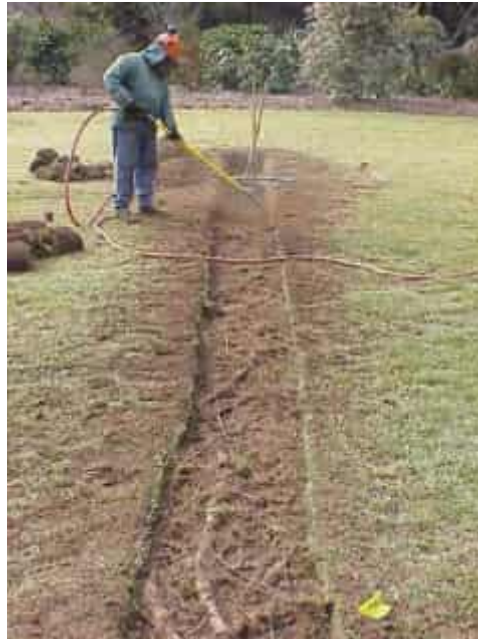
Figure 10: Root exploratory works using an air spade. Air spading avoids damage of structural and even feeder roots of the tree.

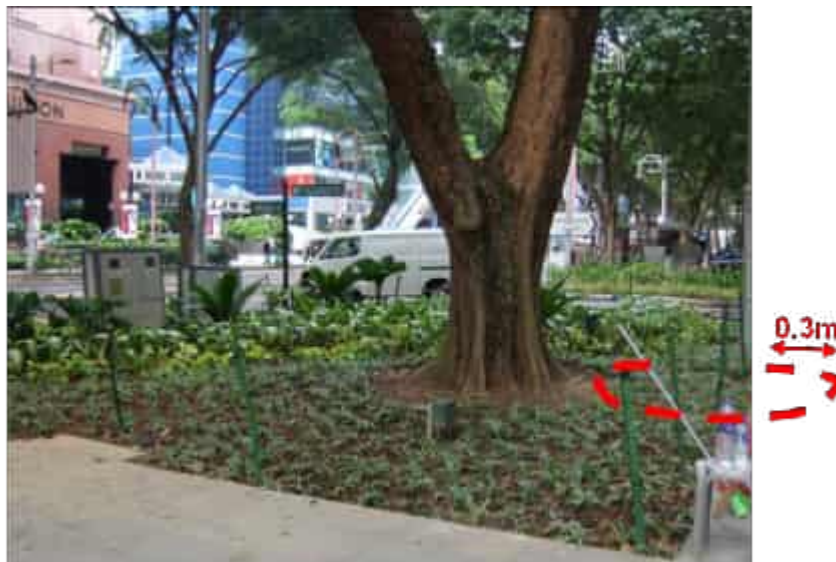
Figure 10: New plantings at a minimum distance of 300mm (all round) from root collar

TPZ barriers can only be removed at this juncture for the purpose. However, when working near trees, cultivation of soils in these areas must be cautiously handled using hand tools. Planting of shrubs shall be at a distance of at least 300mm away from existing root collar.

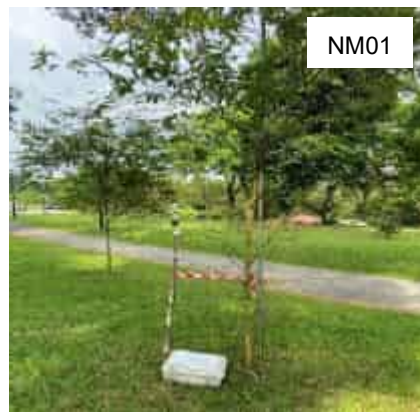
**Figure 1 Airborne Noise Monitoring Setup**

| Instrument | Brand | Model | Serial Numbers | Type |
| 131 Norsonic | 131 | Norsonic | 1313950 | 1 |
