Specialist Consultancy Services for Environmental Impact Assessment (EIA) at Chencharu (Site 2)

Document no: D3886500.EIAS2.1

National Parks Board

Report for Site 2

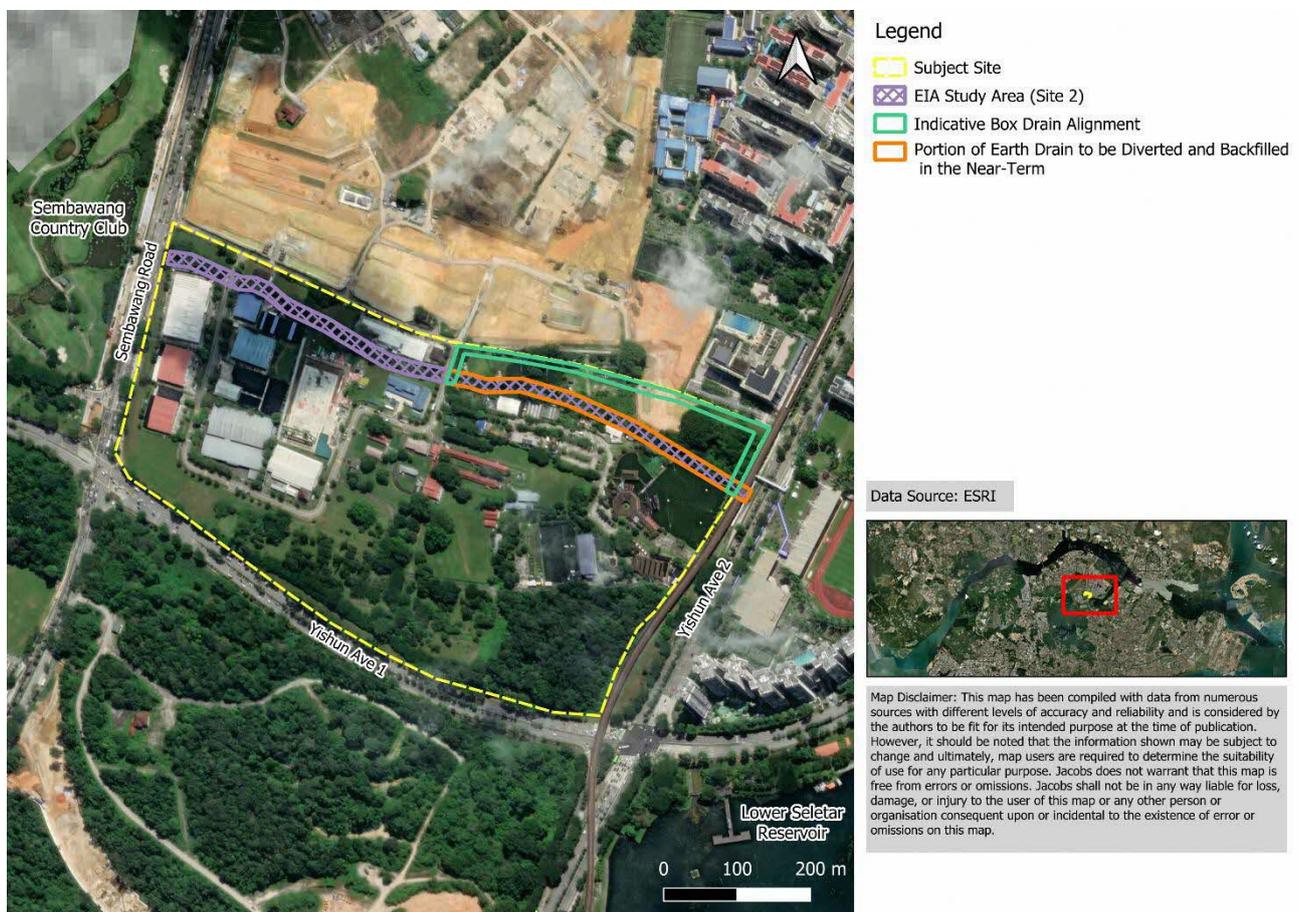
Figure 2-4: Indicative Location for Earth Drain Diversion and Box Drain Alignment

Originally constructed in the 1980s to handle drainage from surrounding agricultural and recreational uses, the earth drain flows from the west through Sembawang Country Club to the east towards Yishun Avenue 2, before discharging into Lower Seletar Reservoir. The surrounding Chencharu area was announced for housing developments, with plans for around 10,000 public and private units along with accompanying amenities. Due to evolving land use needs and the limited drainage capacity of the current earth drain, upgrading and diversion works are required to support the future drainage needs of upcoming residential developments and ensure compliance with updated drainage standards. These works will be conducted in phases, where the eastern half (outlined in orange) will be diverted to a new 4-meter-wide box drain (outlined in green) and backfilled in the near-term, while the remaining western half will be diverted and backfilled in later years (Figure 2-4).

The proposed works for Site 2 include a sequence of diversion and backfilling processes. A new 4-meter-wide box drain with a higher drainage capacity will be constructed to replace the earth drain, and water flow will be redirected into the new box drain before the existing earth drain is isolated and backfilled. The new drainage system will support efficient stormwater management and reduce erosion risks for the future developments. The detailed steps of the proposed diversion and backfilling works for Site 2 are outlined below:

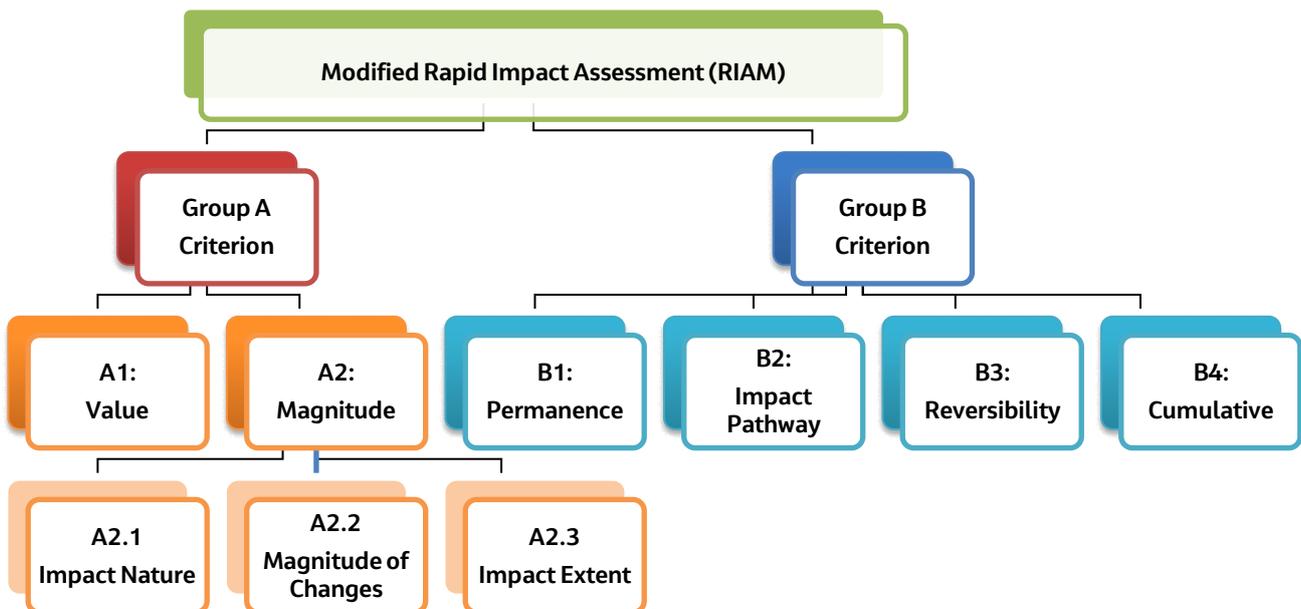
Figure 3-1: Assessment Criteria for Impact Significance following the RIAM Method

The criteria used for the assessment fall into two groups, Group A and Group B, with their respective factors of assessment indicated in Figure 3-1.

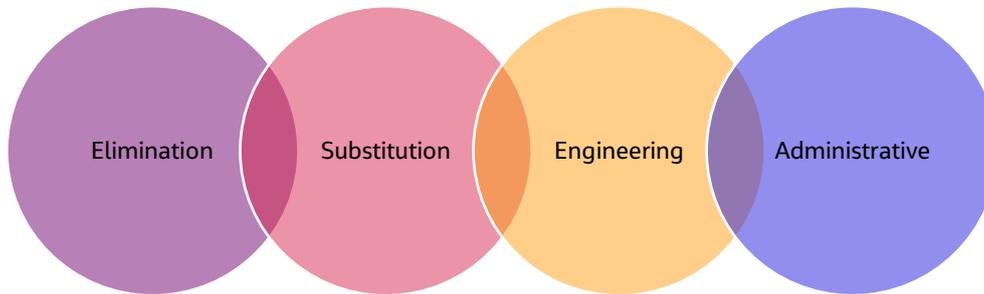
Figure 3-3: Control Method

operation activities to as low as reasonably practicable (ALARP) using the following types of control methods as shown in **Figure 3-3**.

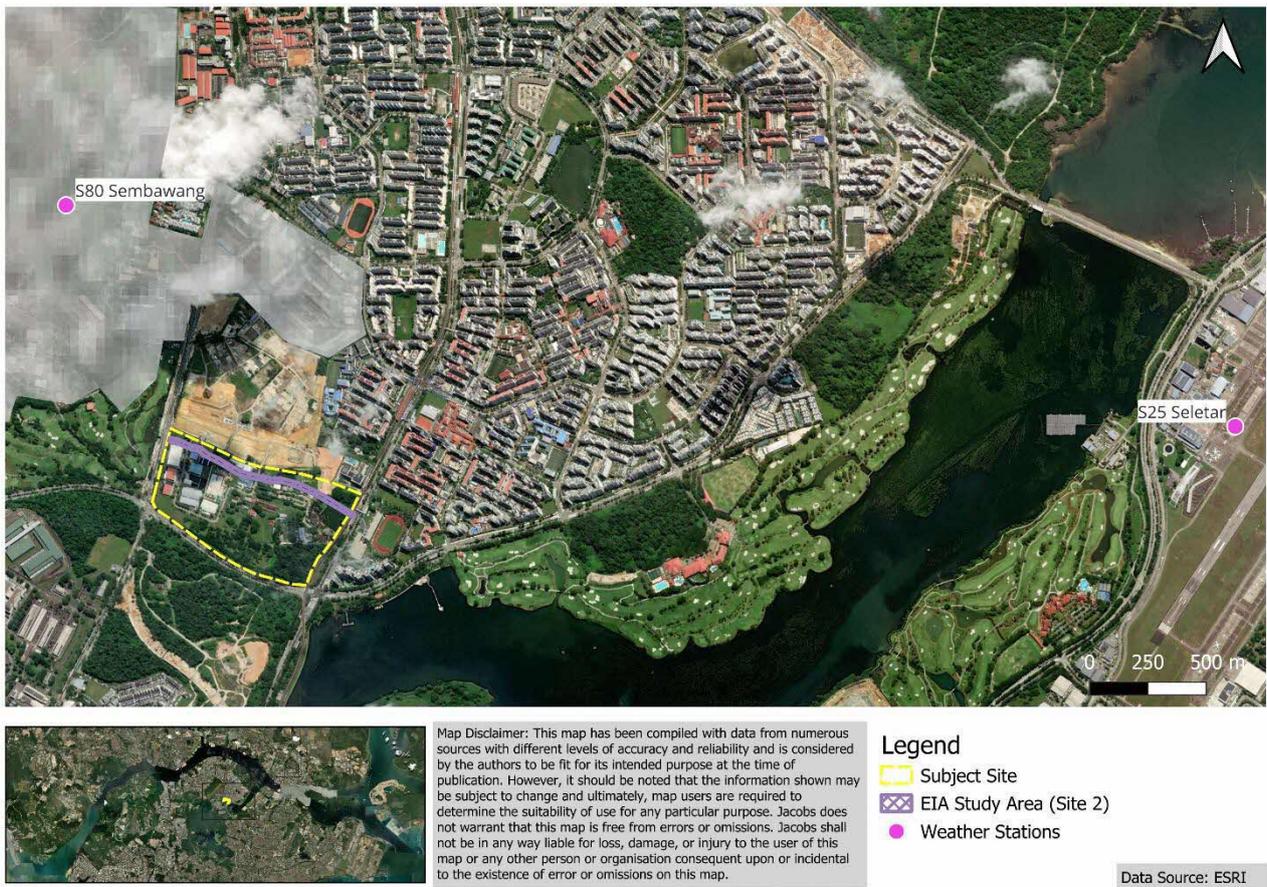
Figure 4-1: Locations of Rainfall Data Stations Closest to the EIA Study Area

There are no rain stations in the immediate vicinity of the EIA Study Area (**Figure 4-1**). Hence, two of the closest rain stations were selected to indicate approximate rainfall during the study (i.e., S25 Seletar, and S80 Sembawang). Sembawang Weather Station is approximately 1.1 km northwest of Site 2, while Seletar Weather Station is approximately 3.8 km northeast of Site 2. Data on the total daily rainfall collected at these two rain stations in September 2024 were obtained from publicly available platforms hosted by NEA's Meteorological Service Singapore (MSS) division and presented in **Figure 4-2**.

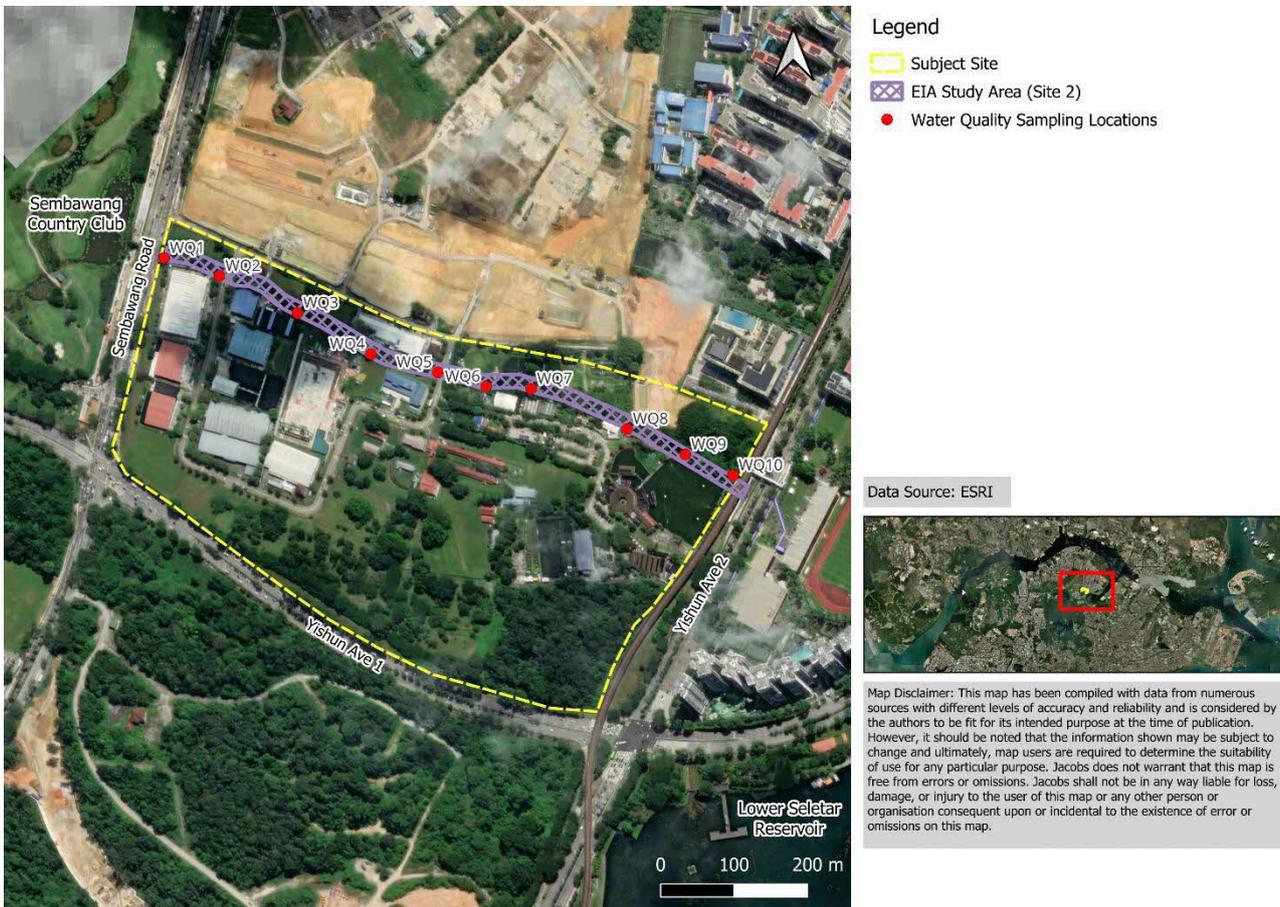
Figure 4-3: Water Quality Sampling Locations

Water samples were sampled across the start, mid, and end portions of the drain, with additional points fixed at outfall points. Water quality samples were collected at ten (10) locations as shown in **Figure 4-3**.

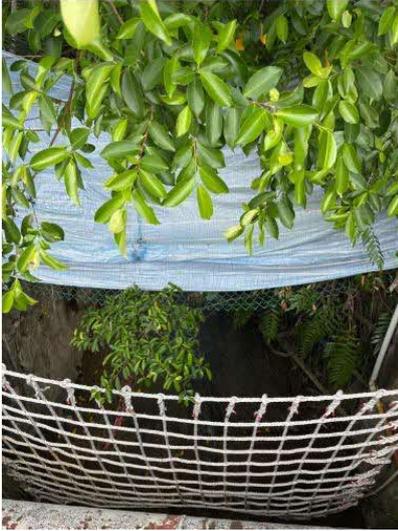
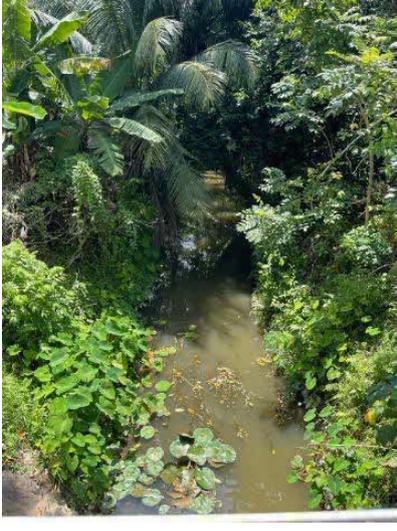
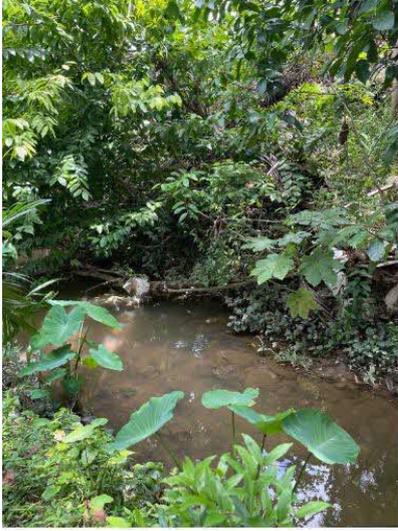
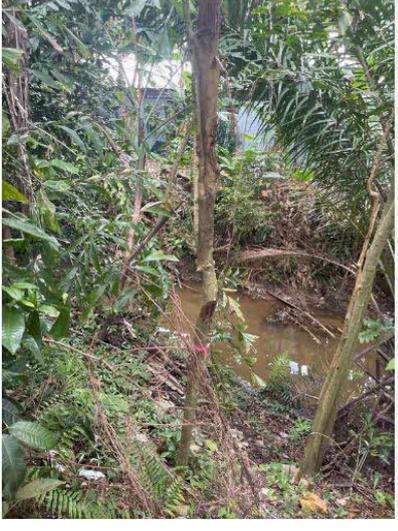
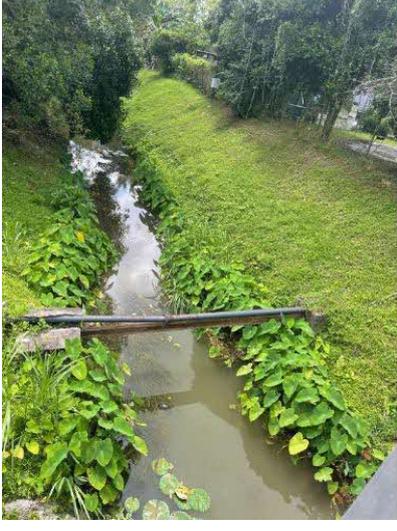
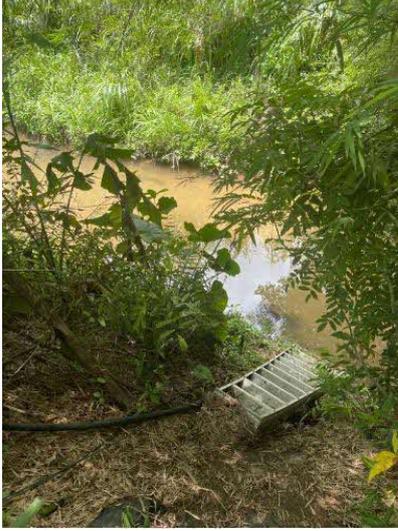
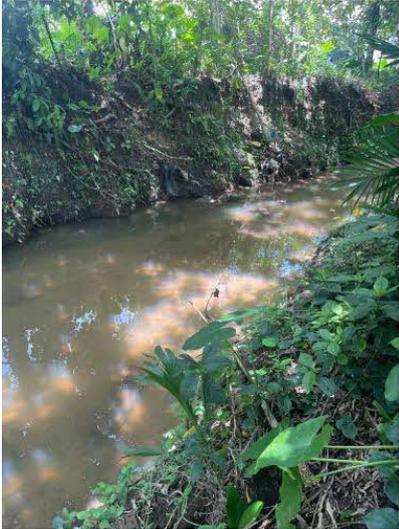
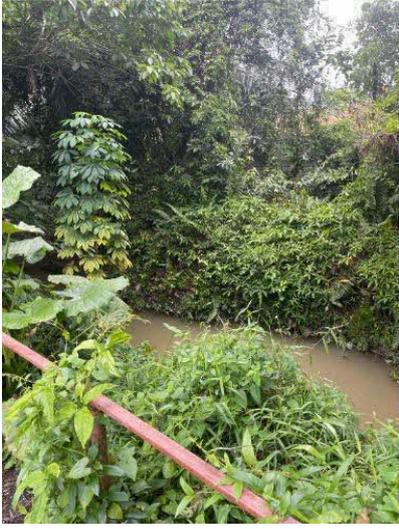
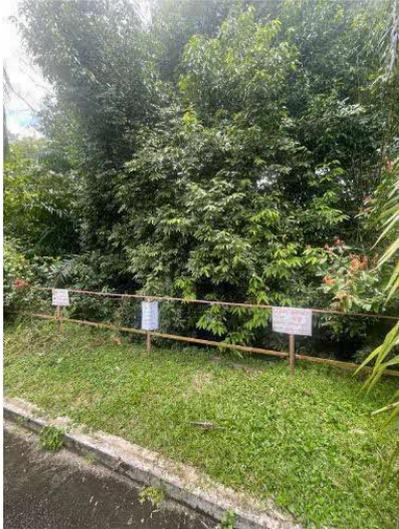
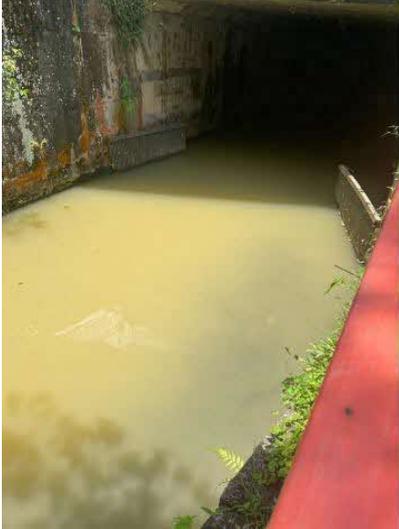
Table 4-2: Waterbody Features and Photographs with Coordinates

The waterbody features observed during the survey are presented in Table 4-2. The photographs were taken during the dry weather sampling on 16 September 2024. Other sampling observations are listed in **Appendix 4A**.

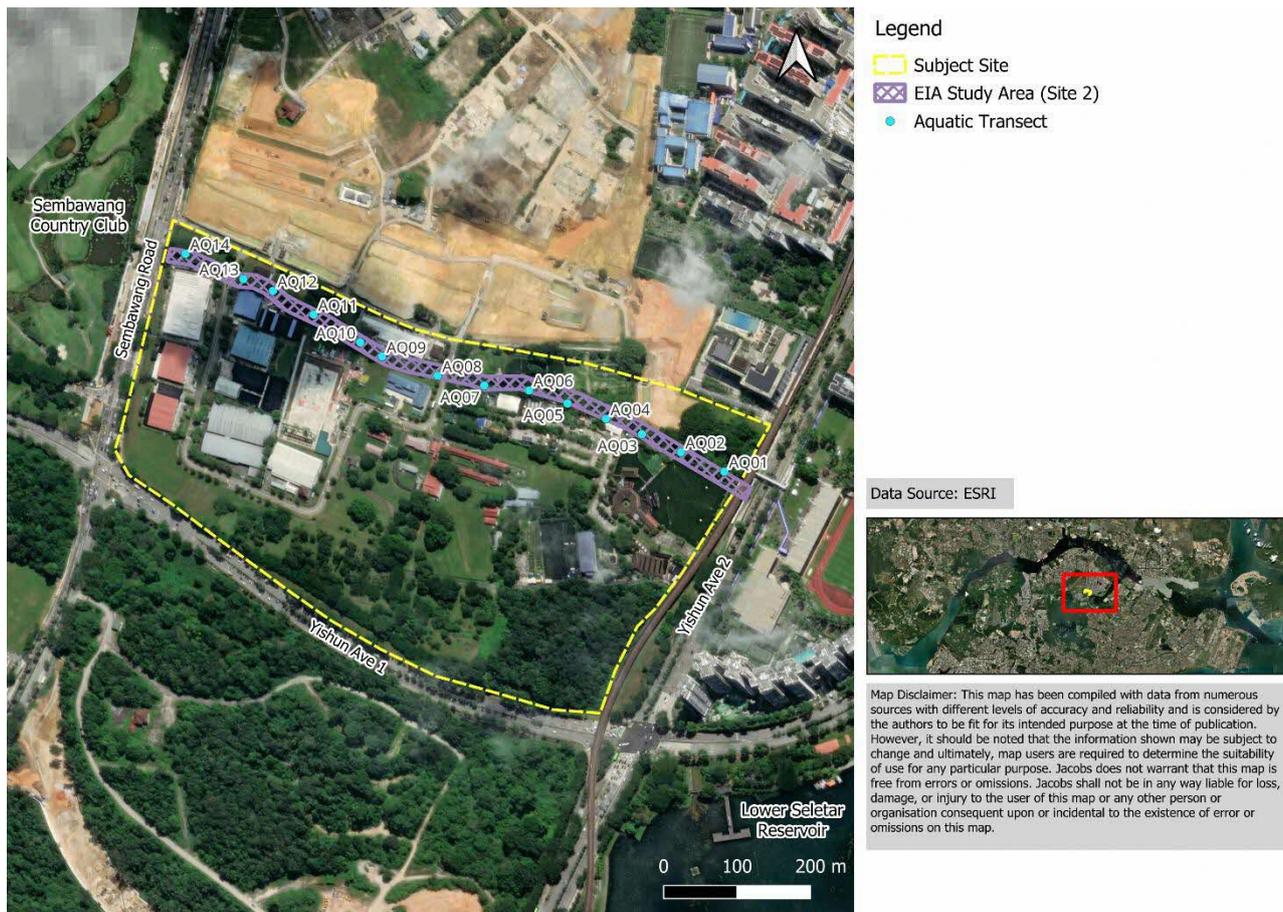
Figure 5-1: Locations of Aquatic Transects

Figure 5-1 shows the locations of the aquatic transects. **Table 5-2** summarises all the surveys that were carried out for fauna. Each survey was performed by at least two surveyors. All fauna encountered were identified to species, or to the next lowest taxonomic level possible, and the location of each sighting was recorded using a handheld GPS (Garmin GPSMAP 64s). The number of individuals observed was also documented.

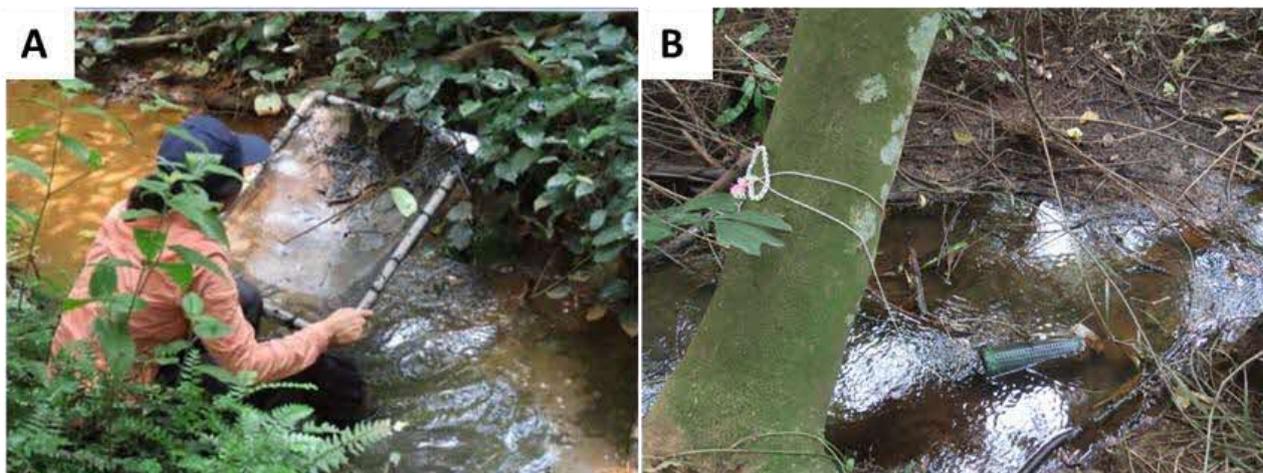
Figure 5-2: Photo of (A) Push Netting and (B) Minnow Trap

Push and/or scoop netting were carried out to capture freshwater aquatic fauna that may be difficult to spot or identify from the water surface. Push netting was carried out, mostly in deeper waters, using a rigid-frame tray net (61 × 49 cm; 5 mm mesh) to catch specimens along the banks or the streambed (**Figure 5-2A**). Scoop netting was carried out, mostly in shallower waters, using hand nets (net size 25 × 18 cm; 2 mm mesh) to catch specimens within the earth drain column. Captured individuals were released immediately after identification. Torches and/or headlamps were used to elicit eyeshine during nocturnal surveys.

Minnow traps baited with halal meat (e.g., sausage or liver) was deployed at suitable locations within the earth drain (**Figure 5-2B**). The traps were left overnight, then checked and removed the following morning. All caught individuals were released immediately upon identification. Minnow trapping was conducted once per location, at locations with suitable water levels, except for AQ10 due to the presence of a honeybee nest in proximity to the sampling location.

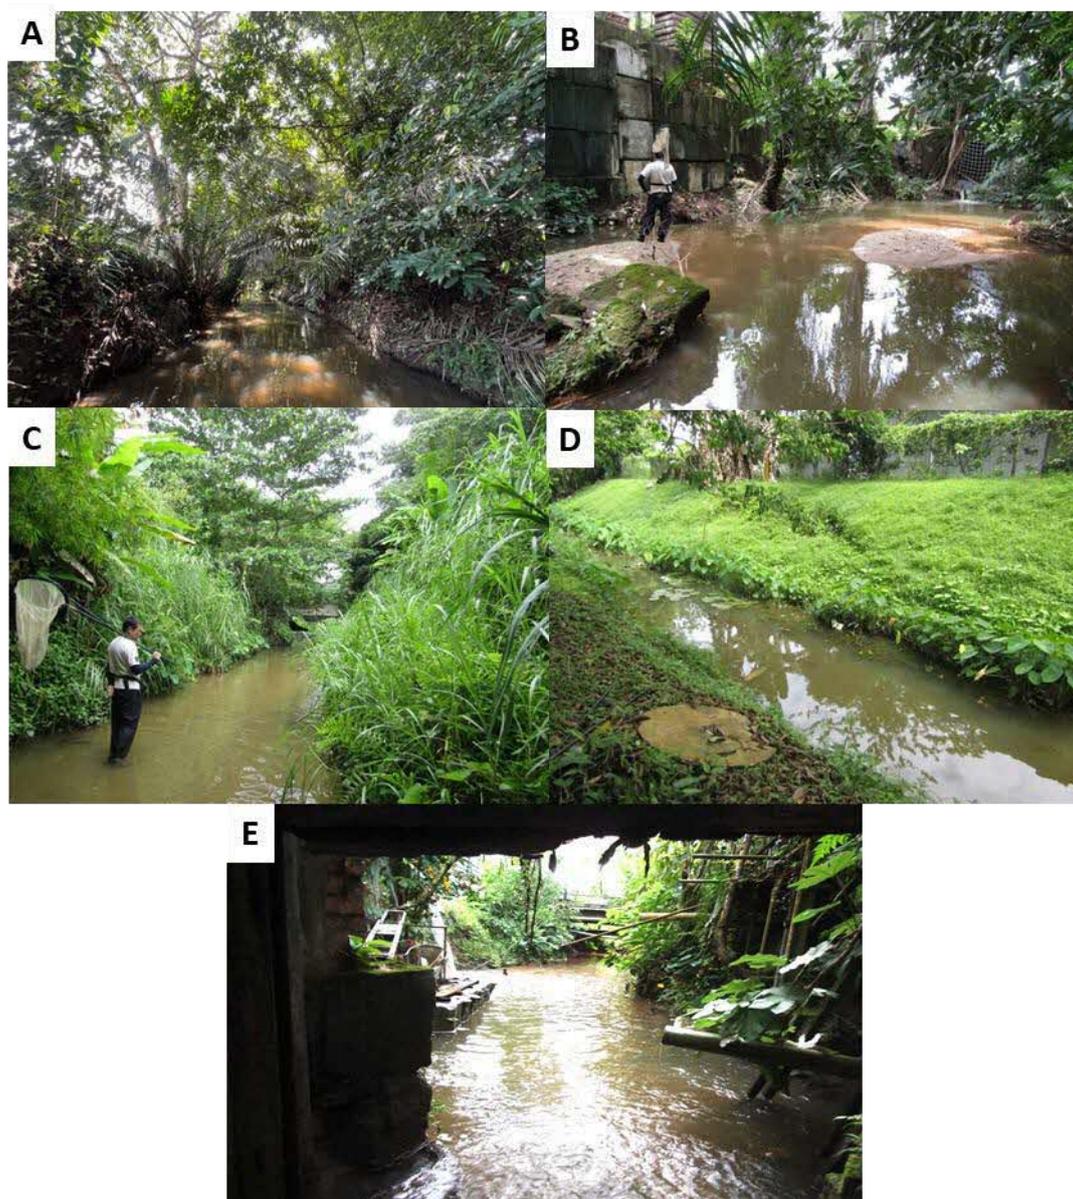
Figure 5-3: Photos of (A) AQ01, AQ02, (B) AQ14, (C) AQ07, (D) AQ08, (E) AQ05.

As established in earlier sections, the EIA Study Area (Site 2) consists of a single earth drain receiving water from Sembawang Country Club and flows downstream towards Yishun Avenue 2, and subsequently Lower Seletar Reservoir. Most of the earth drain was soft-bottomed, with common native and exotic flora species, both spontaneous and cultivated, growing along the riparian banks along the whole earth drain. There was scarce aquatic vegetation growing only at AQ08 and AQ13. There was a mix of habitat conditions observed along the earth drain where shady forested areas with steeper banks were observed at AQ01–AQ06, AQ09–AQ10 and AQ14, open sunny areas with more gradual banks at AQ07–08, and debris/litter and concrete structures at AQ05. Stronger currents were also observed upstream. The depth of the earth drain varied with some downstream (AQ02–AQ05) and upstream (AQ08) points being deeper, while the remaining points were generally shallower.

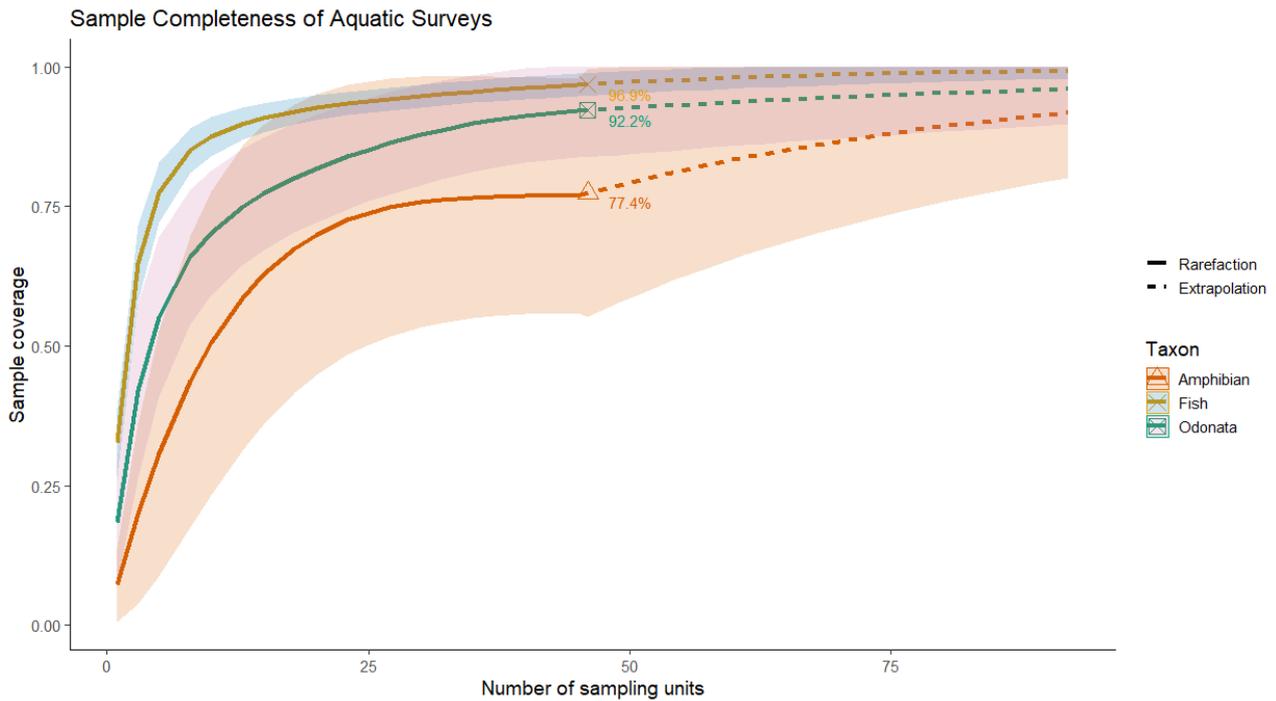
Figure 5-4: Sample Coverage Curves for Amphibian, Freshwater Fish and Odonata.

Faunal Group	Sample coverage (%)	Observed Richness	Estimated Richness	95% Confidence Interval
Amphibian	77.4%	5	7.9	5.4 – 28.9
Fish	96.9%	16	18.6	16.4 – 34.5
Odonate	92.2%	9	13.4	9.5 – 49.1

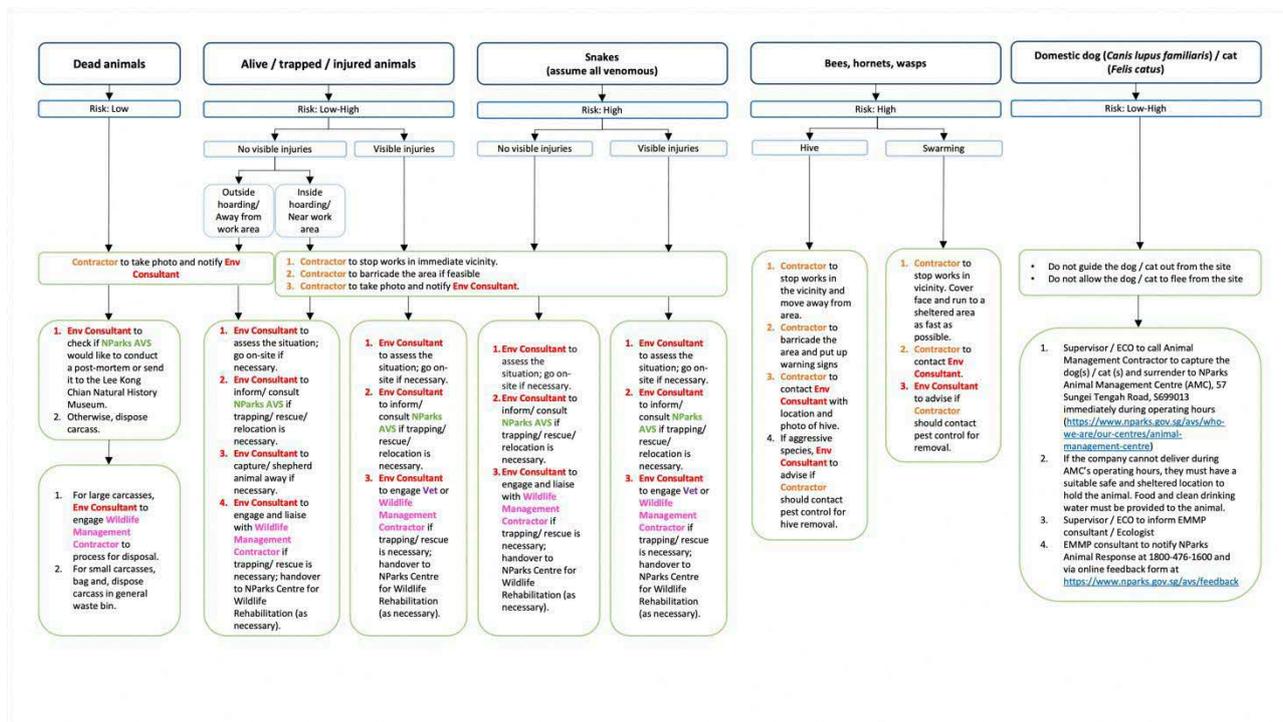
Figure 5-6: A Flowchart of the Wildlife Response Plan

In scenarios where certain animal groups are encountered around or within the worksite, external specialists may be contacted to handle the animal safely. These scenarios include the following:

- For snakes that require relocation/handling, a trained specialist should be contacted.
- For animal carcasses that require disposal, an animal carcass disposal service should be contacted.
- For injured animals that require medical attention, a veterinarian should be contacted.

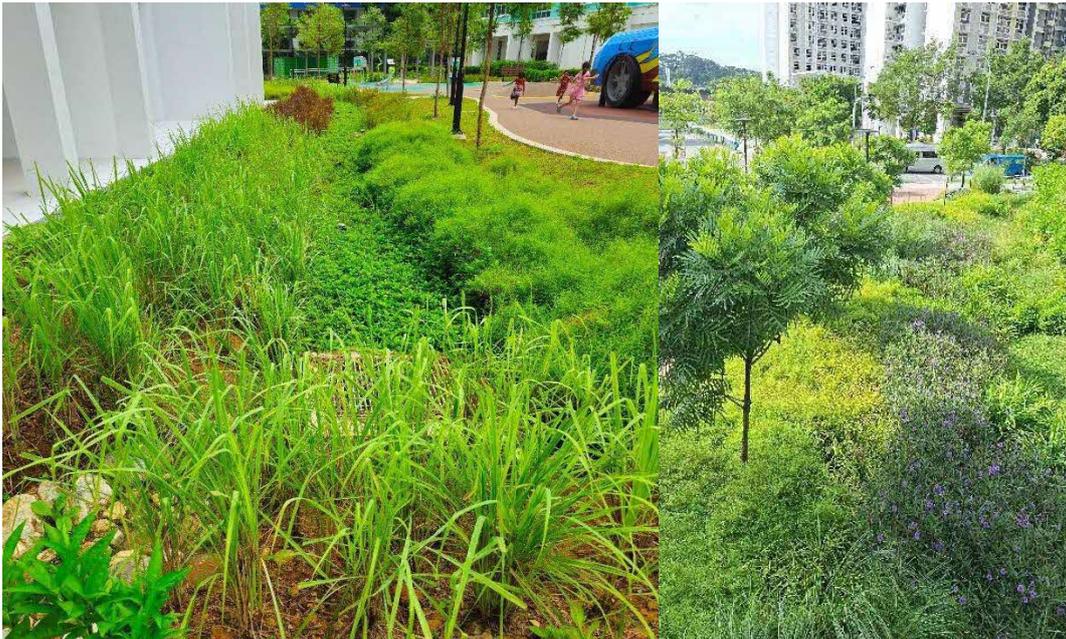
Figure 5-7: Biophilic ABC features that can be implemented in future developments to attract local biodiversity (Left: Rain Garden; Right: Vegetated Swales) (HDB)

- Integration of biophilic ABC (Active, Beautiful, Clean Waters) (**Figure 5-7**) features such as rain gardens and vegetated swales within the development that can also be used as bioretention basins to help manage surface water runoff and filter pollutants. These features are typically planted with lush native foliage, which can potentially create habitats for native wildlife across different taxa such as butterflies, birds, odonates and frogs.

While ABC features will not provide a permanent waterbody, they provide an opportunity for the creation of new enhanced habitats within the Subject Site, especially considering the degraded conditions of the existing earth drain. A new freshwater habitat could also be integrated as part of the upcoming developments, depending on site considerations and technical complexity.

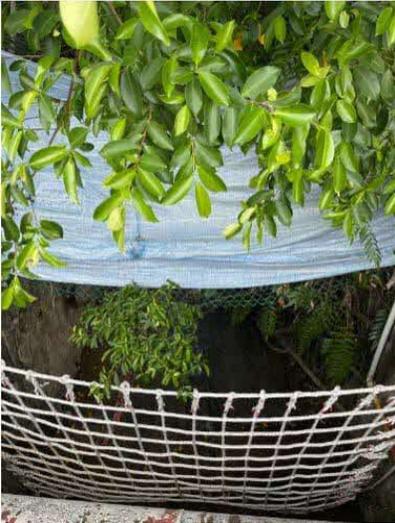
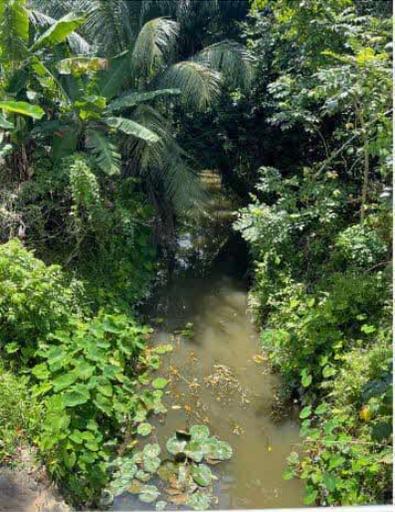
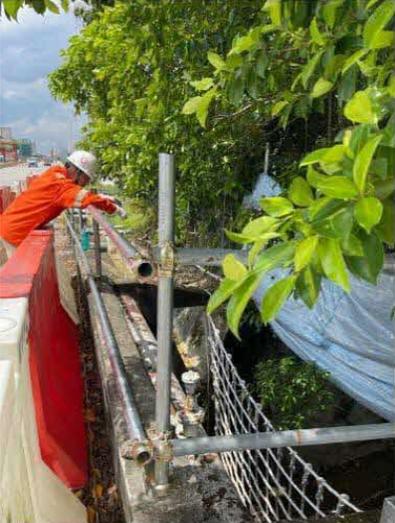
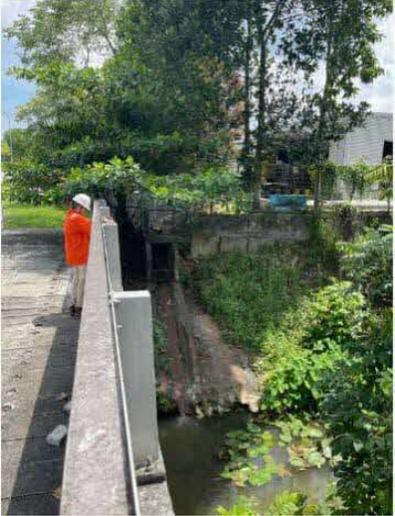
Dry Weather Sampling (16th September 2024)

GPS coord	N1.416050 E103.823870	N1.415794 E103.824610
Time of Sampling	14:25	14:16

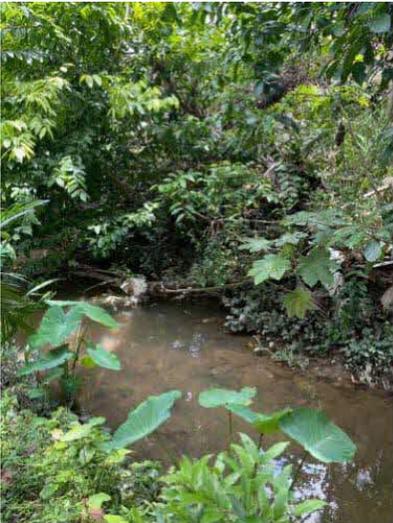
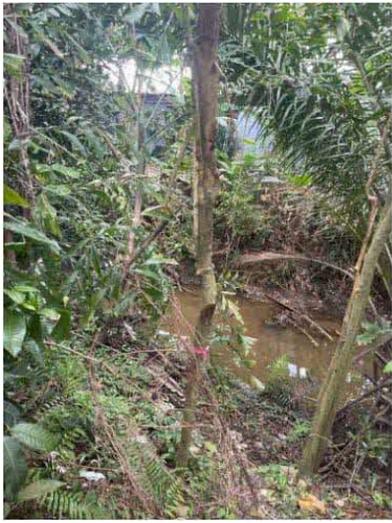
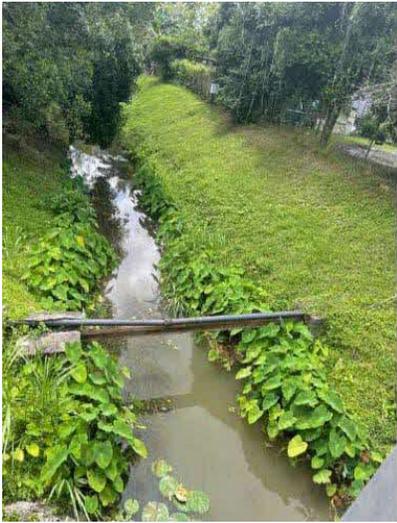
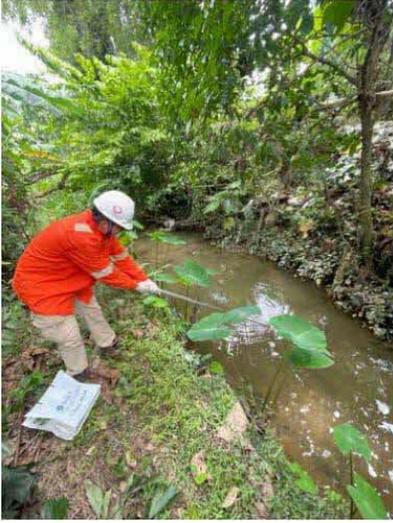
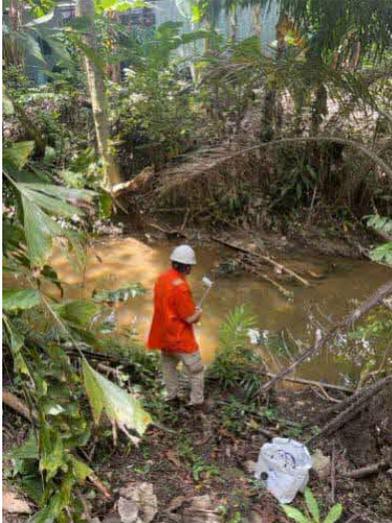
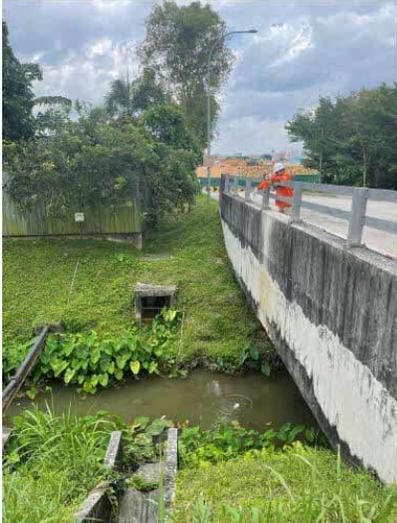
Dry Weather Sampling (16th September 2024)

N1.415288 E103.825582	N1.414805 E103.826496	N1.414522 E103.827263
14:08	13:55	13:48

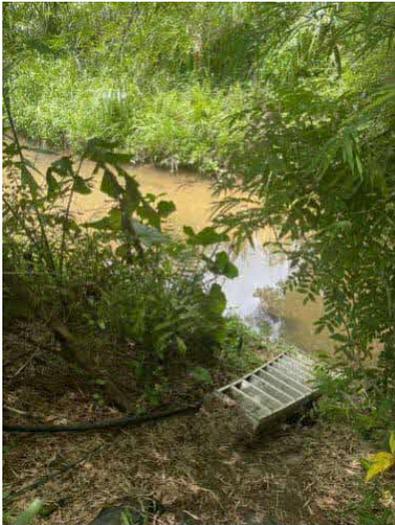
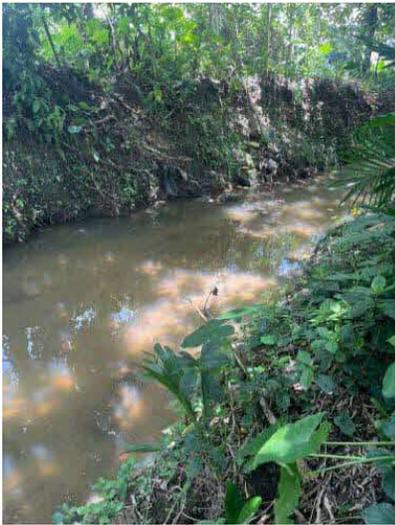
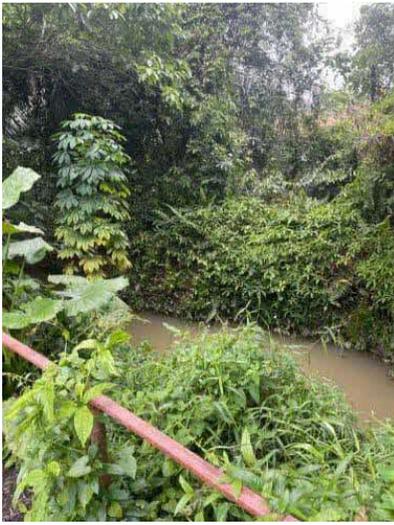
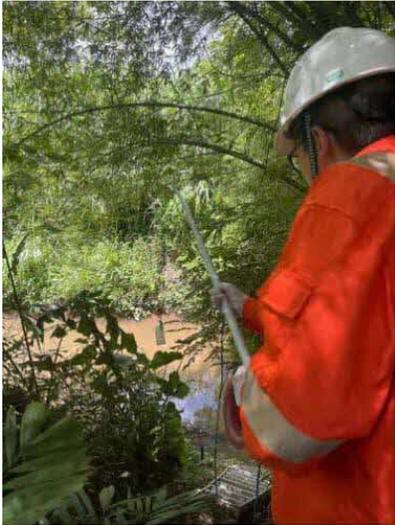
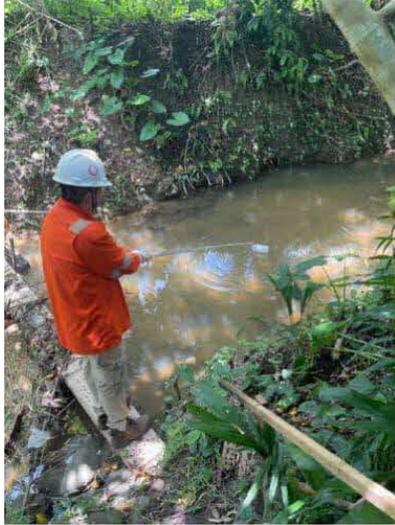
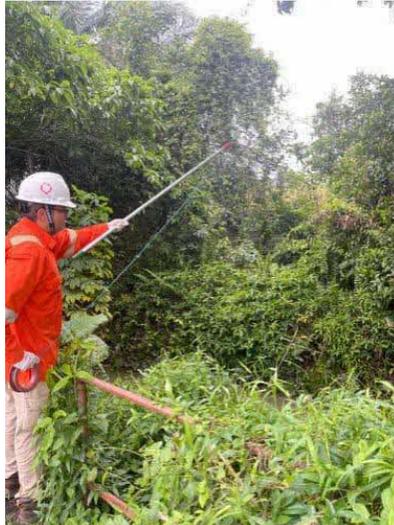
Dry Weather Sampling (16th September 2024)

N1.414387 E103.828366	N1.414381 E103.828392	N1.413768 E103.829819
13:38	13:30	13:15

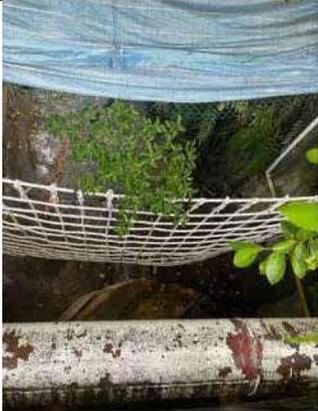
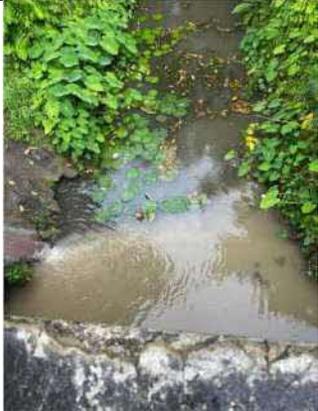
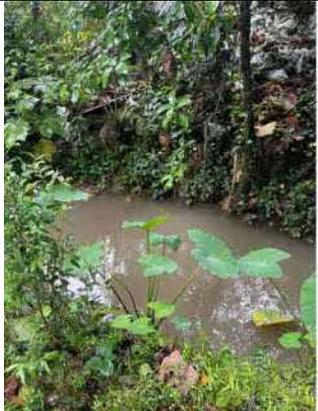
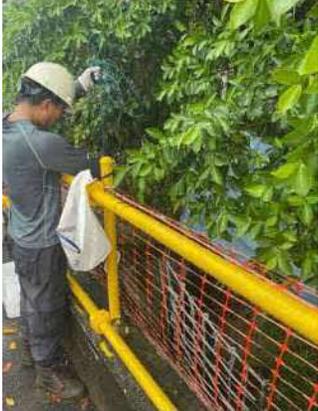
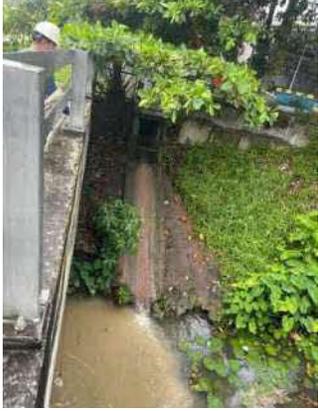
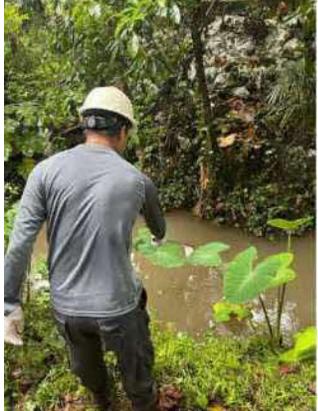
Wet Weather Sampling (23rd September 2024)

WQ1	WQ2	WQ3
GPS coord	N1.416058 E103.823878	N1.415758 E103.824835	N1.415311 E103.825632
Time of Sampling	17:00	16:53	16:47
Remarks

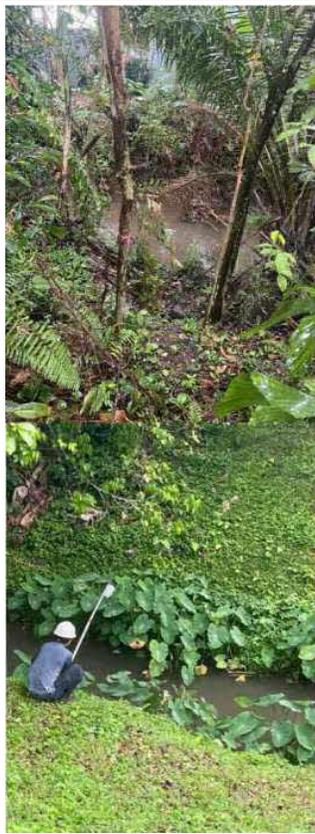
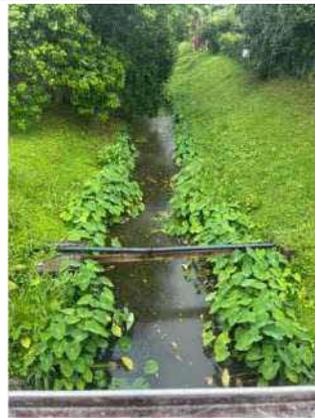
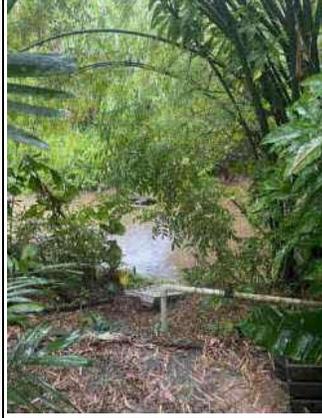
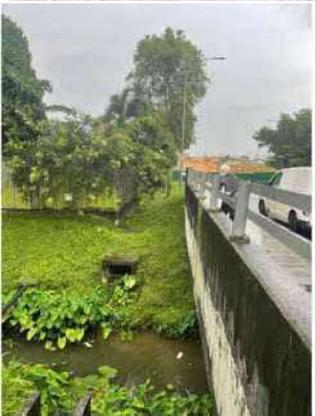
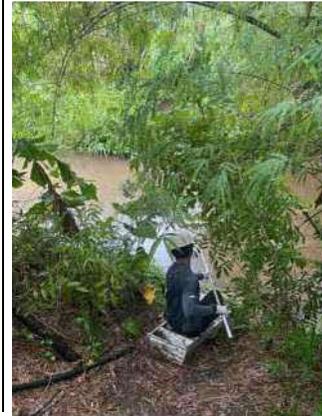
N1.414704 E103.826618	N1.414582 E103.827252	N1.414416 E103.827847
16:40	16:34	16:26
<p>Sampling location shifted approx. 10m downstream as the original location was too slippery to access. Top photo shows original sampling location.</p>

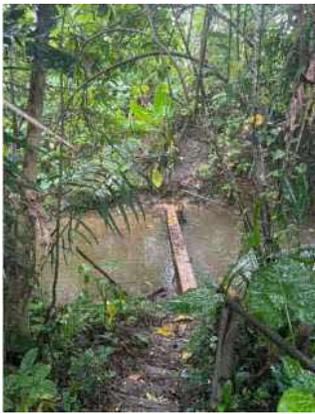
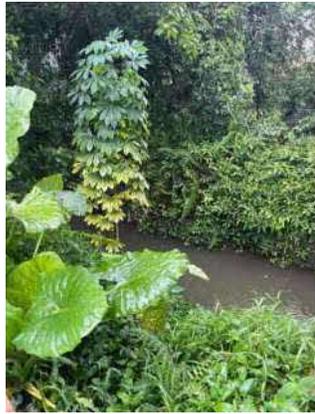
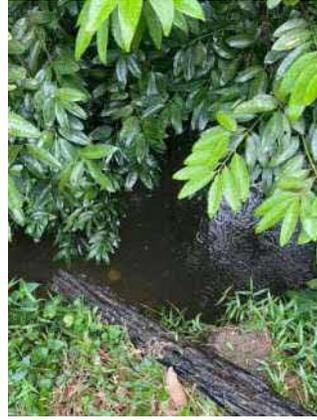
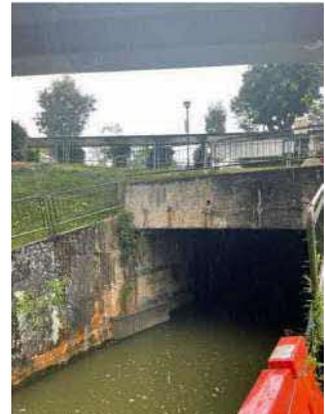
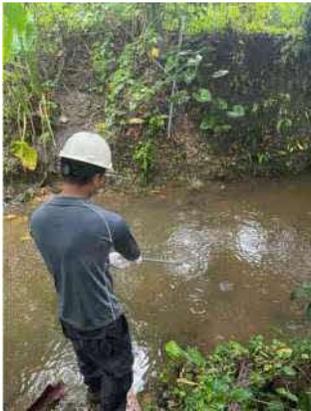
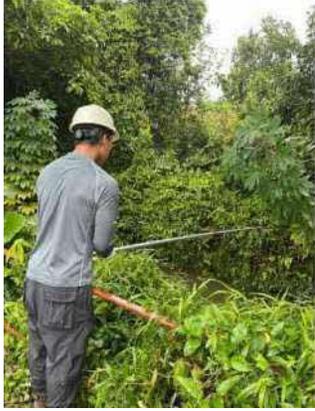
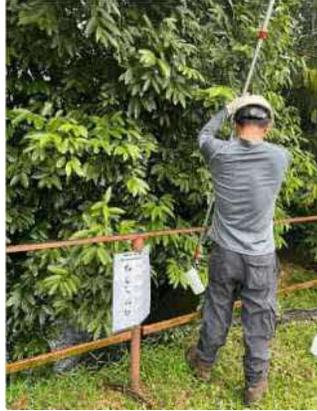
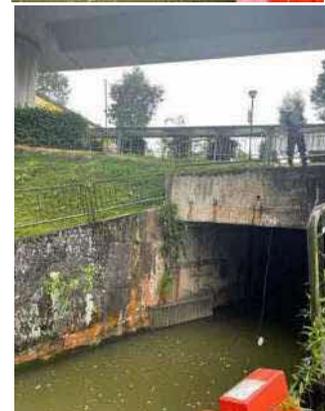
Wet Weather Sampling (23rd September 2024)

N1.414412 E103.828335	N1.413816 E103.829829	N1.413561 E103.830328	N1.413165 E103.830955
16:20	16:15	16:10	16:05
