# Louvred windows

The images below show the different parts of a louvred window:

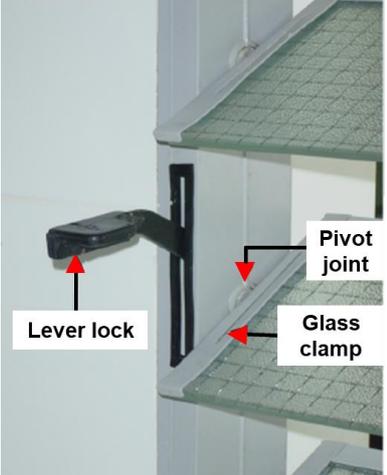
Adjustable louvred window	Fixed timber/ aluminium louvred window

<p>Lever lock</p> <p>Pivot joint</p> <p>Glass clamp</p>

<p>Glass panes are secure and not cracked</p> <p>Lever lock works properly</p> <p>U-cleat provided</p>

4) Lever lock is too tight/ does not work smoothly	<ul style="list-style-type: none"> <li>• Apply lubricant to the pivot joints</li> <li>• Remove and refrain from hanging heavy objects on the lever lock</li> </ul>

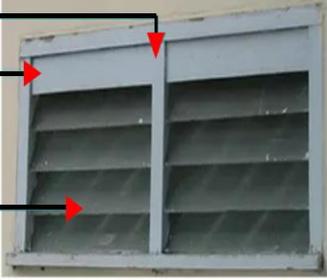
<p>Frame and shielding plate are in good condition</p> <p>Glass panes are secure and not cracked</p>

Problems	Solutions/ Requirements
1) Worn out or damaged frame and shielding frame	<ul style="list-style-type: none"> <li>• Engage a BCA-approved window contractor listed with HDB to replace the window and frame</li> <li>• For louvred window on the façade of building, ensure that wired-glass panes and U-cleats are installed</li> </ul>

2) Peeling paint on the frame	<ul style="list-style-type: none"> <li>• Repaint the frame</li> </ul>
3) Cracked or loose glass panels	<ul style="list-style-type: none"> <li>• Engage a BCA-approved window contractor listed with HDB to replace any cracked glass panes with wired-glass panes and checked that U-cleats are installed</li> </ul>
<b>Additional problem for adjustable louvred windows</b>
